2017 Flood System Status Report

AUGUST 2017

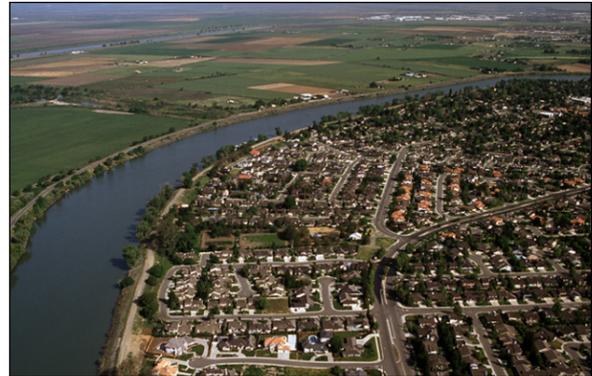
Opposite sides of a river reach can have different flood risks because of different consequences of failure

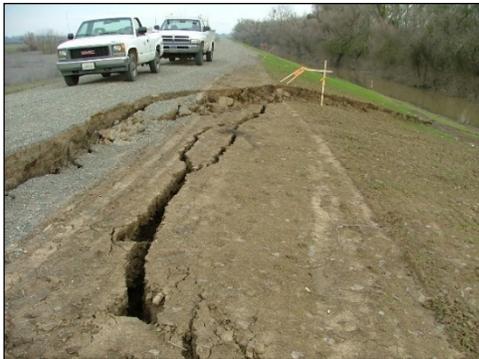
Levee stability concerns

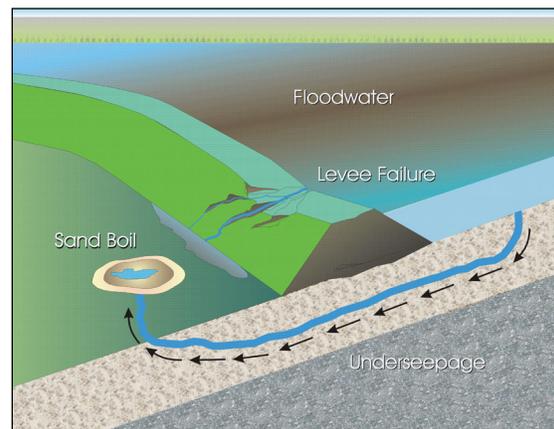
Levee underseepage

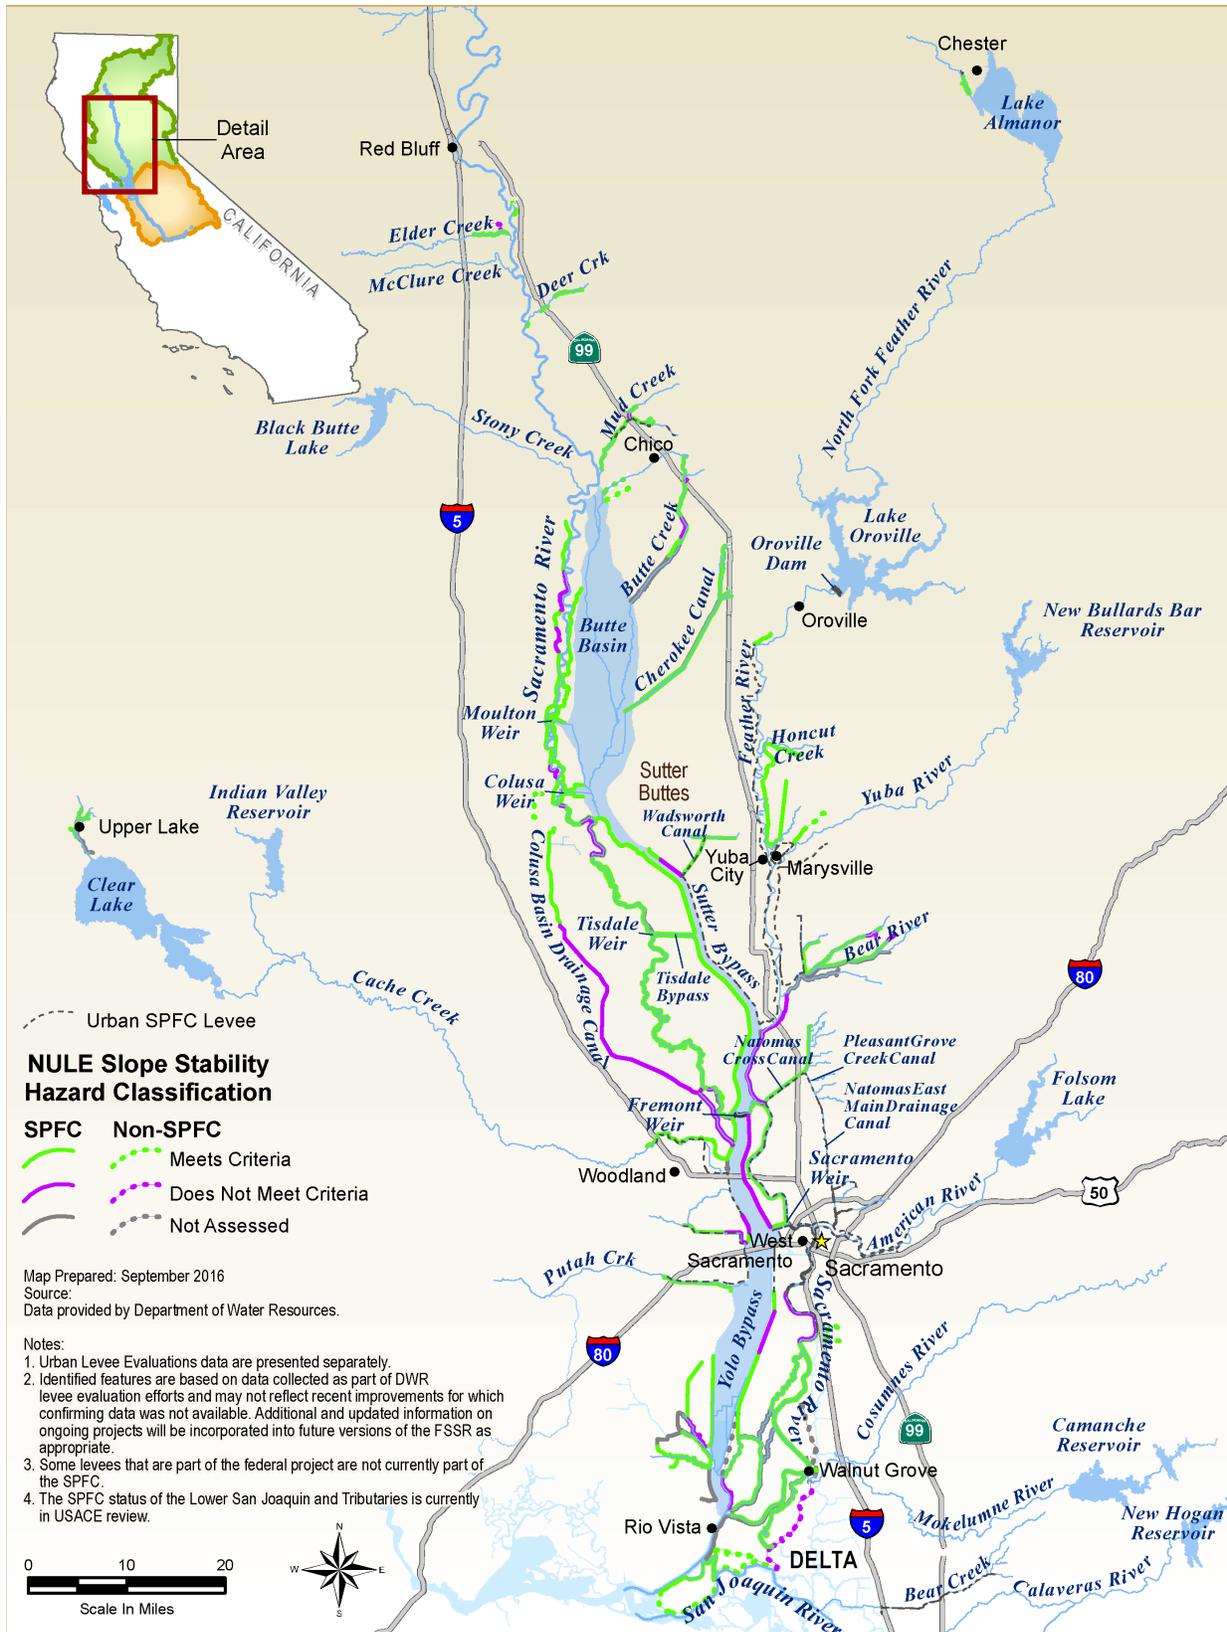
Figure 4-12. NULE Slope Stability Hazard Categorizations in the Sacramento River Watershed

Approximately one-eighth of SPFC NULE levees in the Sacramento River watershed and 1 percent in the San Joaquin River watershed have a high slope stability hazard.

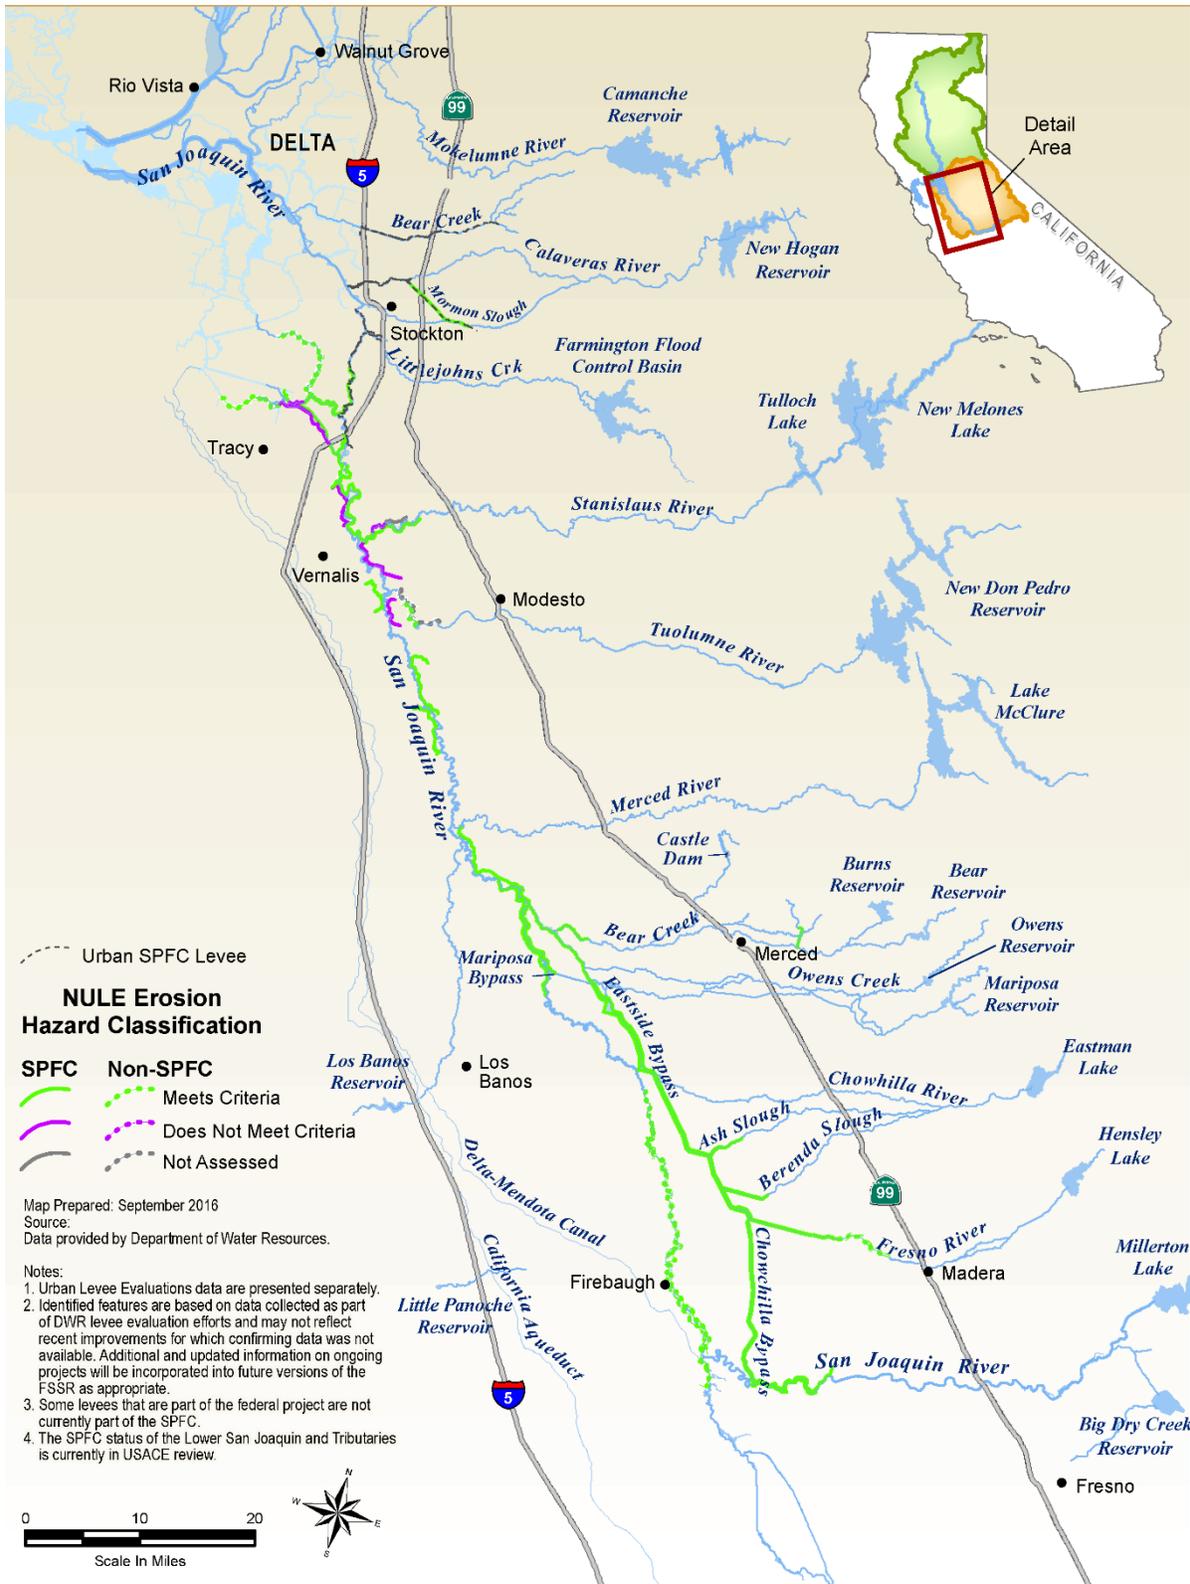
Figure 4-16. NULE Erosion Hazard Categorizations in the San Joaquin River Watershed

The majority of NULE levees in the San Joaquin River watershed were categorized as having a low erosion hazard. The approximately one-eighth of SPFC NULE levee segments with high erosion hazard are predominantly located on the lower San Joaquin River (downstream from the Tuolumne River confluence), at Berenda Slough, and on the Fresno River.

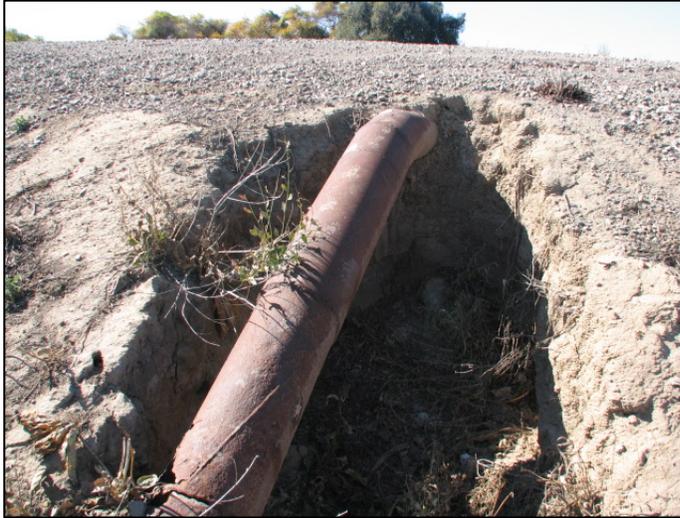
Penetrations can be potential pathways for seepage

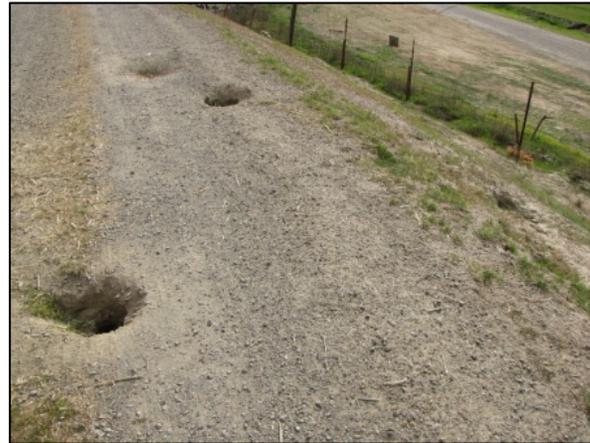
Animal burrows can increase seepage through a levee

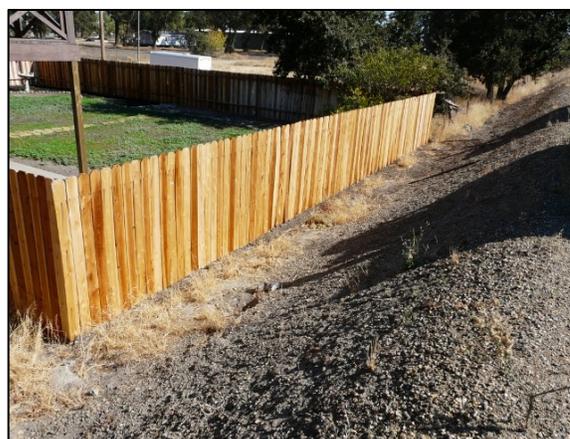
Encroachments can interfere with floodfighting, inspection, and maintenance
