Bulletin 250

Fish Passage Improvement

An Element of CALFED's Ecosystem Restoration Program

June 2005

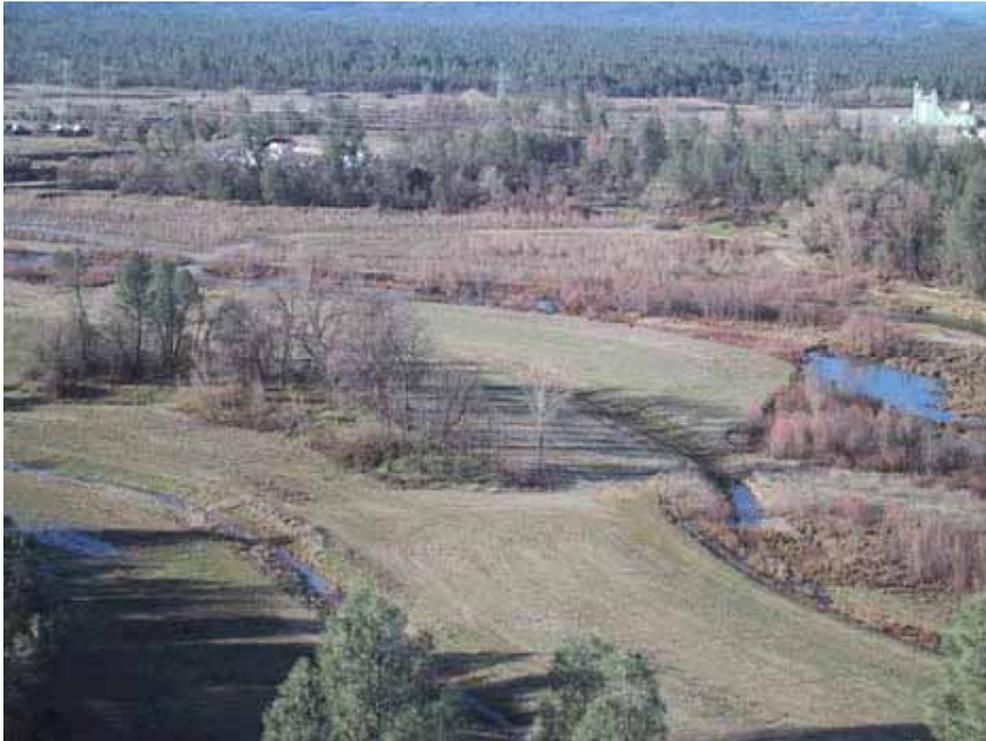
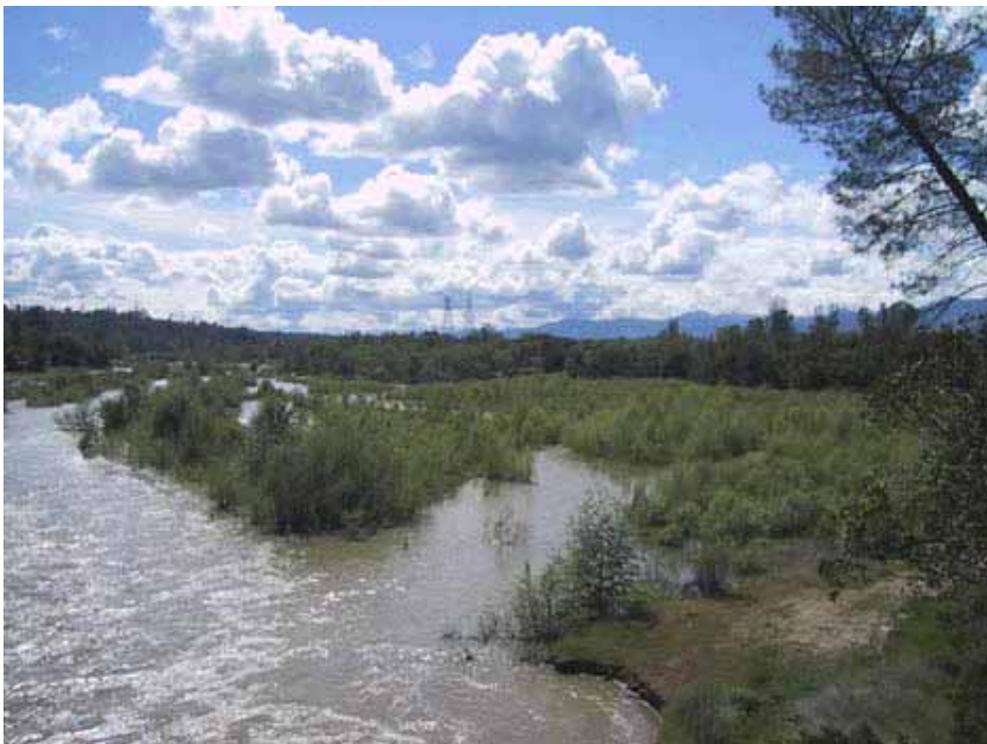
Photos 3-1 and 3-2 The Lower Clear Creek Floodway Rehabilitation overview (top photo) and the new floodplain at work

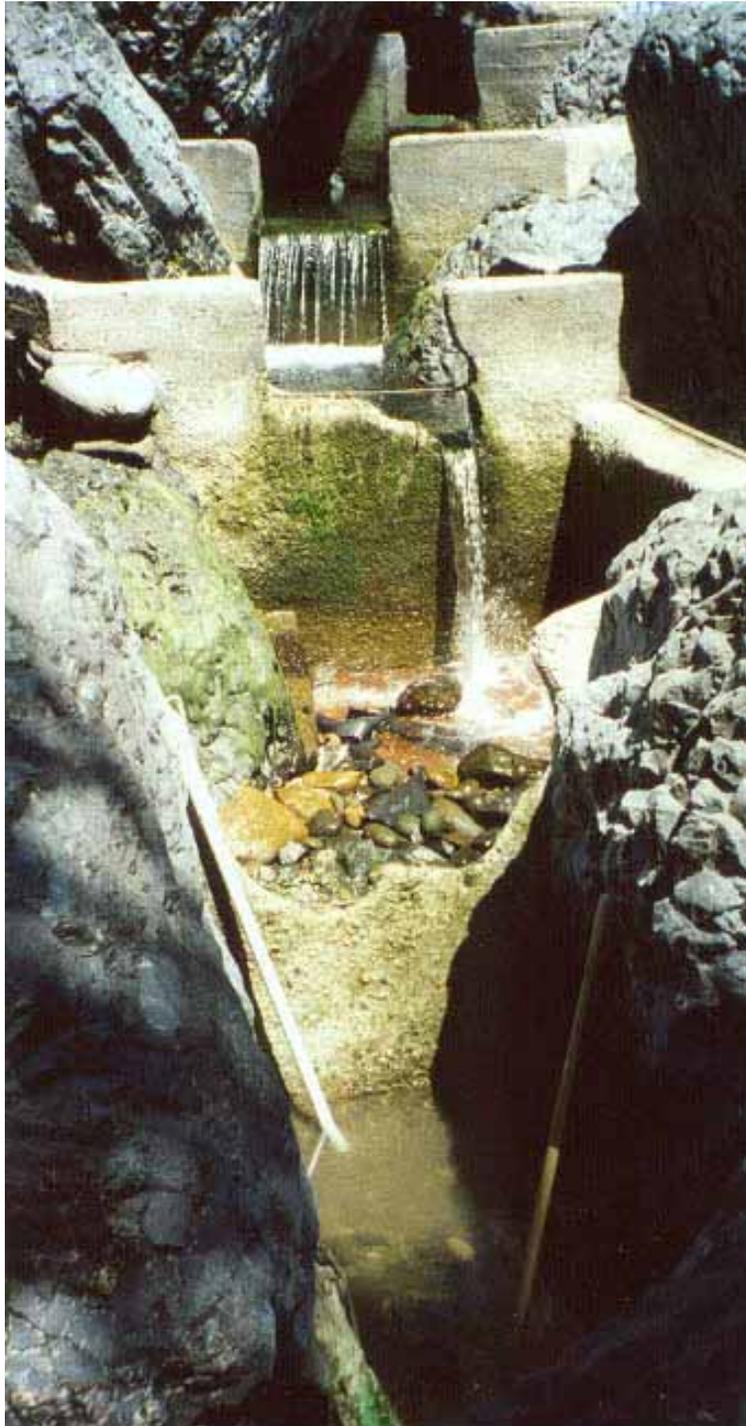
Photo 4-3 Big Chico Creek—Iron Canyon's worn concrete and collapsed floor

Photo 4-3 Big Chico Creek—Iron Canyon's worn concrete and collapsed floor /DWR photo

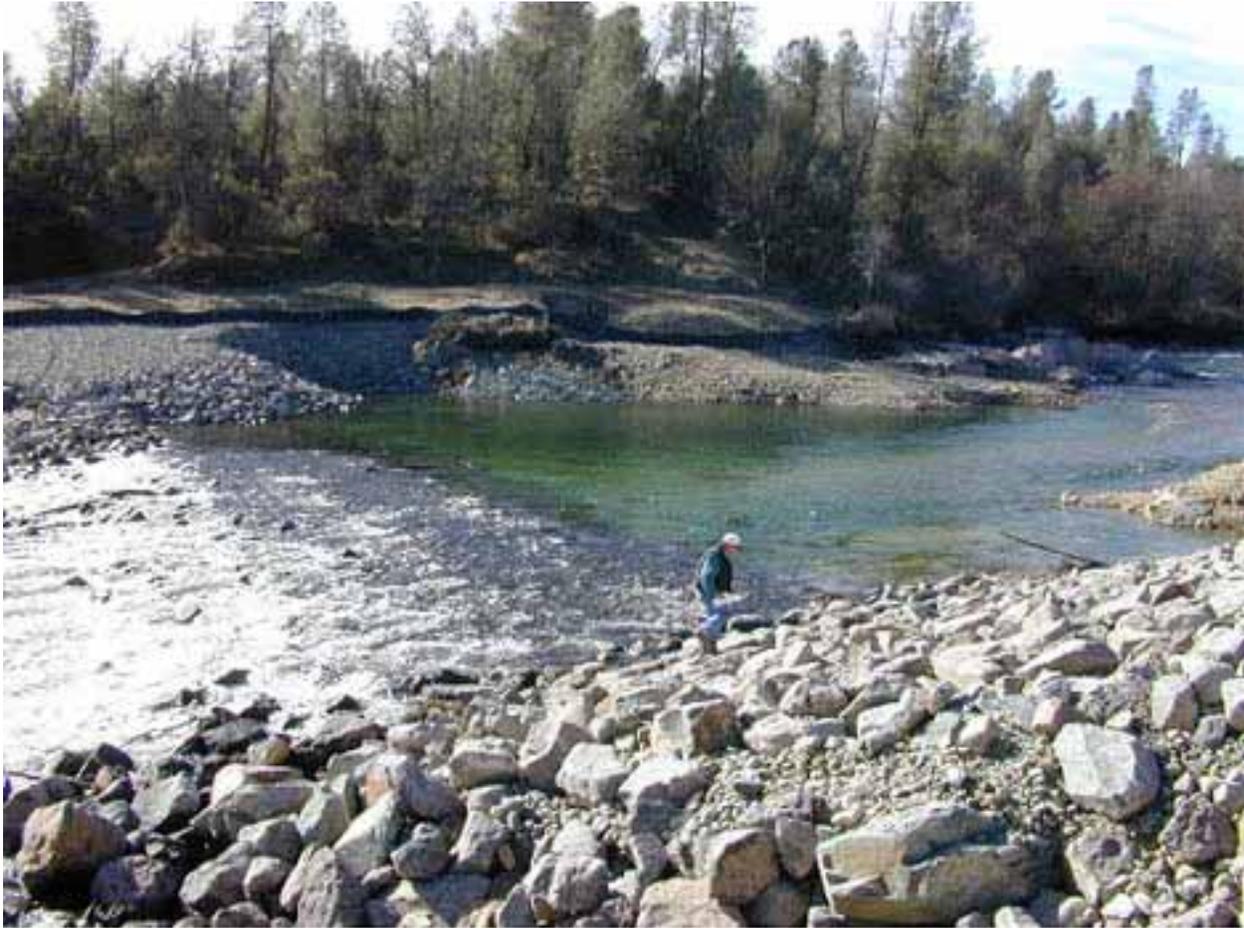
Photo 4-7 Clear Creek—Saeltzer Dam Berm (Shasta County) before removal of armored gravel berm

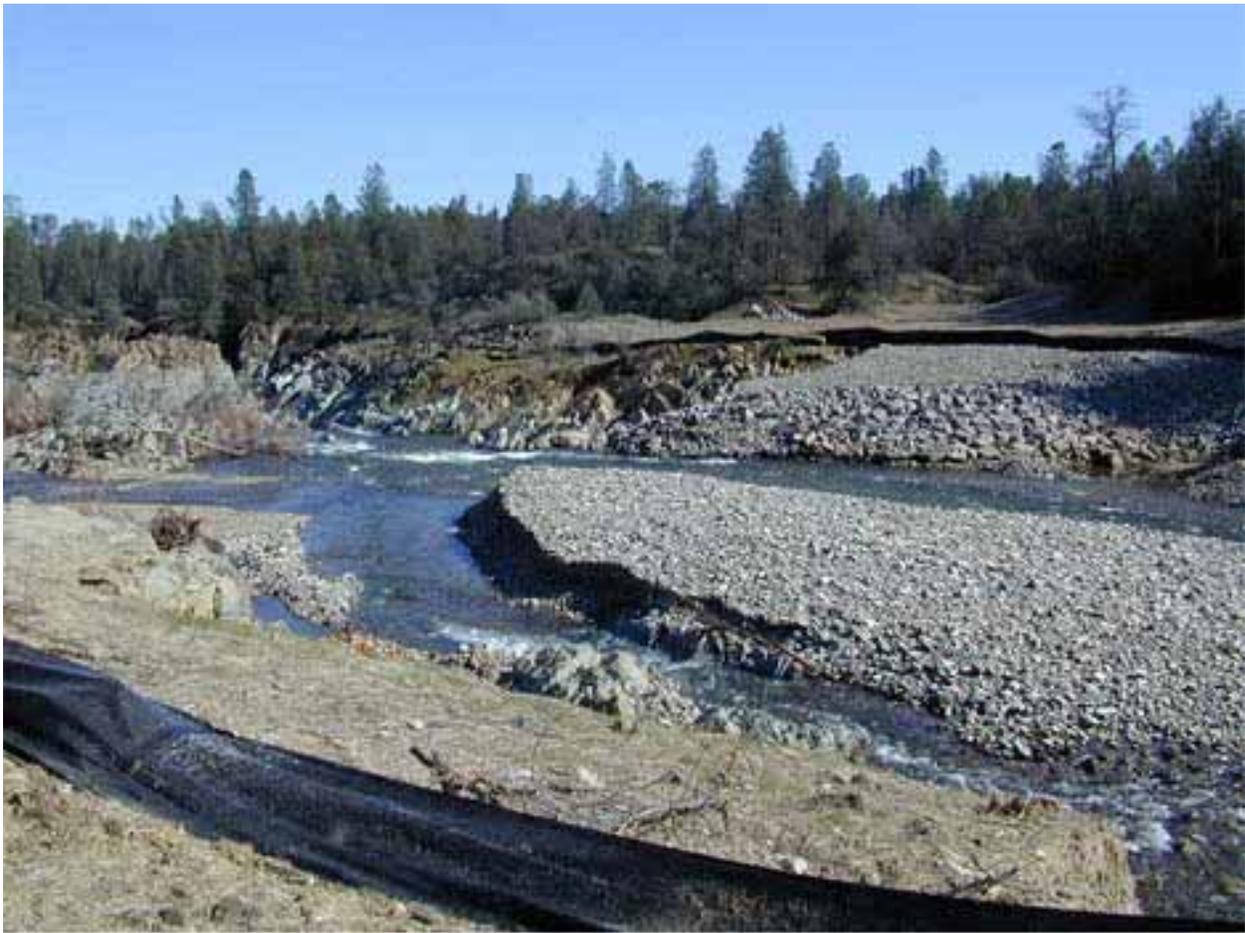
Photo 4-8 Clear Creek after removal of armored gravel berm

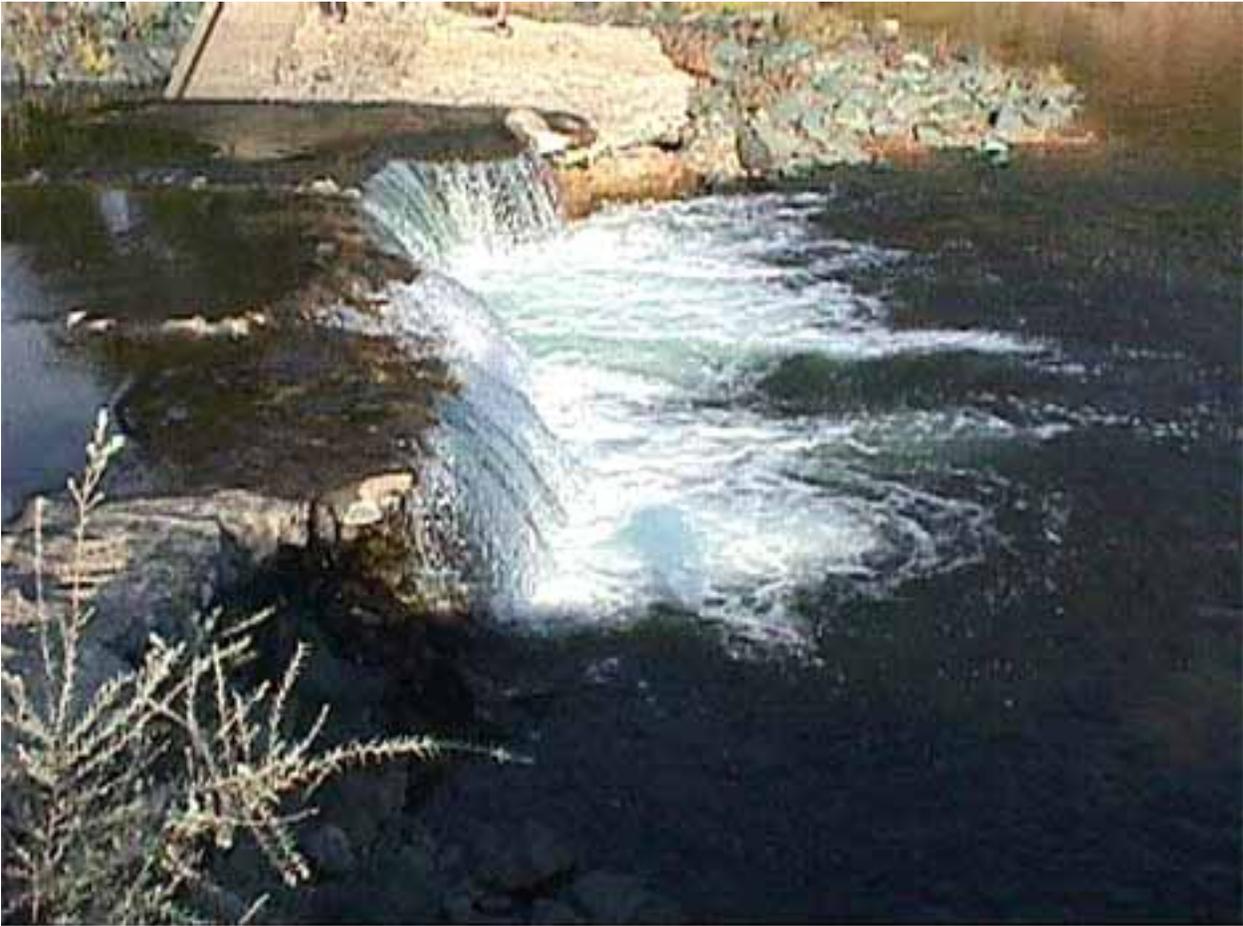
Photo 4-13 Cosumnes River—Blodgett Dam after flood damage

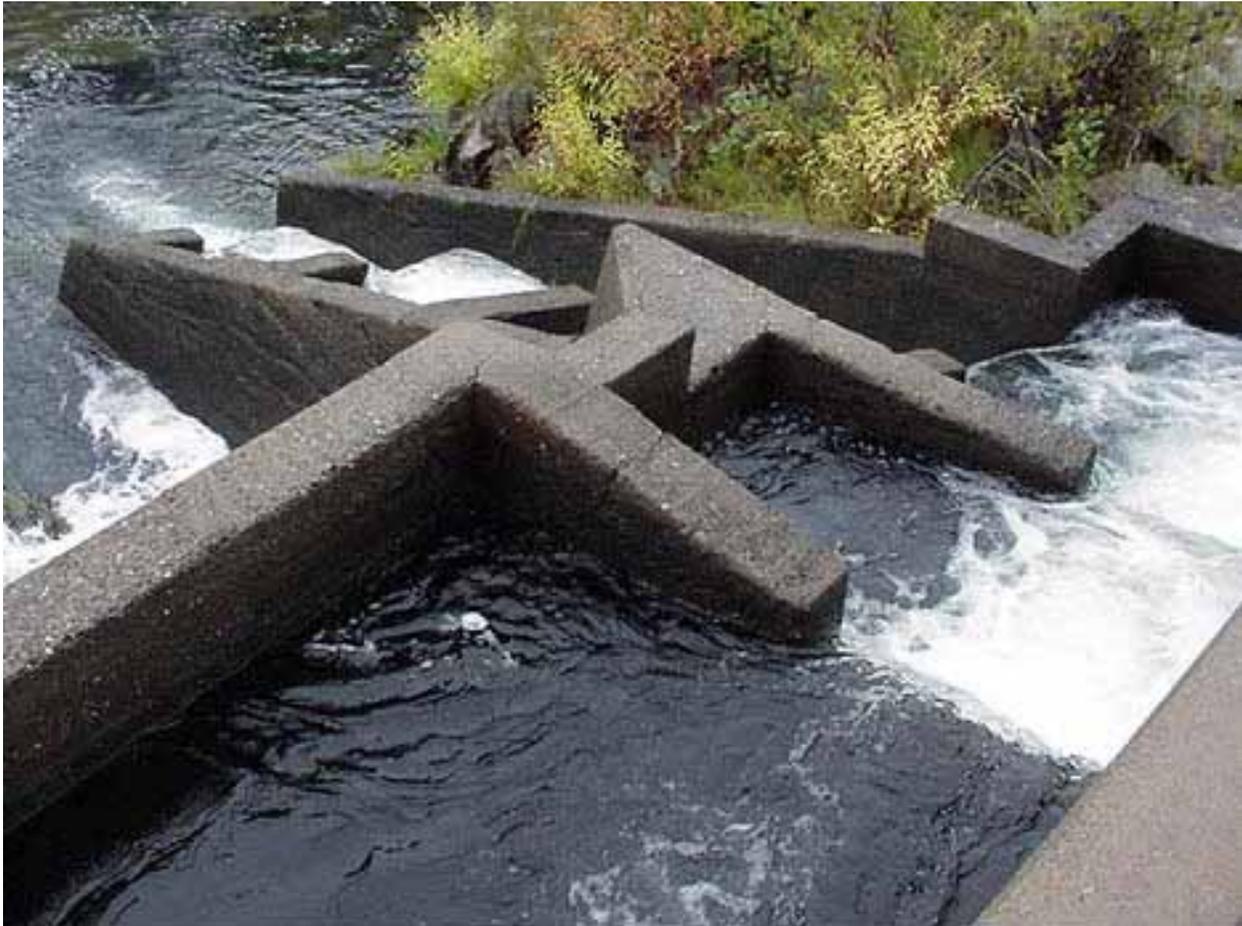
**Photo 4-15 Cosumnes River—fish ladder at North Granlees Dam
(Retrofit in 2003)**

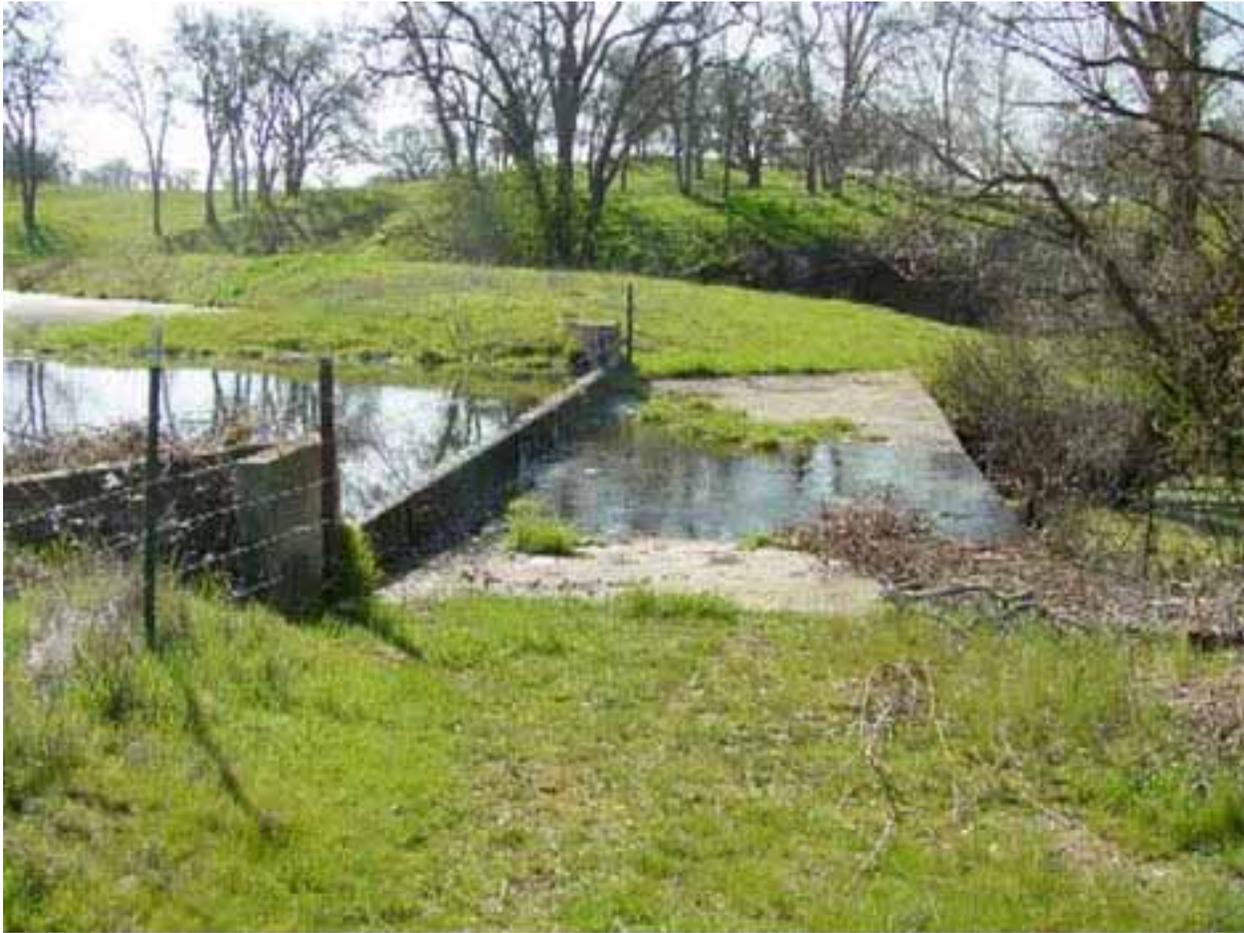
Photo 4-18 Murphy Creek–Sparrowk Dam with concrete spillway in foreground, dam in background (Amador and San Joaquin counties)

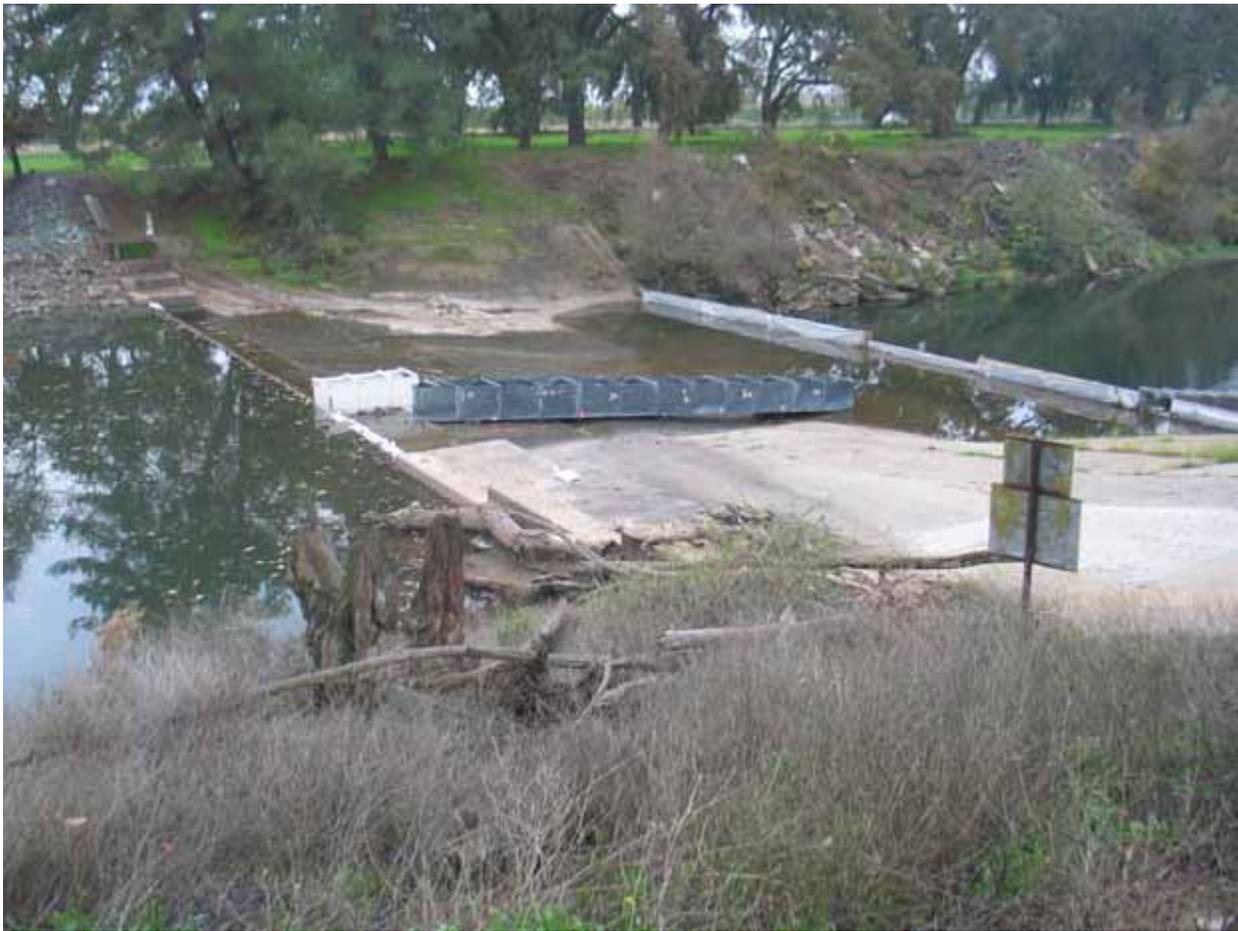
Photo 4-23 Mormon Slough—Bellota Weir with temporary fish ladder

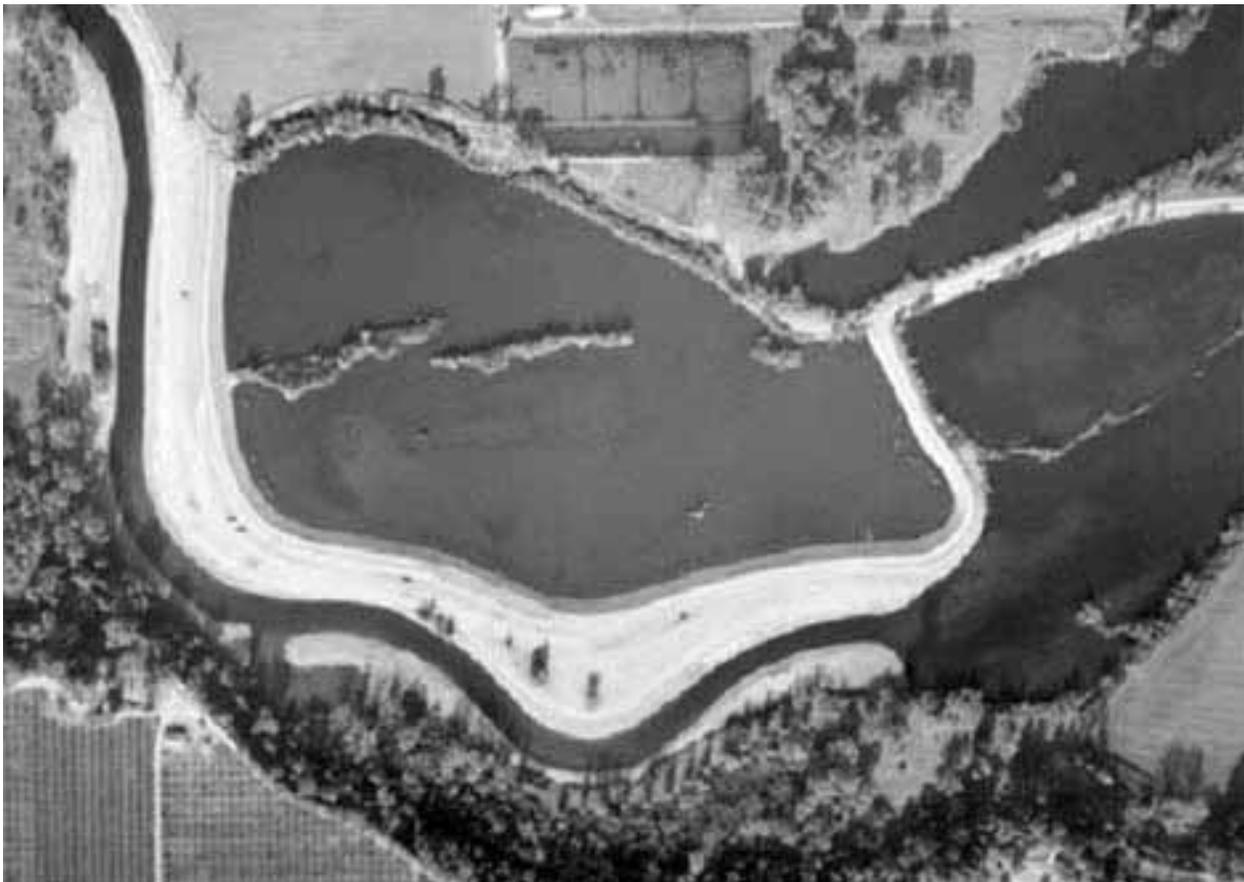
Photo 4-25 Merced River—Ratzlaff gravel pit after restoration (Merced County)

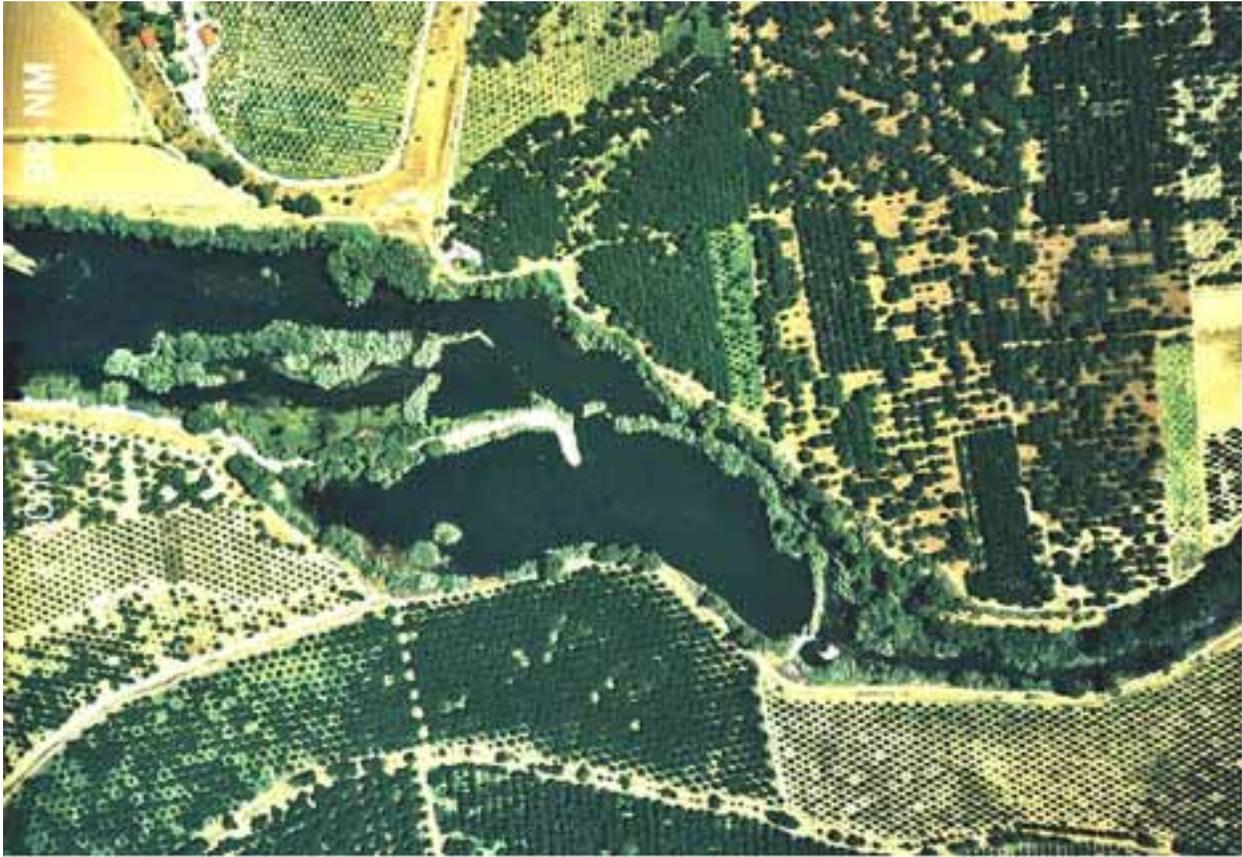
Photo 4-26 Stanislaus River—Oakdale Recreation Pond gravel pit isolation/restoration project
