2017 Flood System Status Report

AUGUST 2017

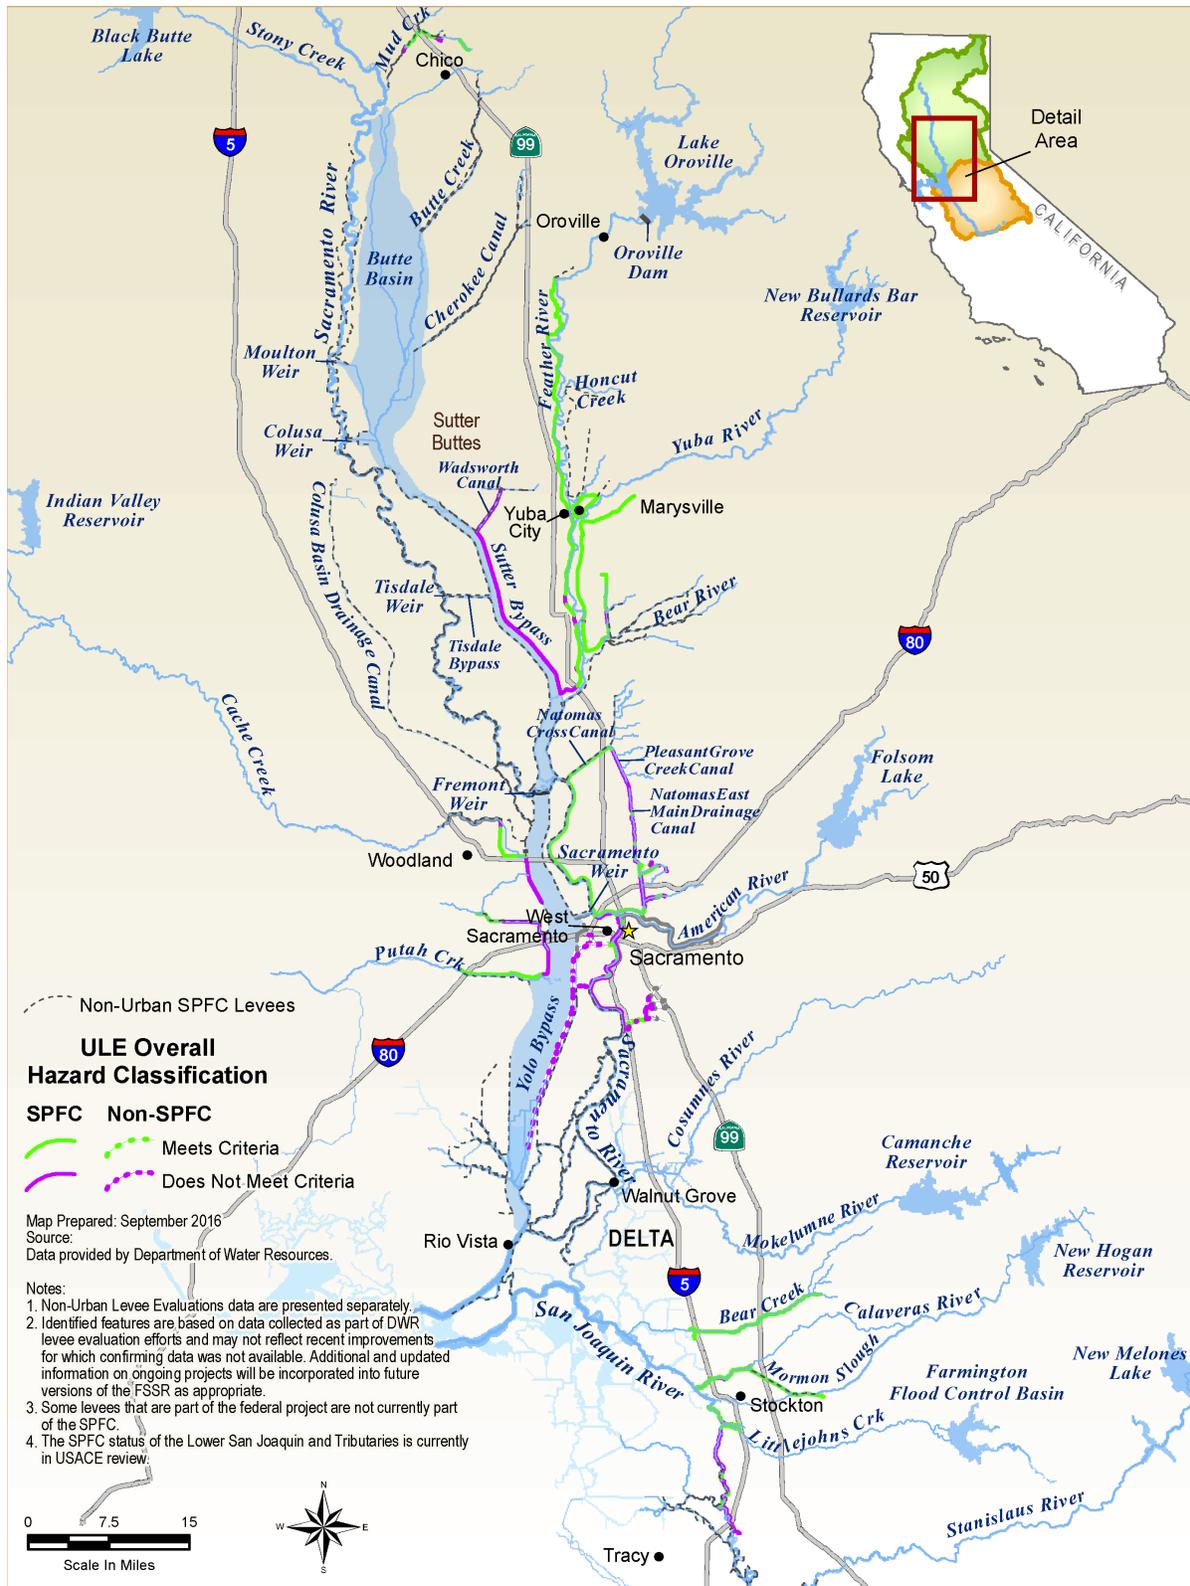
Figure 3-4. ULE Overall Hazard Classifications in the Sacramento and San Joaquin River Watersheds

Overall hazard classifications of SPFC ULE levee segments in the Sacramento and San Joaquin river watersheds are shown in Figure 3-4.

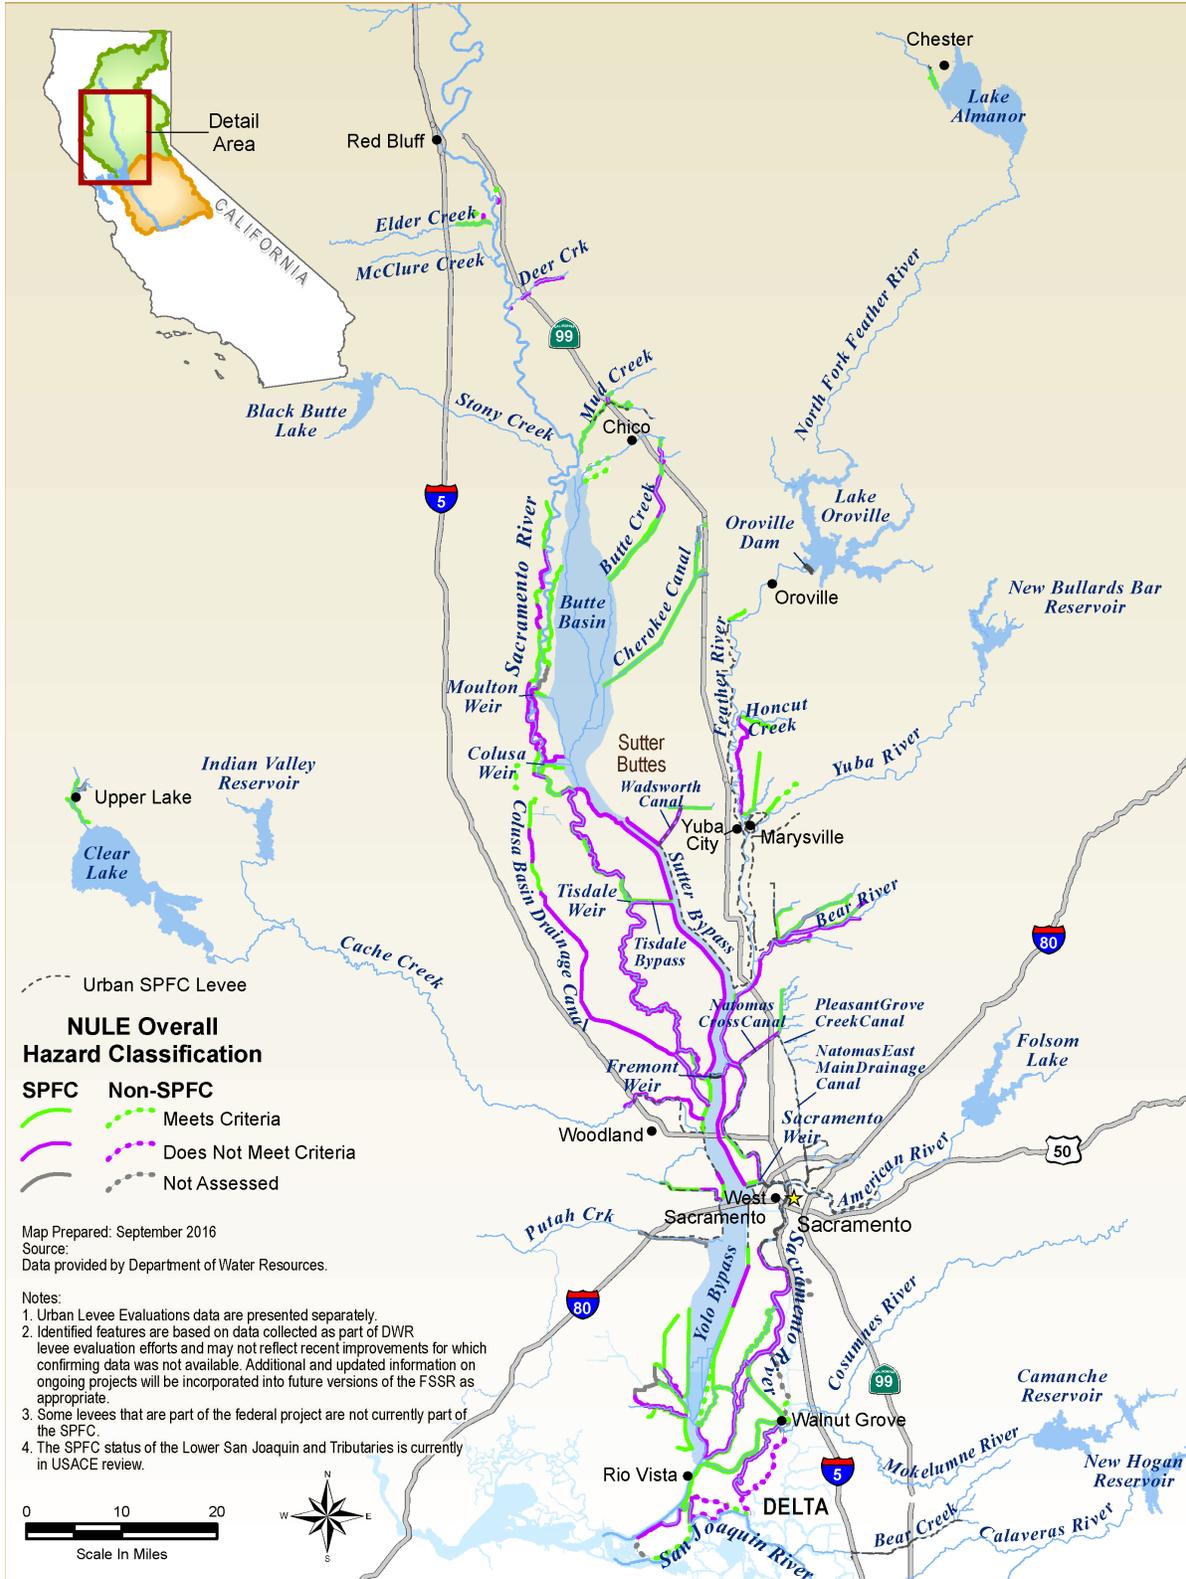
Figure 3-6. North NULE Study Area Overall Hazard Categorizations in the Sacramento River Watershed

Overall, just under three-fifths (54 percent) of NULE SPFC levees were categorized as “Does Not Meet Criteria” at the assessment water surface elevation. Just over two-fifths (43 percent) of NULE SPFC levees were categorized as “Meets Criteria”. In the Sacramento River watershed, NULE SPFC levees categorized as “Meets Criteria” are primarily along tributaries; none of the NULE SPFC levees along the Sacramento River were categorized as “Meets Criteria.” In the San Joaquin River watershed, NULE levees categorized as “Meets Criteria” were primarily along tributaries, with some short segments along the San Joaquin River.

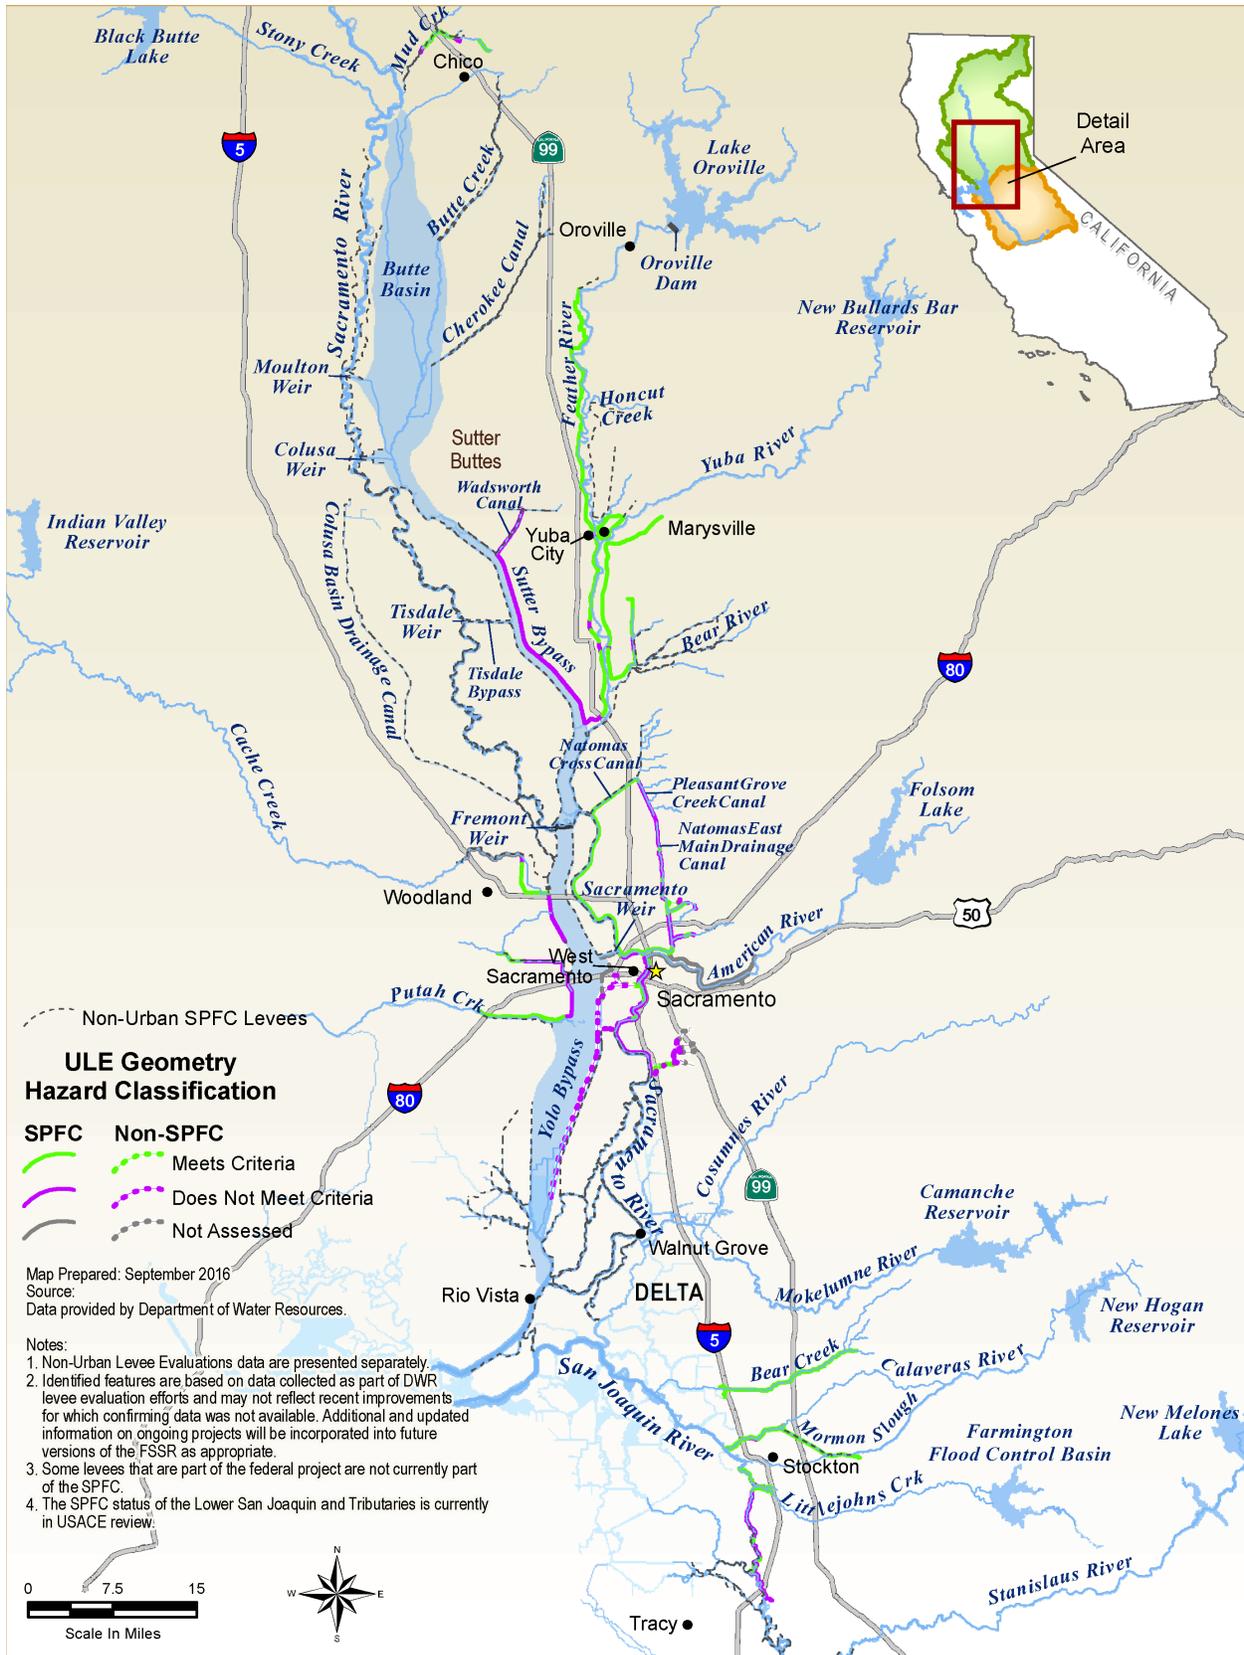
Figure 4-2. ULE Levee Geometry Check

Results of the geometry check for SPFC ULE levees are shown in Figure 4-2. The majority of SPFC ULE levees along the Feather River, American River, and Sacramento River north of the City of Sacramento were met standard levee design prism geometry criteria. Approximately one-third of SPFC ULE levees deviate from current standard levee design prism geometry. These levees were located along bypass features and associated tributaries to the west, and along the Sacramento River south of Sacramento. Geometry check results for SPFC ULE levees in the San Joaquin River watershed and elsewhere in the Sacramento River watershed varied.

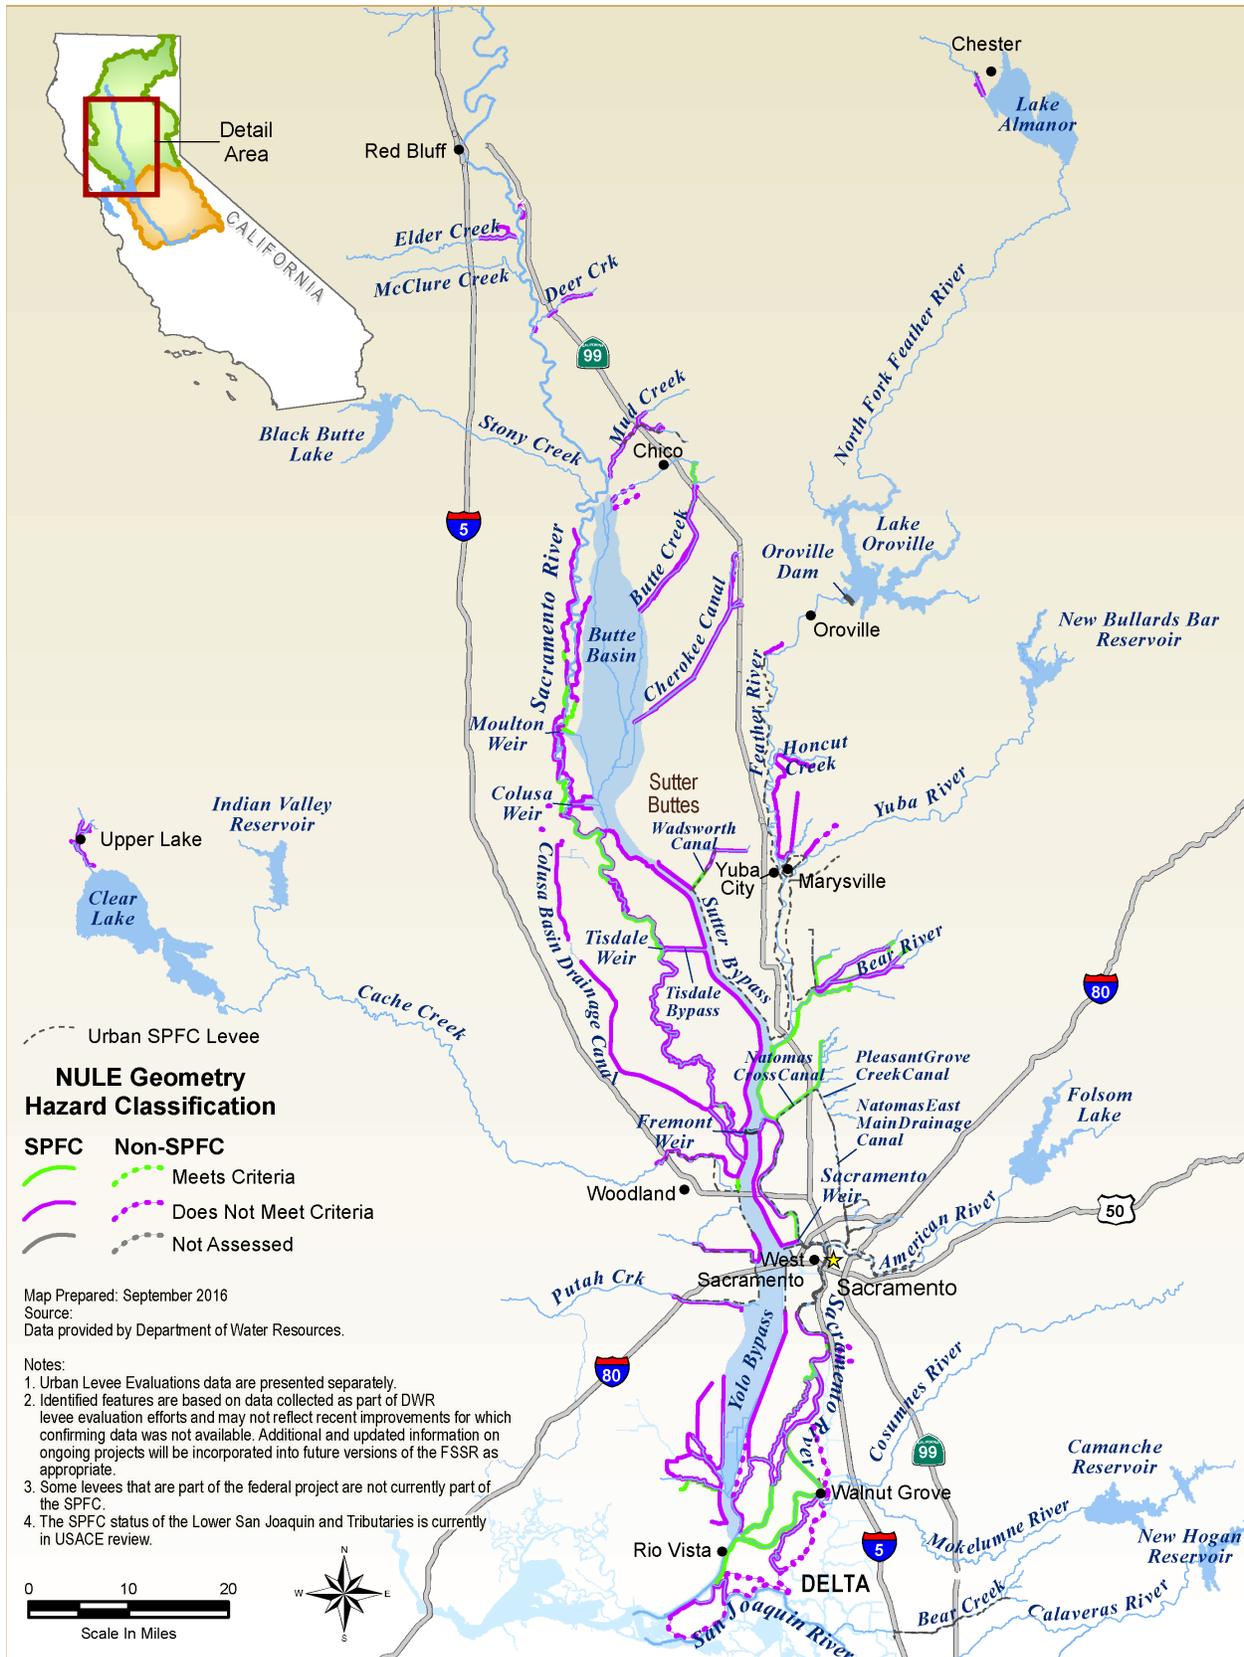
Figure 4-3. NULE Levee Geometry Check in the Sacramento River Watershed

Geometry check results for NULE levees are shown in Figures 4-3 and 4-4. The percentages mapped are the percentage of each NULE levee segment that deviated from standard levee design prism geometry. Compliance with minimum levee geometry criteria varied across the Sacramento and San Joaquin river watersheds. Results suggest that the San Joaquin river watershed and Sacramento River have the highest percentage of levees that conform to standard levee design prism geometry. Further, levees along the bypasses and along the tributary streams to the Sacramento River in the northern Sacramento River watershed have the lowest percentage of NULE levee segments that conform to standard levee design prism geometry. Results elsewhere along NULE levees were variable.

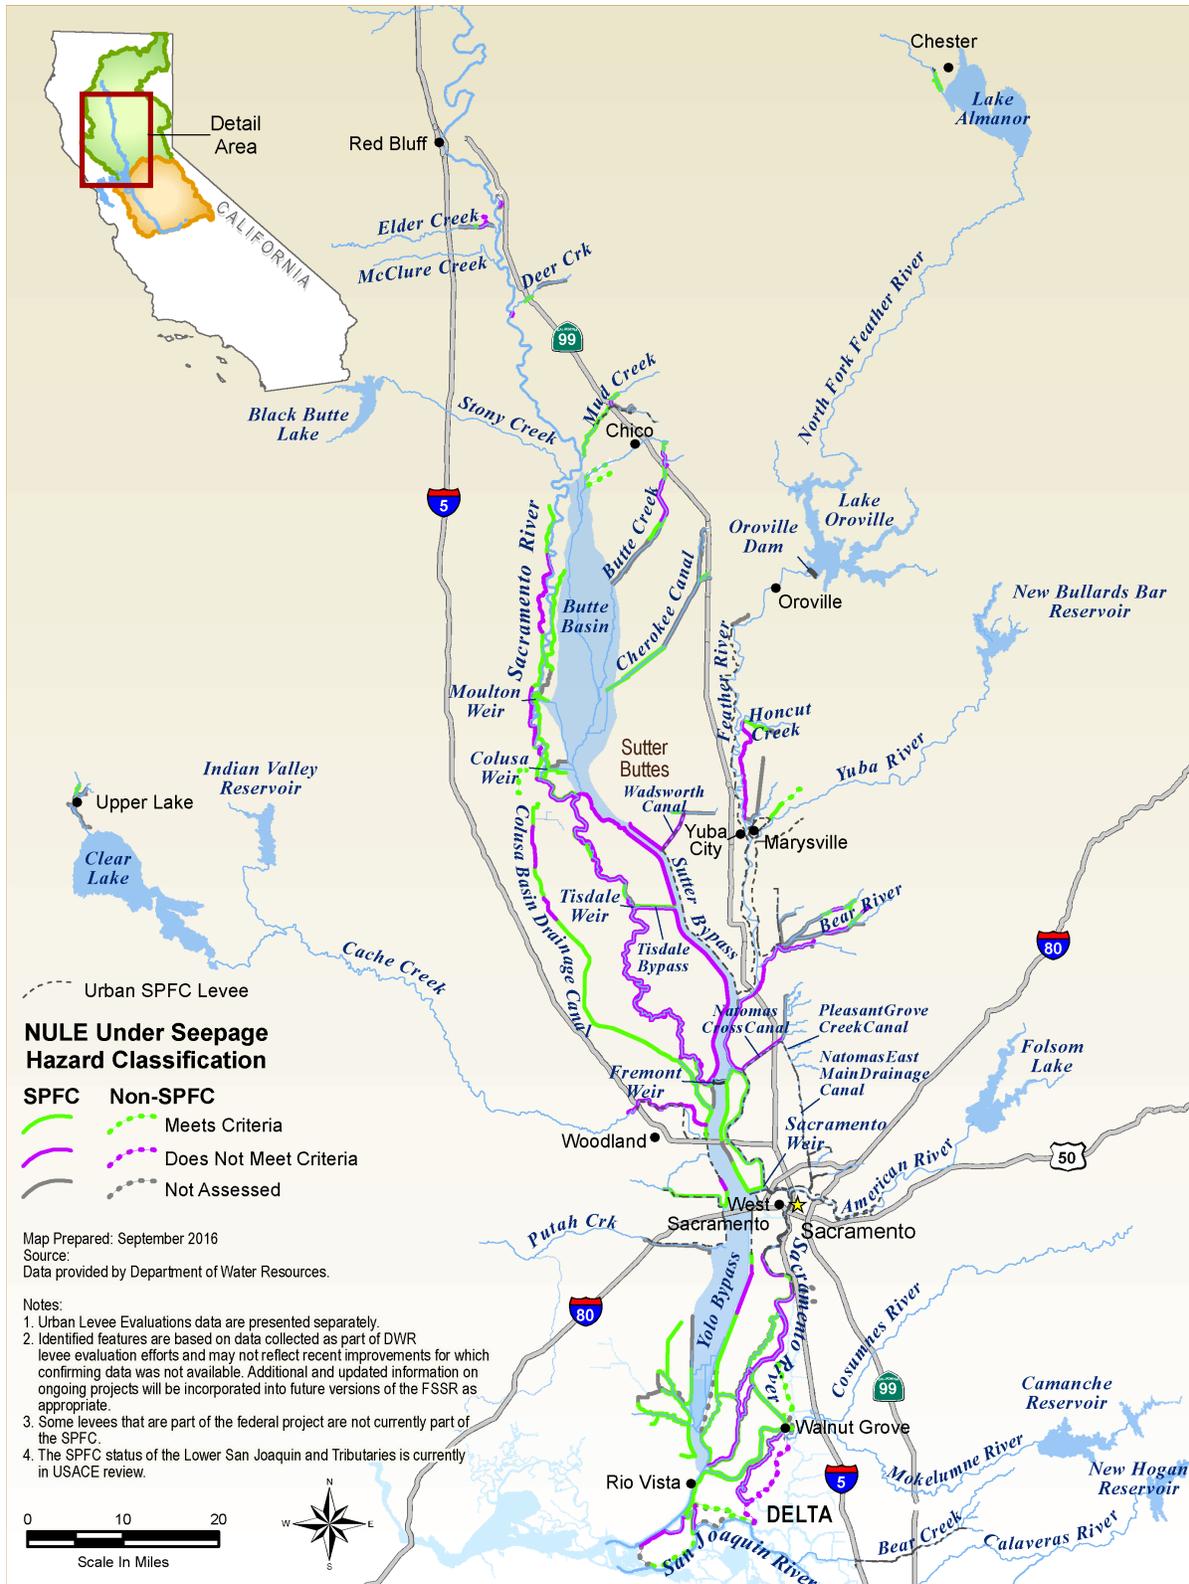
Figure 4-6. NULE Underseepage Hazard Categorizations in the Sacramento River Watershed

NULE underseepage hazard categorization results are shown in Figures 4-6 and 4-7. These figures show that approximately one-third of SPFC NULE levees in the Sacramento River watershed and almost two-thirds in the San Joaquin River watershed have a high underseepage hazard. Figures 4-9 and 4-10 show through seepage hazard categorizations for NULE levees in the two watersheds. In general, through seepage is less prevalent than underseepage; approximately one-eighth of SPFC NULE levees in the Sacramento River watershed and approximately half in the San Joaquin River watershed have a high through seepage hazard.

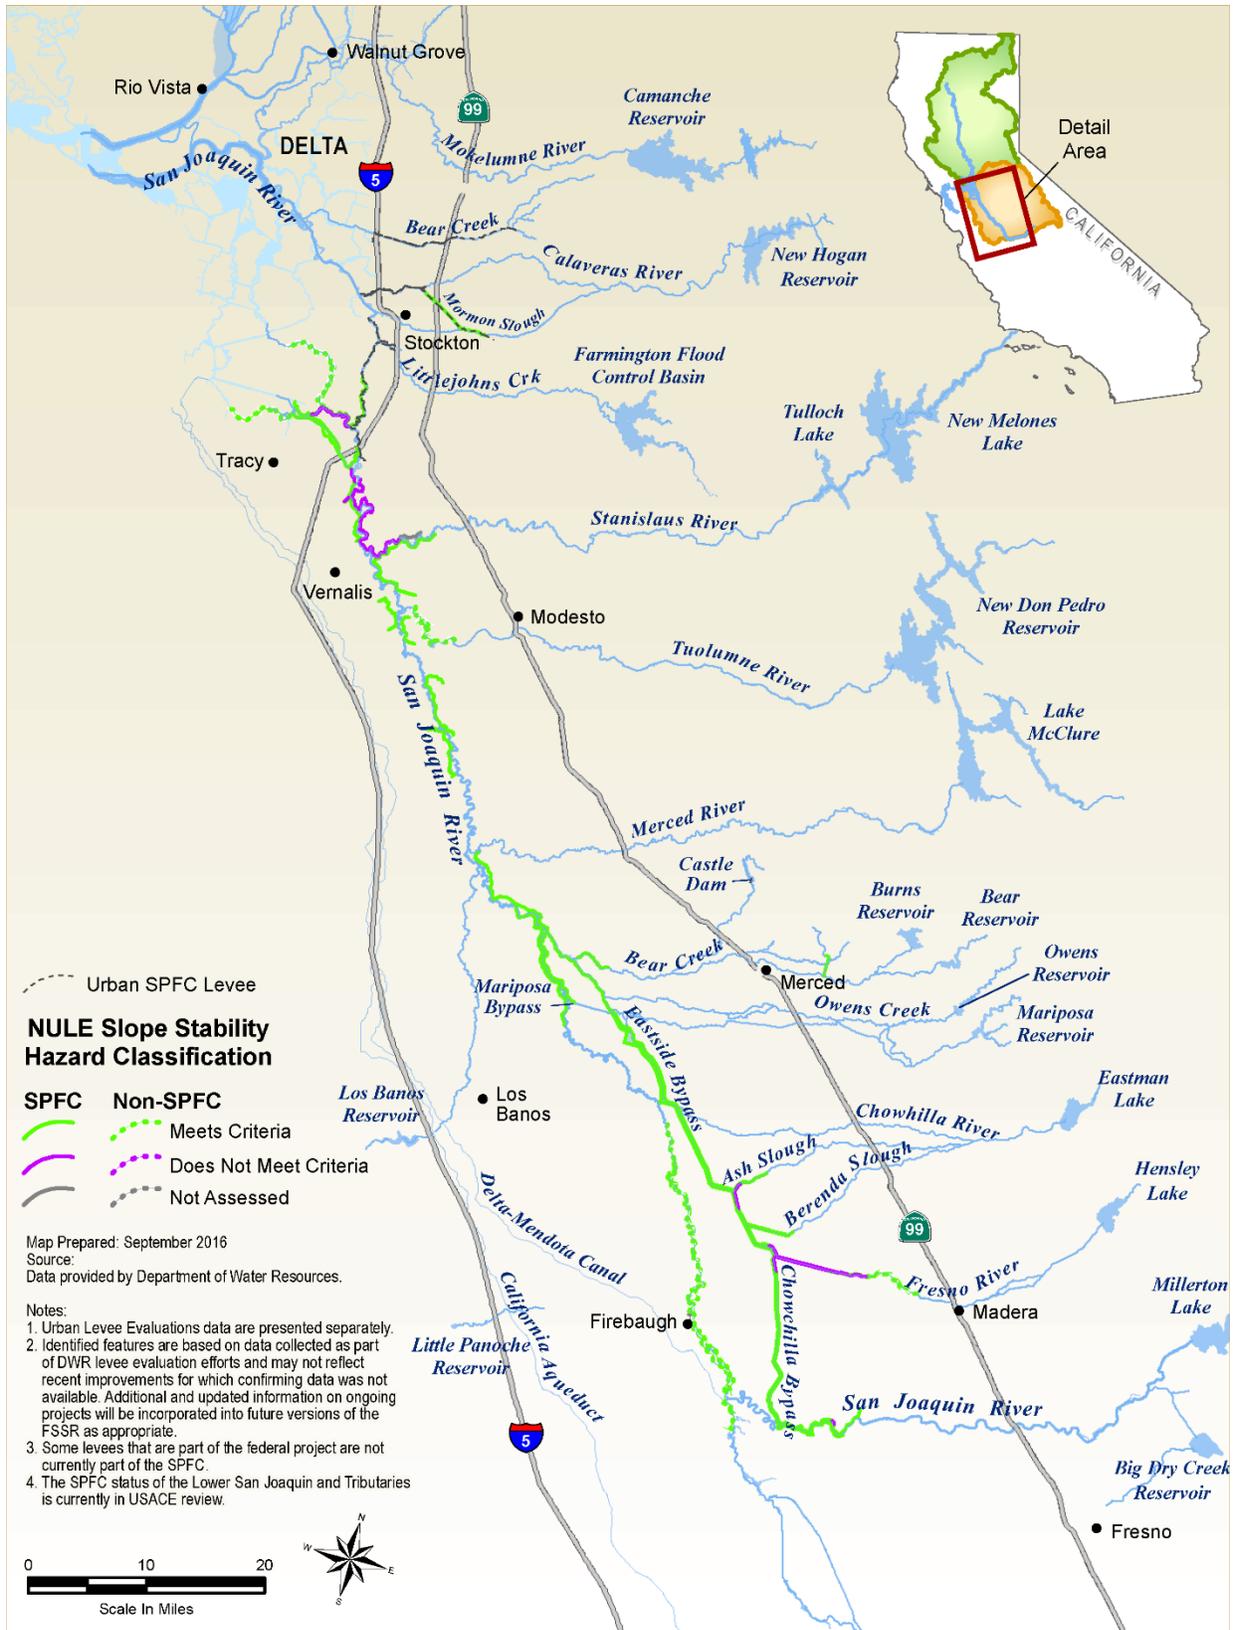
Figure 4-13. NULE Slope Stability Hazard Categorizations in the San Joaquin River Watershed

NULE slope stability hazard categories are shown in Figures 4-12 and 4-13. As shown, there is generally a higher slope stability hazard for levees in the Sacramento River watershed compared to the San Joaquin River watershed.

Approximately one-eighth of SPFC NULE levees in the Sacramento River watershed and 1 percent in the San Joaquin River watershed have a high slope stability hazard.

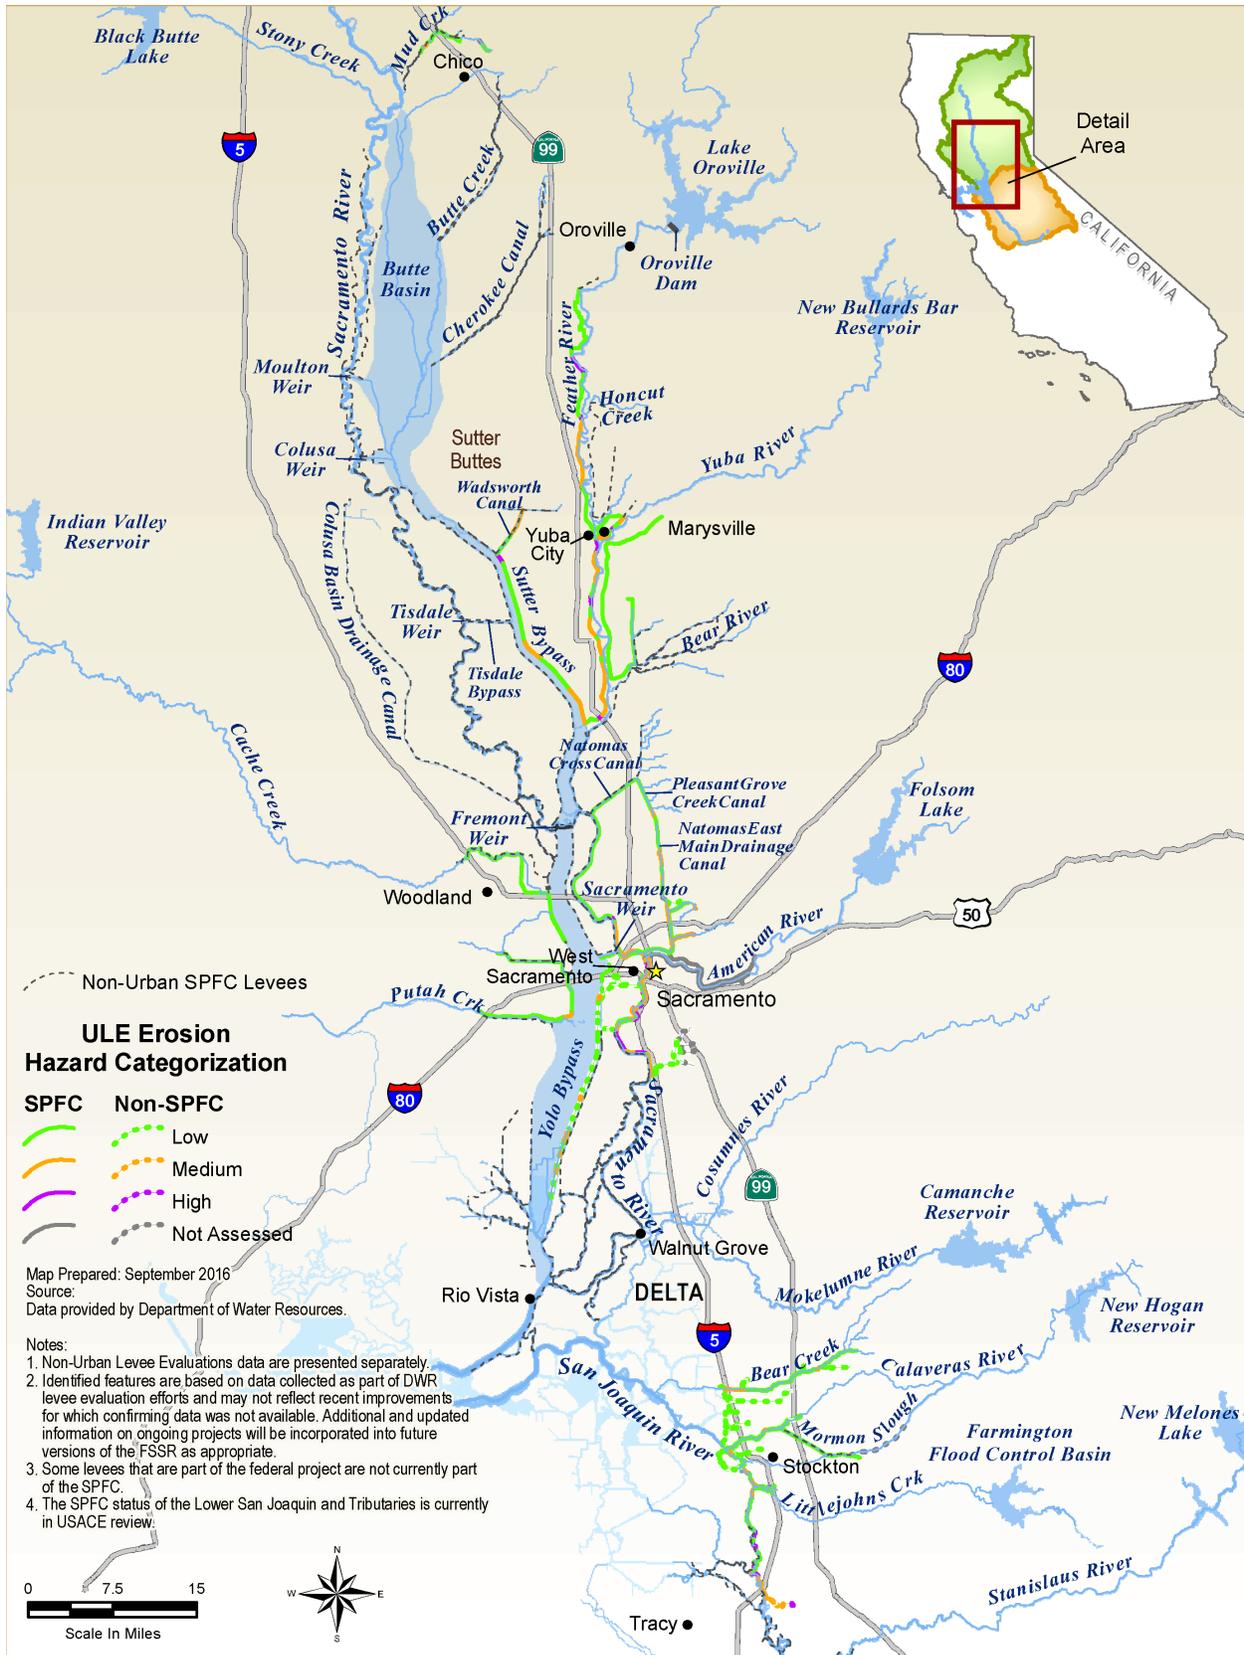
Figure 4-14. ULE Erosion Hazard Categorization

ULE has completed a hazard assessment specifically for levee erosion susceptibility; this is summarized in Figure 4-14.

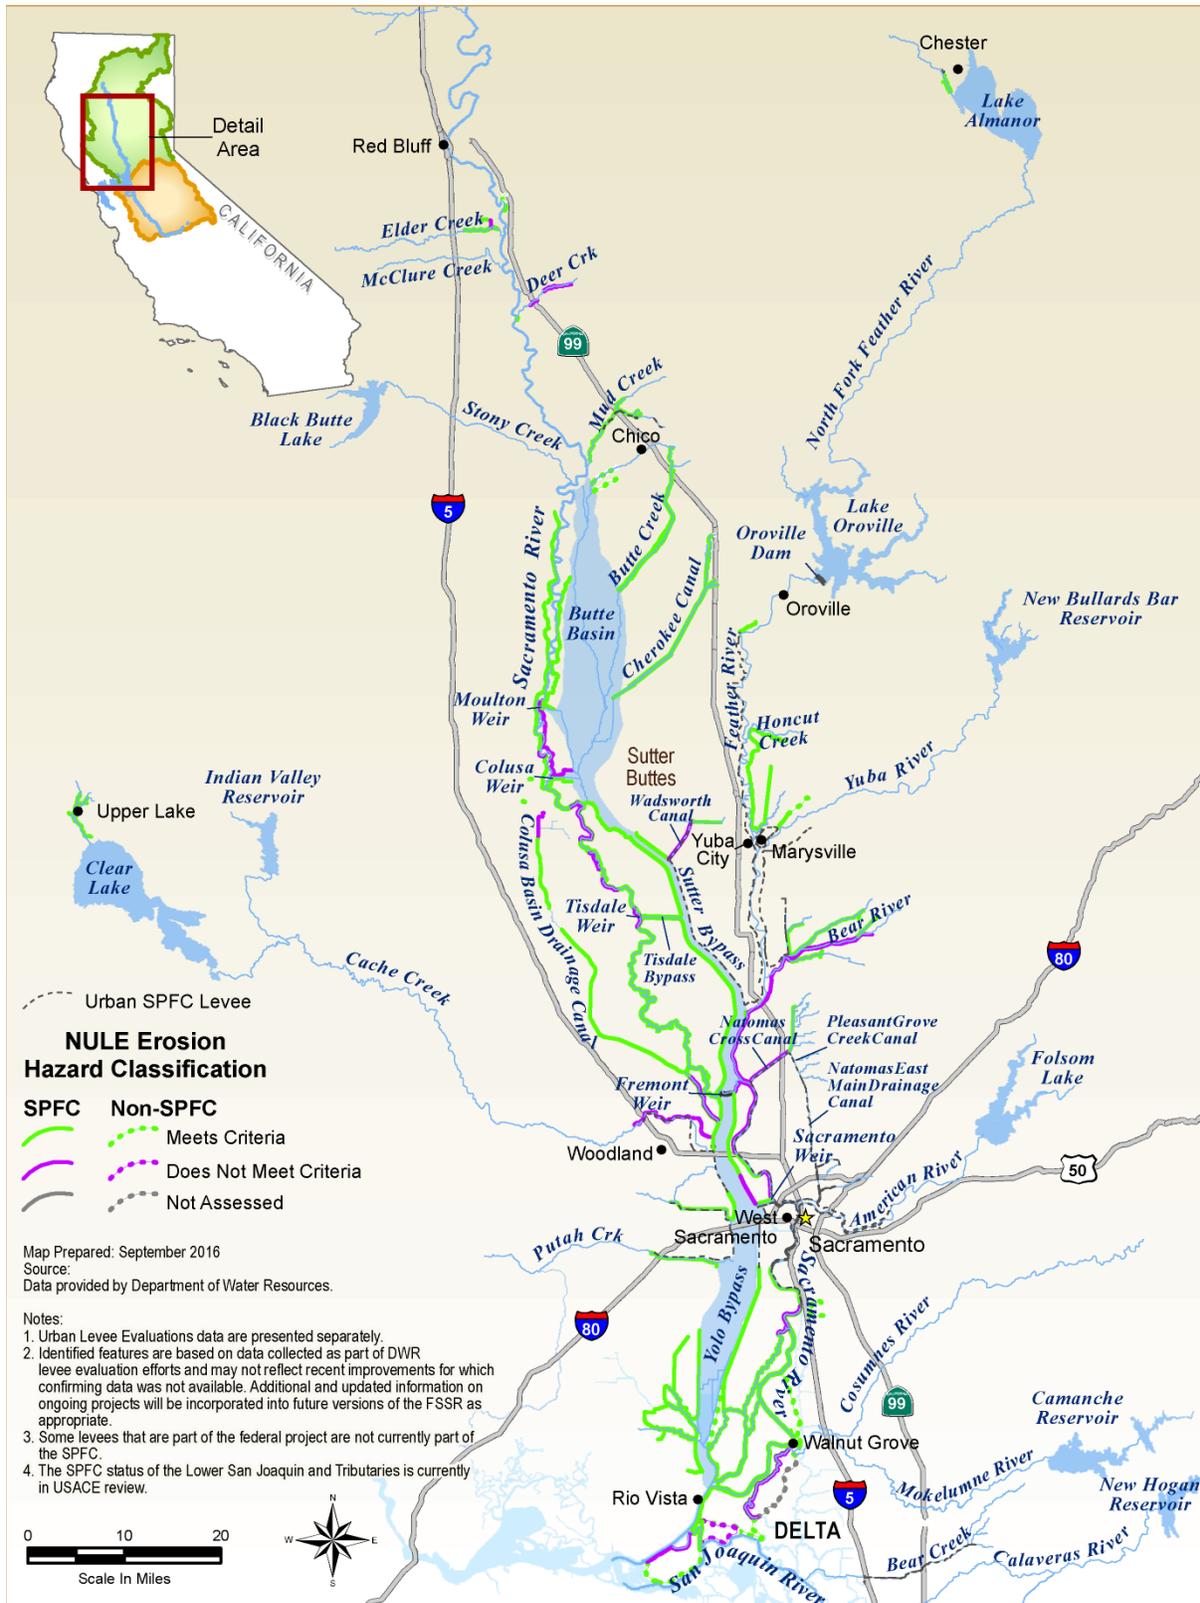
Figure 4-15. NULE Erosion Hazard Categorizations in the Sacramento River Watershed

Estimates of NULE levee erosion hazard categorizations for the Sacramento River and San Joaquin river watersheds are shown in Figures 4-15 and 4-16, respectively. Approximately one-seventh of SPFC NULE levees in the Sacramento River watershed were categorized as having a high erosion hazard. NULE levee segments with high erosion hazard in the Sacramento River watershed are predominantly located in the area between the City of Sacramento and the Bear River in Yuba County.

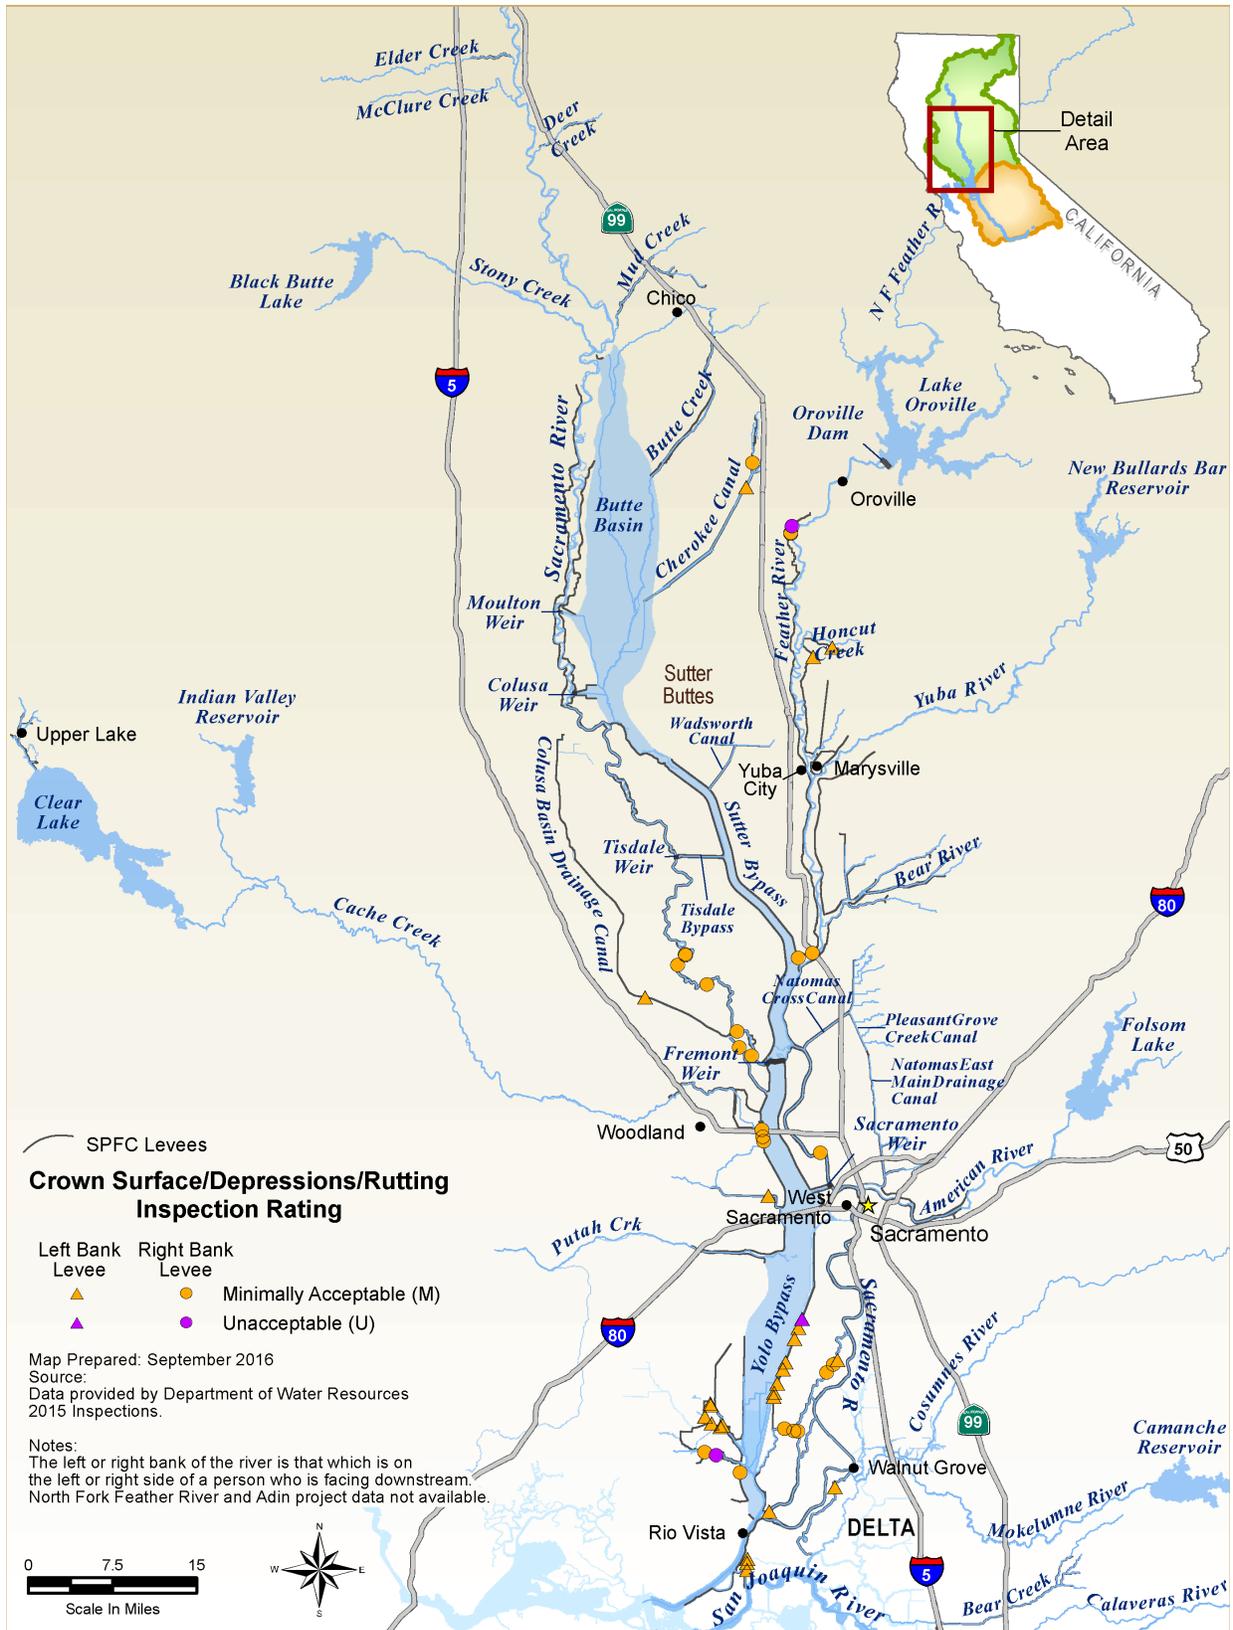
Figure 4-17. 2015 Crown Surface/Depressions/Rutting Inspection Ratings in the Sacramento River Watershed

Minimally Acceptable and Unacceptable levee crown surface/depressions/rutting inspection ratings from the 2015 Inspection and Local Maintaining Agency Report of the Central Valley State-Federal Flood Protection System (DWR, 2015b) are shown in Figures 4-17 and 4-18. DWR inspections identified five locations of localized levee settlement that affect the integrity of levees (i.e., ratings of Unacceptable).

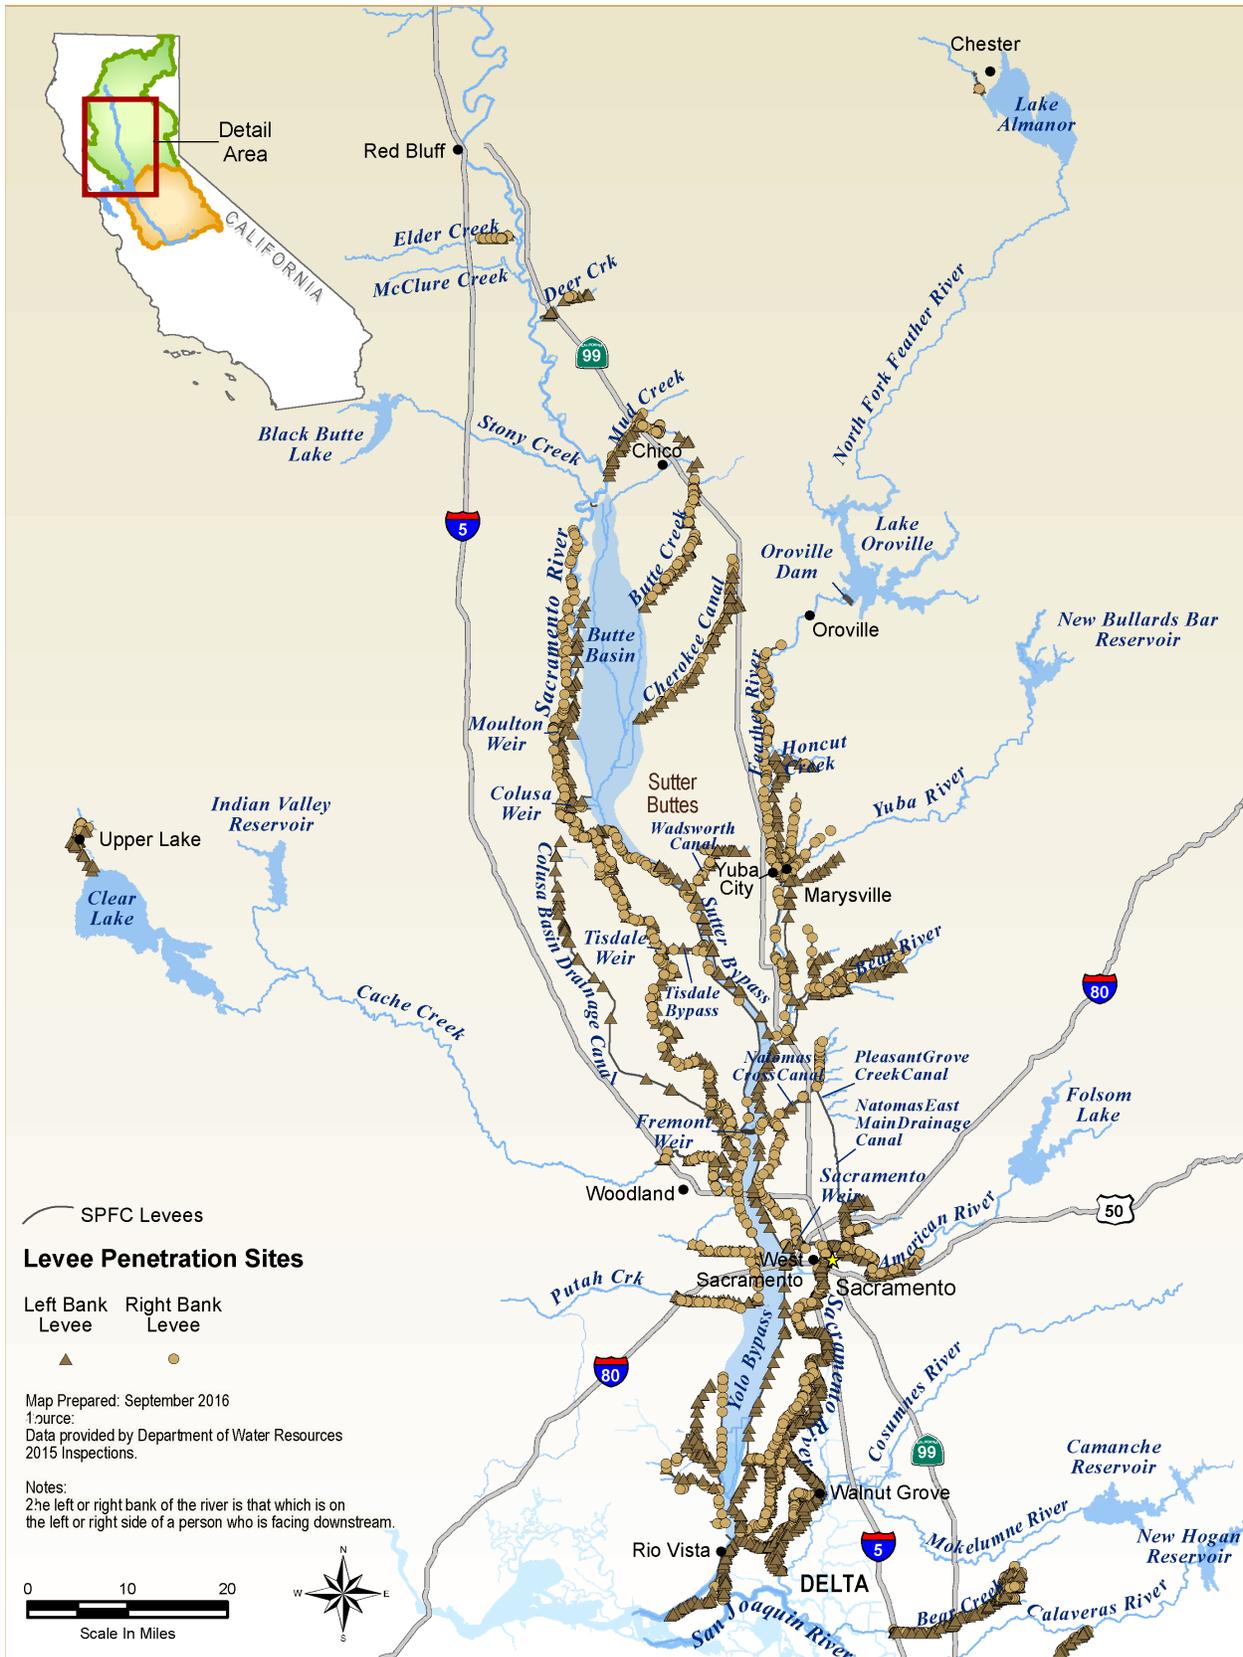
Figure 4-19. Levee Penetrations in the Sacramento River Watershed

Figures 4-19 and 4-20 show documented levee penetrations for the Sacramento and San Joaquin river watersheds, respectively. Data show that penetrations are prevalent throughout the entire levee system. As mentioned, the current DWR UCIP database includes more than 7,600 penetrations through SPFC levees. In the Sacramento Valley, existing data include the greatest density of penetrations along the Sacramento River levees upstream from the Sutter Bypass and downstream from the City of Sacramento, with fewer penetrations documented along the Feather River levee system, along the smaller tributary stream levees, and along the bypass levees. In the San Joaquin Valley, penetrations have been identified throughout the San Joaquin River levees between Stockton and Fresno.
