2017 Flood System Status Report

AUGUST 2017

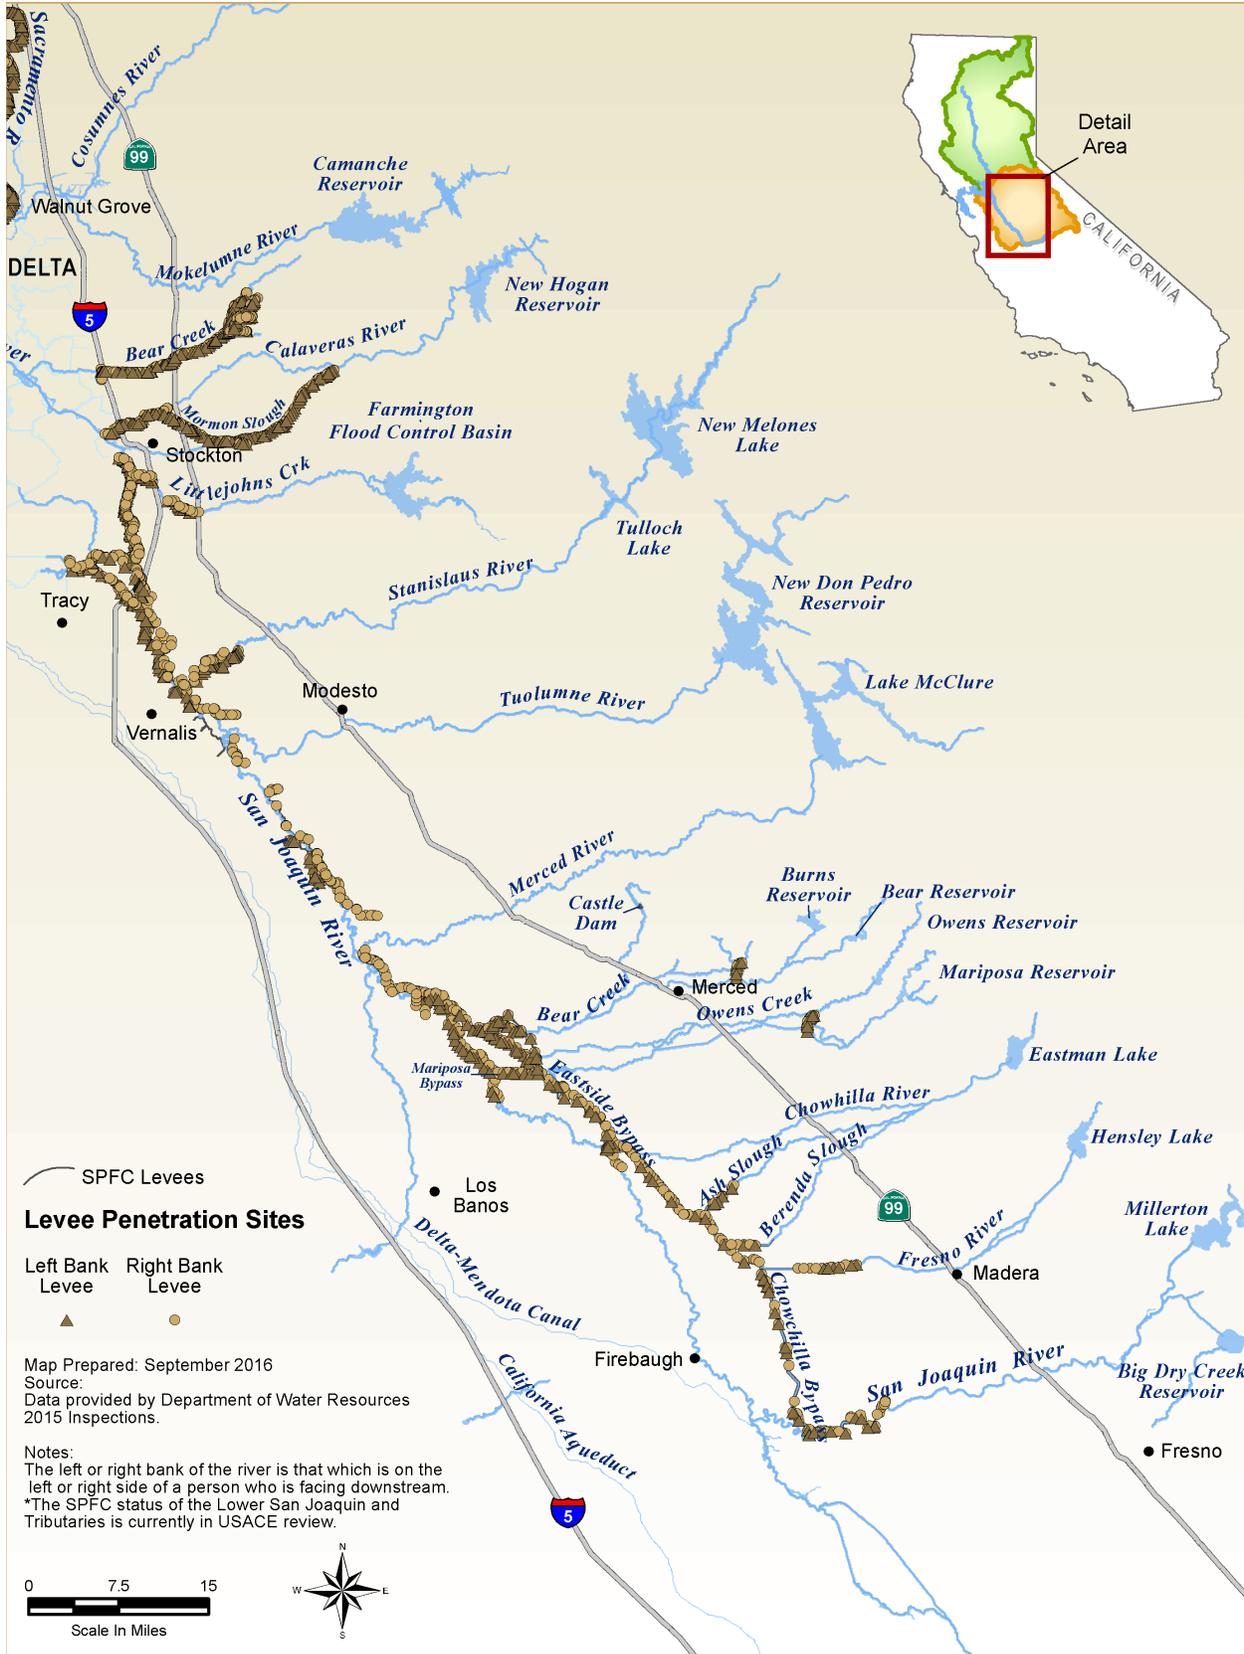
Figure 4-20. Levee Penetrations in the San Joaquin River Watershed

Figures 4-19 and 4-20 show documented levee penetrations for the Sacramento and San Joaquin river watersheds, respectively. Data show that penetrations are prevalent throughout the entire levee system. As mentioned, the current DWR UCIP database includes more than 7,600 penetrations through SPFC levees. In the Sacramento Valley, existing data include the greatest density of penetrations along the Sacramento River levees upstream from the Sutter Bypass and downstream from the City of Sacramento, with fewer penetrations documented along the Feather River levee system, along the smaller tributary stream levees, and along the bypass levees. In the San Joaquin Valley, penetrations have been identified throughout the San Joaquin River levees between Stockton and Fresno.

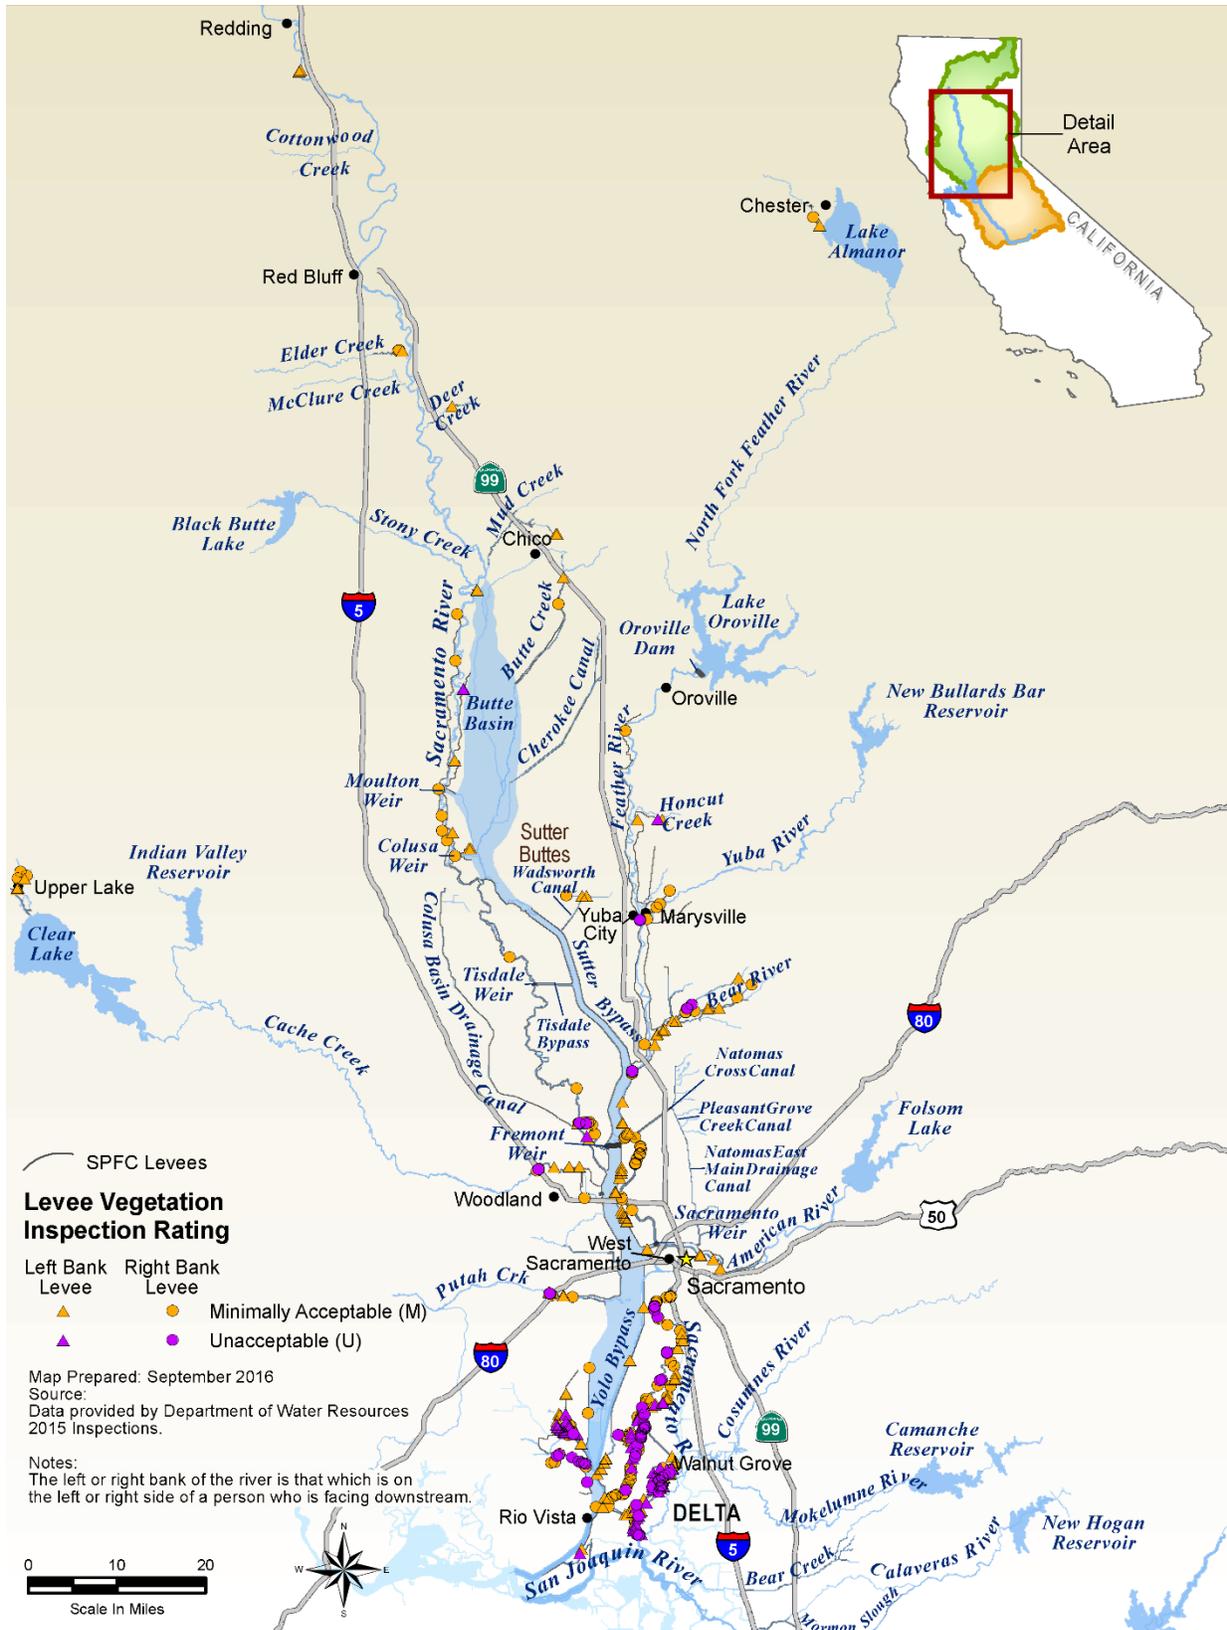
Figure 4-21. 2015 Levee Vegetation Inspection Ratings in the Sacramento River Watershed

Inspection results reflect vegetation and trimming/thinning trees levee inspection ratings from the 2015 Annual Inspection Report (DWR, 2015a), updated by data collected from DWR's additional site visits in 2015. Unacceptable and Minimally Acceptable inspection ratings for vegetation and trimming/thinning trees maintenance issues are shown in Figures 4-21 through 4-24 for the Sacramento and San Joaquin river watersheds.

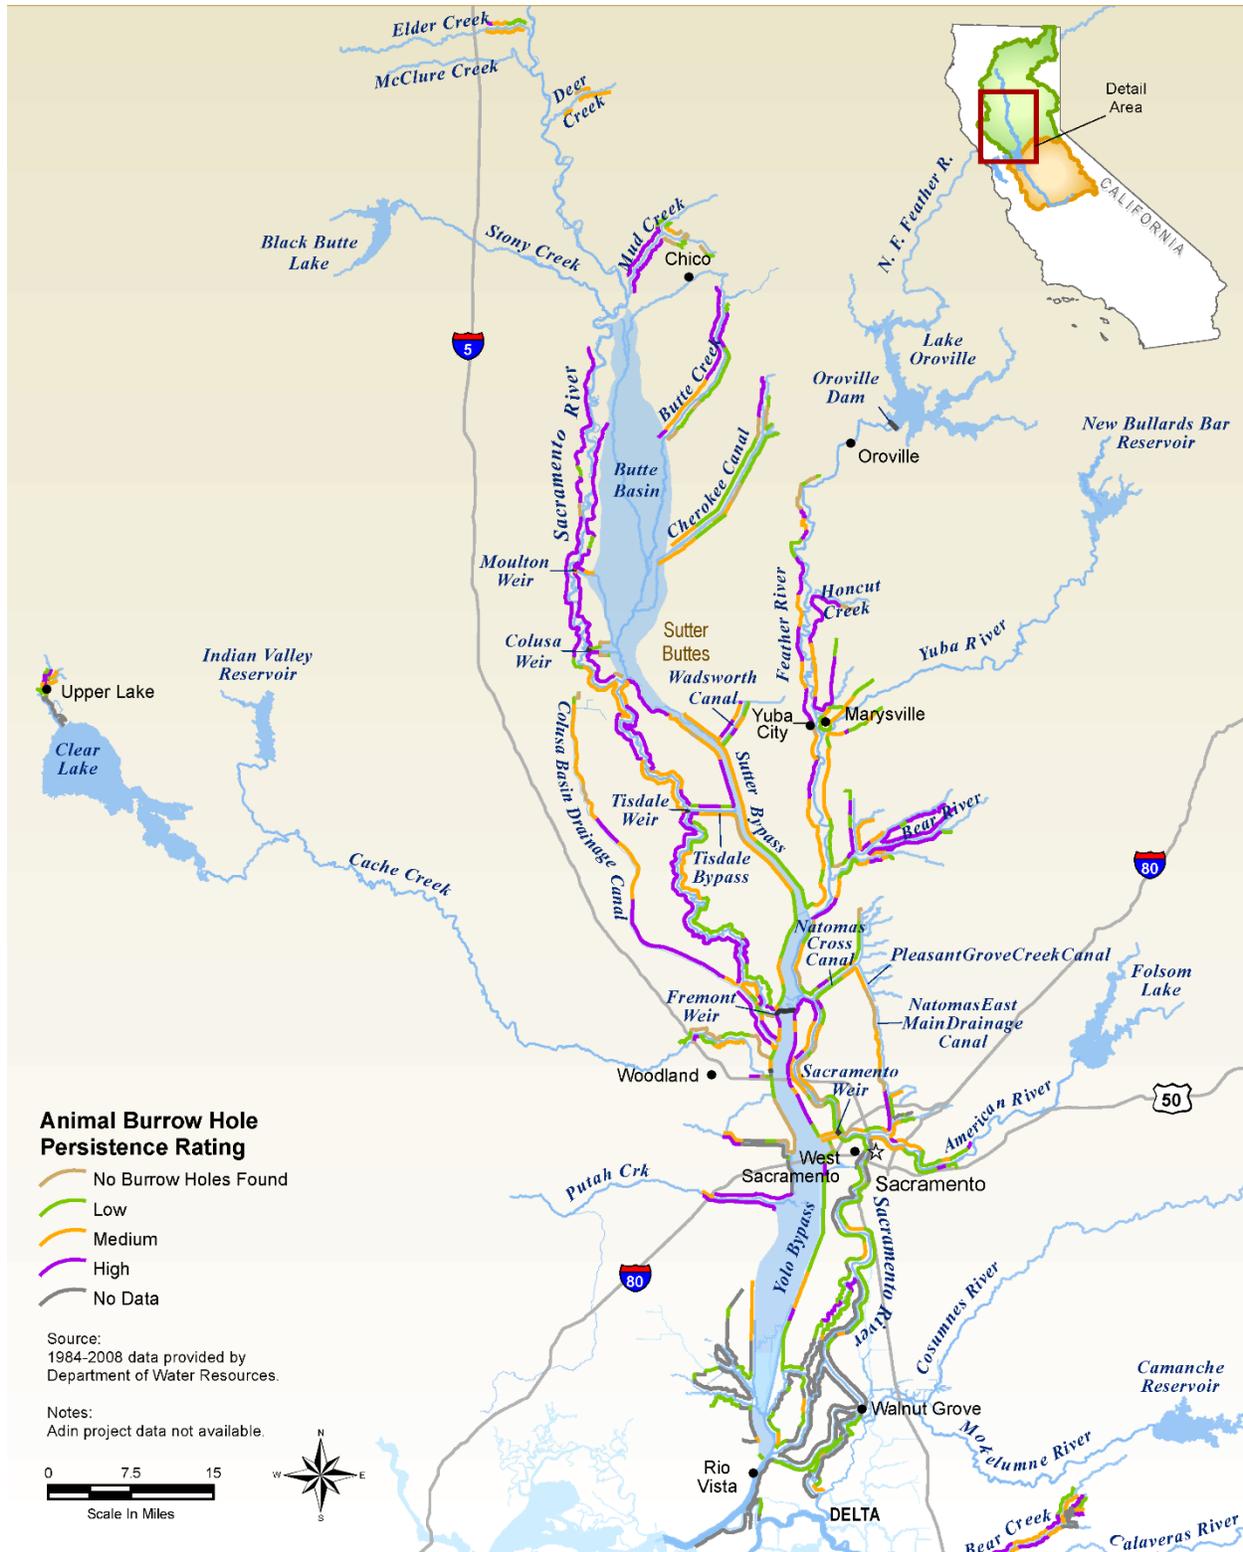
Figure 4-25. Animal Burrow Hole Persistence in the Sacramento River Watershed

Figures 4-25 and 4-26 show results for the DWR Animal Burrow Hole Persistence Study for the Sacramento and San Joaquin river watersheds, respectively (DWR, 2009b). More than one-third of the 1,459 miles of SPFC levees studied had high persistence (at least eight reported incidences of burrowing activity over the 21-year study span of inspection results).

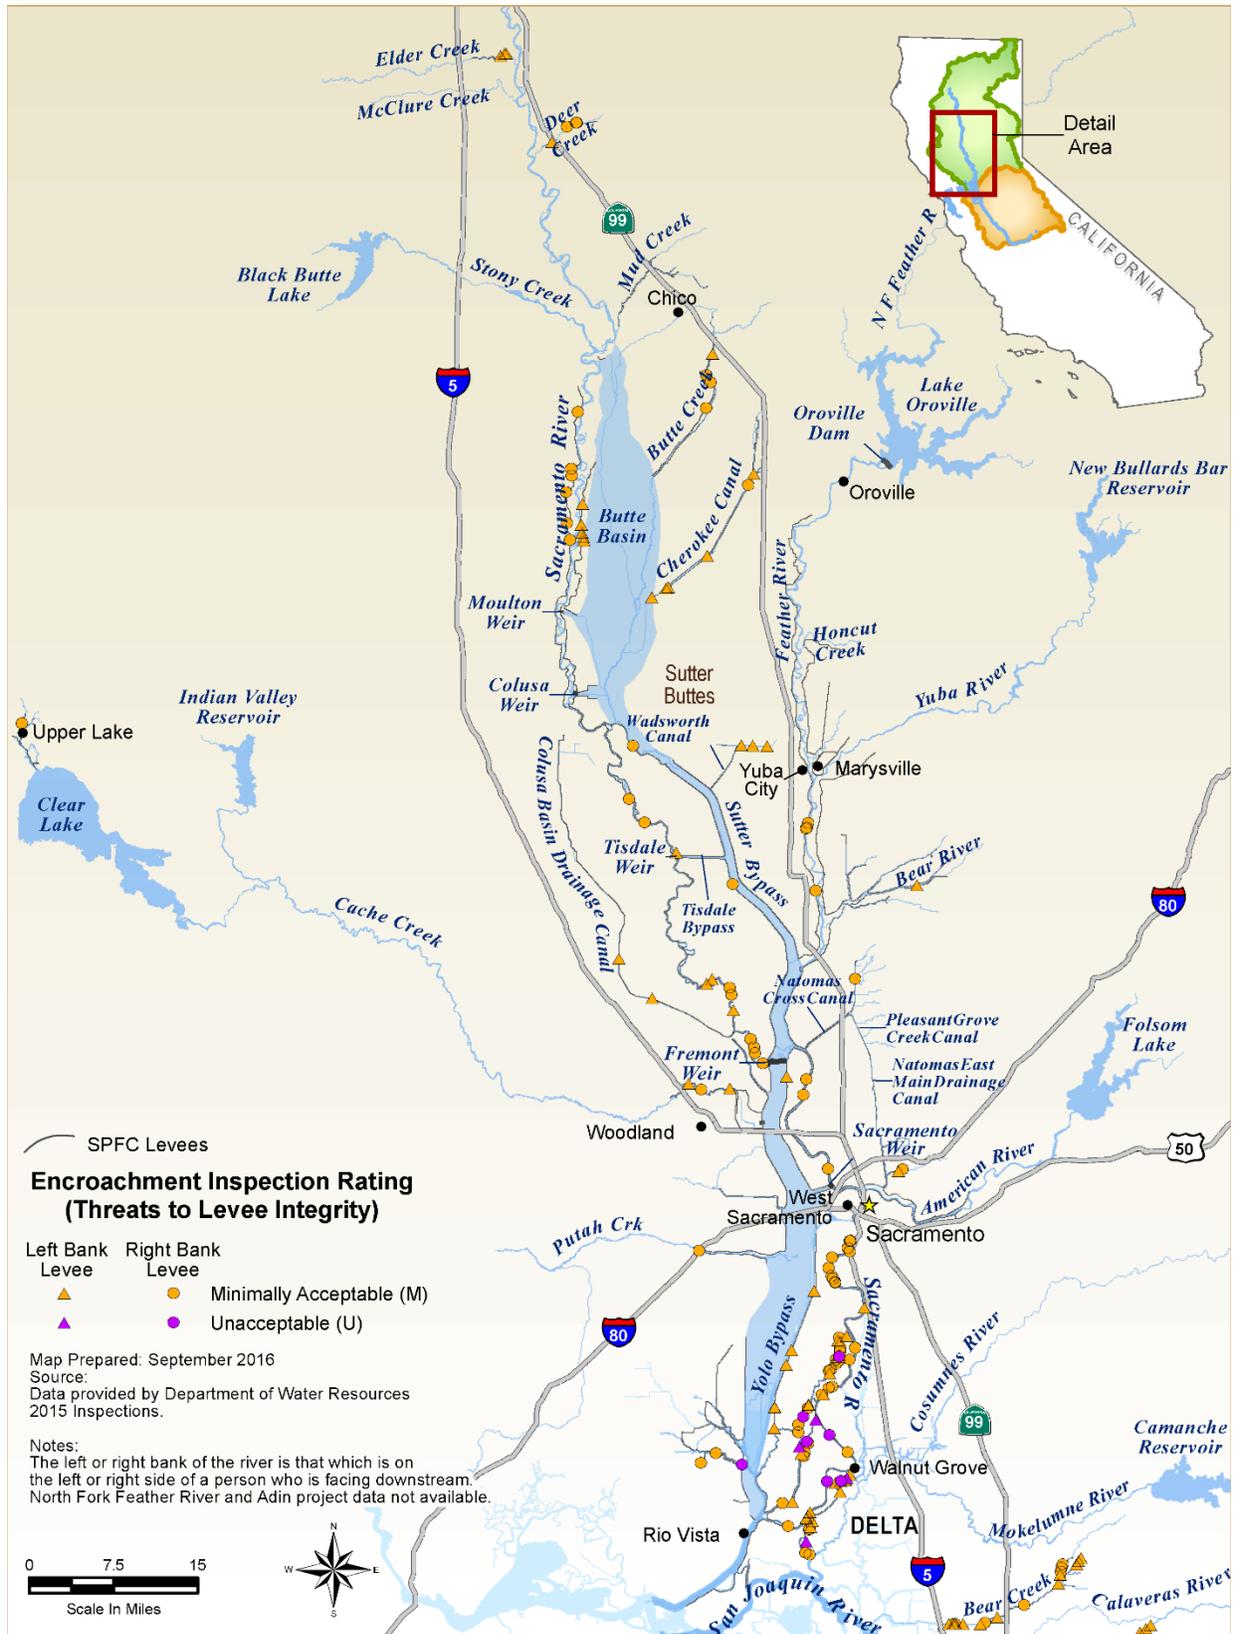
Figure 4-27. 2015 Encroachment Inspection Ratings in the Sacramento River Watershed (Maintenance Issue Type)

Minimally Acceptable and Unacceptable ratings with a maintenance issue type are shown in Figures 4-27 and 4-28. Inspection results include 235 encroachment sites identified as minor threats to levee integrity (i.e., Minimally Acceptable) and 24 encroachment sites identified as major threats to levee integrity (i.e., Unacceptable). Encroachment sites may consist of multiple individual encroachments.¹²

Minimally Acceptable and Unacceptable ratings with a design/system obsolescence issue type are shown in Figure 4-27. Inspection results include two encroachment sites identified as minor threats to levee integrity (i.e., Minimally Acceptable) and zero encroachment sites identified as major threats to levee integrity (i.e., Unacceptable). Additional information about recent, ongoing, and planned levee remedial actions for encroachments and ongoing actions to improve future evaluations is included in Appendix A, Section A-10. Also, USACE periodic inspection results on encroachments for 10 USACE levee systems are included in Appendix A, Section A-1.

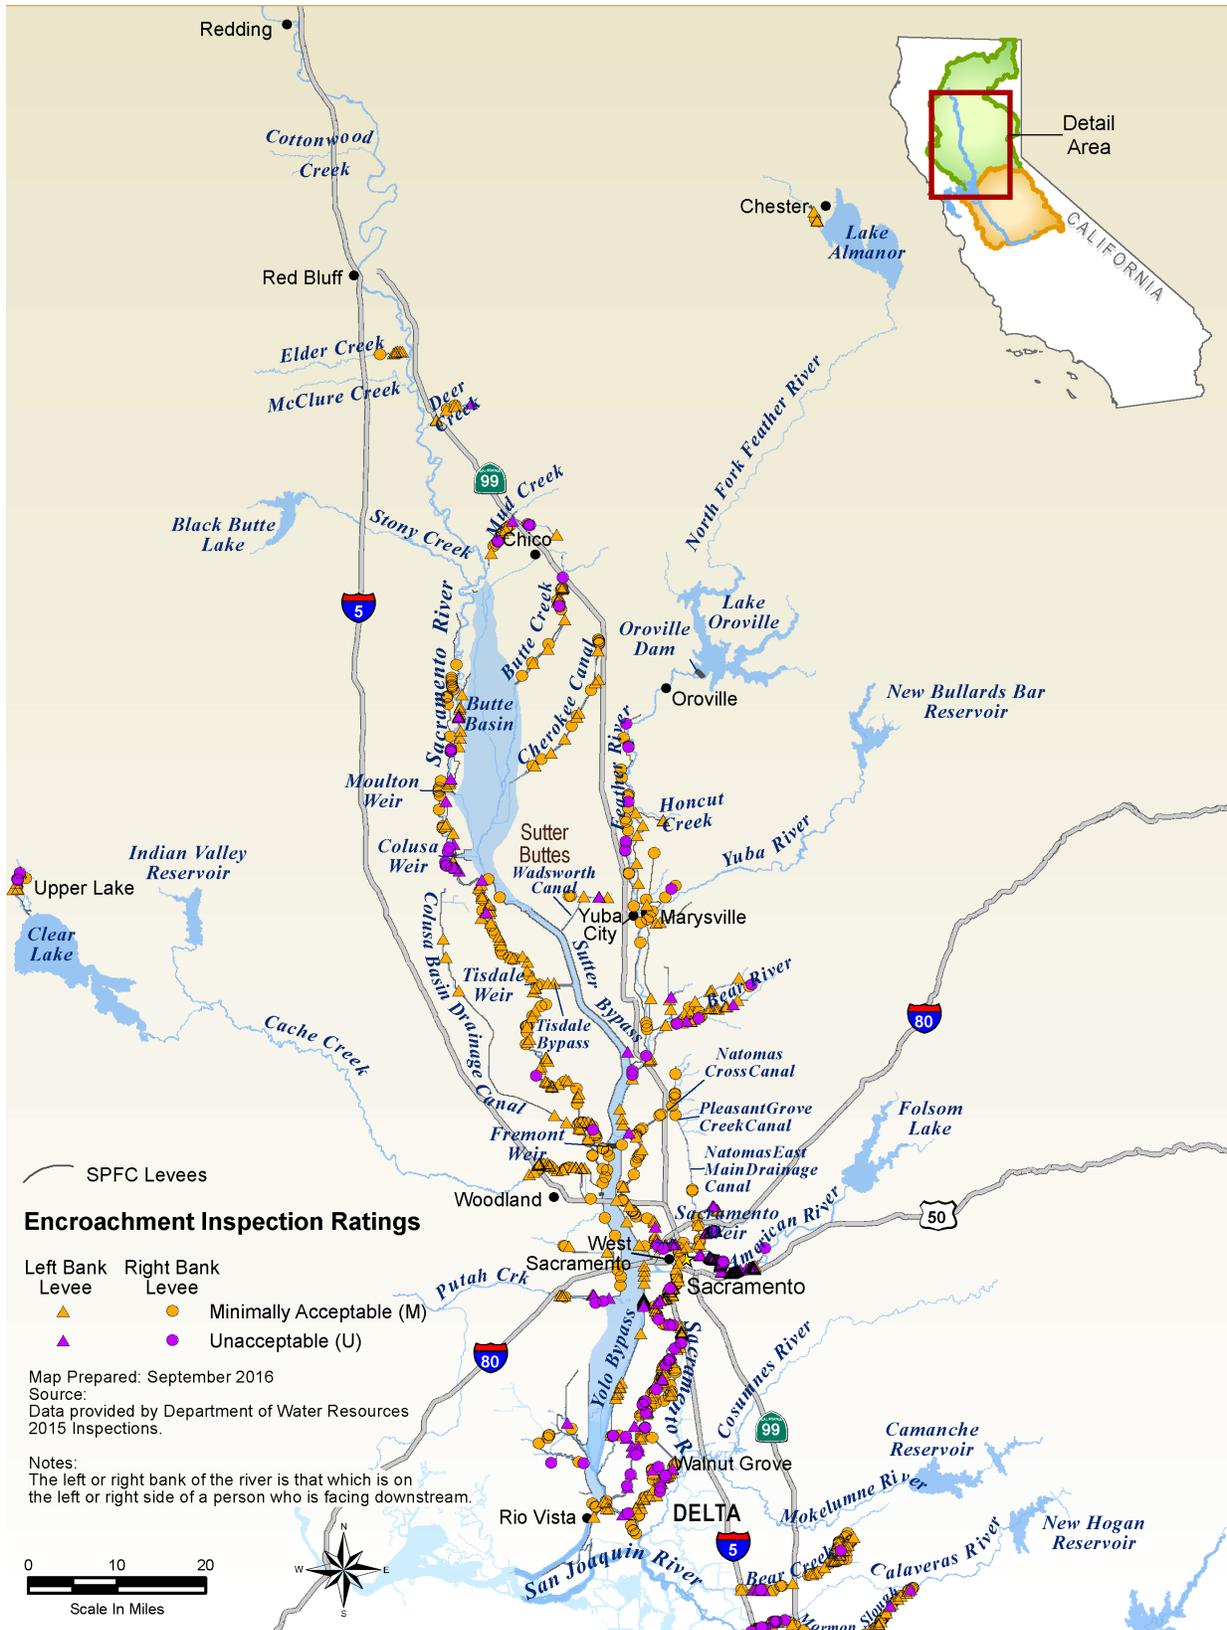
Figure 4-29. 2015 Encroachment Inspection Ratings in the Sacramento River Watershed (Enforcement and Design/System Obsolescence Issue Type)

Minimally Acceptable and Unacceptable ratings with an enforcement issue type are shown in Figures 4-29 and 4-30. Inspection results include 1,096 encroachment sites identified as minor threats to levee integrity (i.e., Minimally Acceptable) and 372 encroachment sites identified as major threats to levee integrity (i.e., Unacceptable).

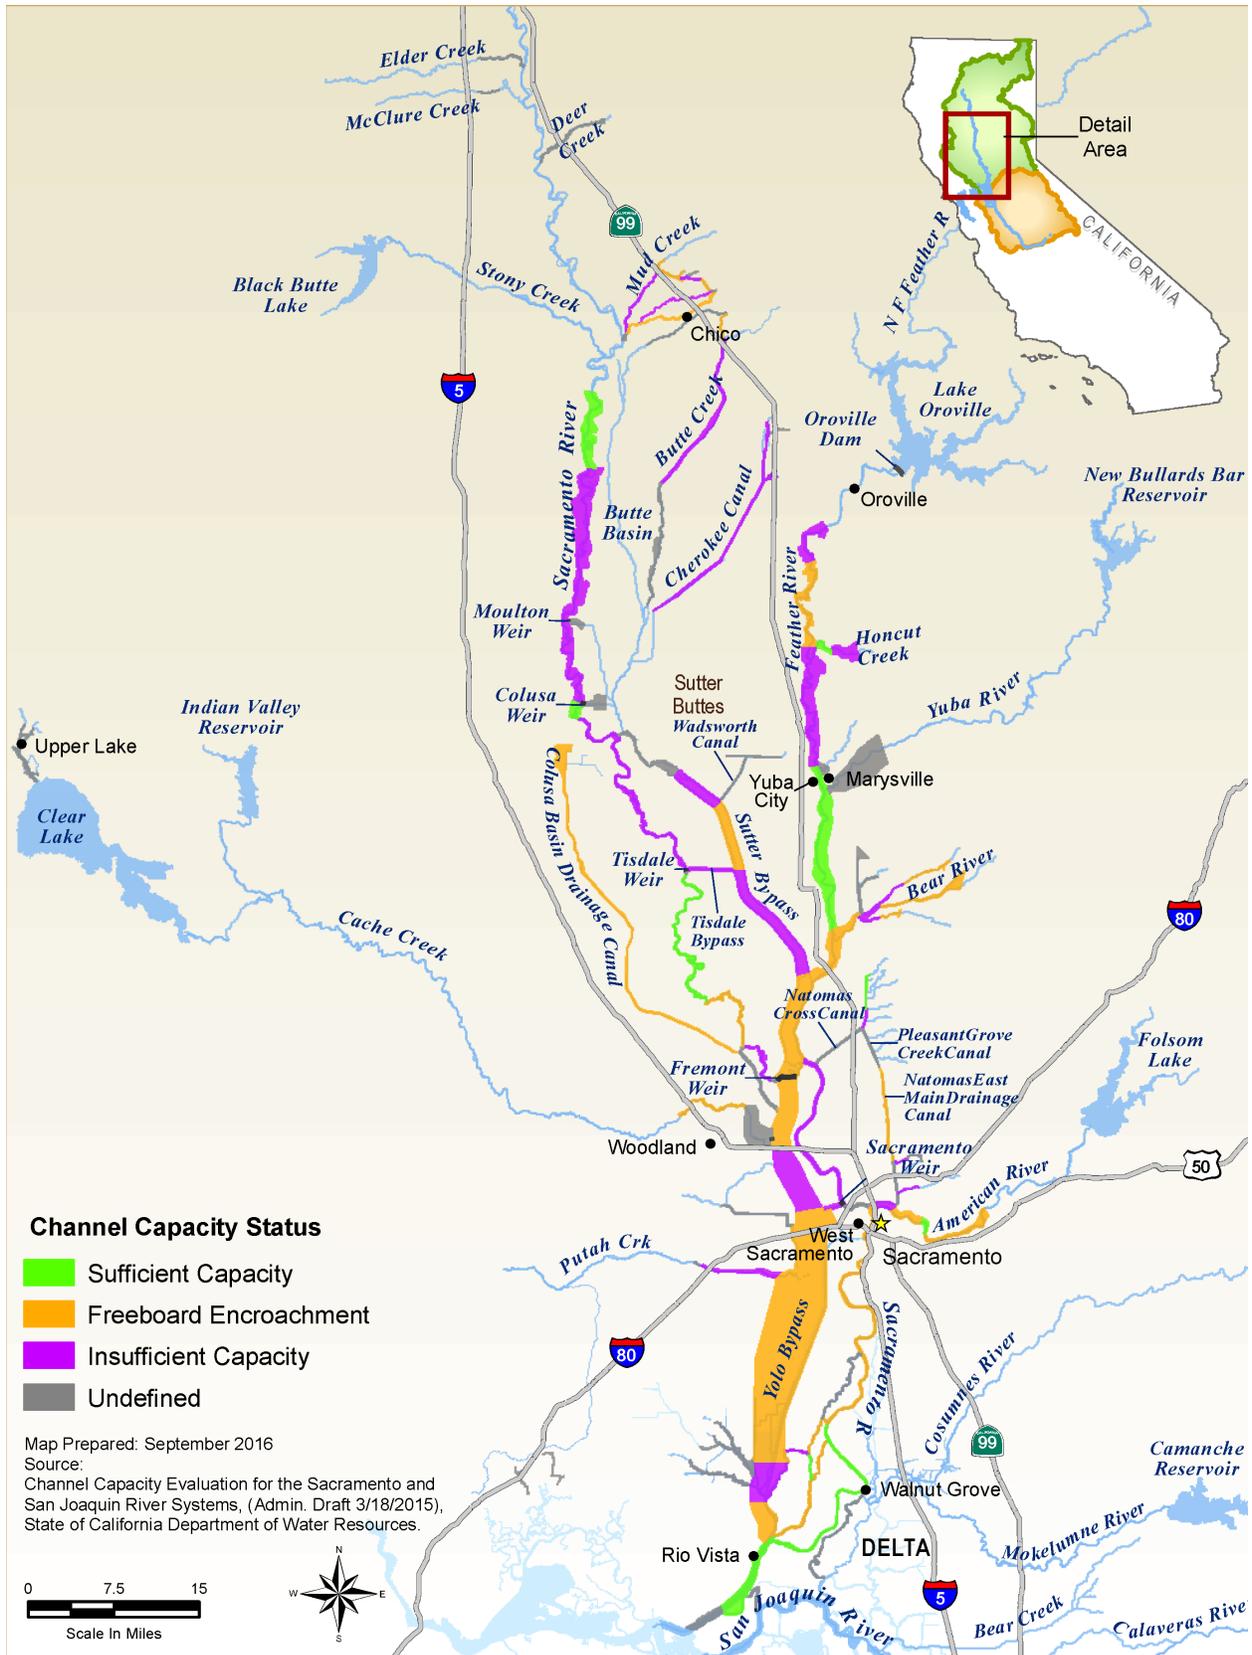
Figure 5-3. Channel Capacity Status in the Sacramento River Watershed

Differences between design capacities reported in O&M manuals and flows associated with the design profiles shown in Figures 5-1 and 5-2 demonstrate the need to resolve discrepancies in some locations. Potential inadequate channel conveyance capacities are shown in Figures 5-3 and 5-4.

For the Sacramento River watershed, approximately four-ninths of the channels show a potential capacity inadequacy and need for additional evaluation, and data are insufficient for approximately one-fifth of the channels. In general, approximately three-fifths of the channels in the San Joaquin River watershed show a potential capacity inadequacy and need for additional evaluation, and data are insufficient for one-eighth. These results will be refined as systemwide and project-specific hydraulic modeling efforts progress. Appendix B, Section B-1, contains tables of the results shown in Figures 5-3 and 5-4.

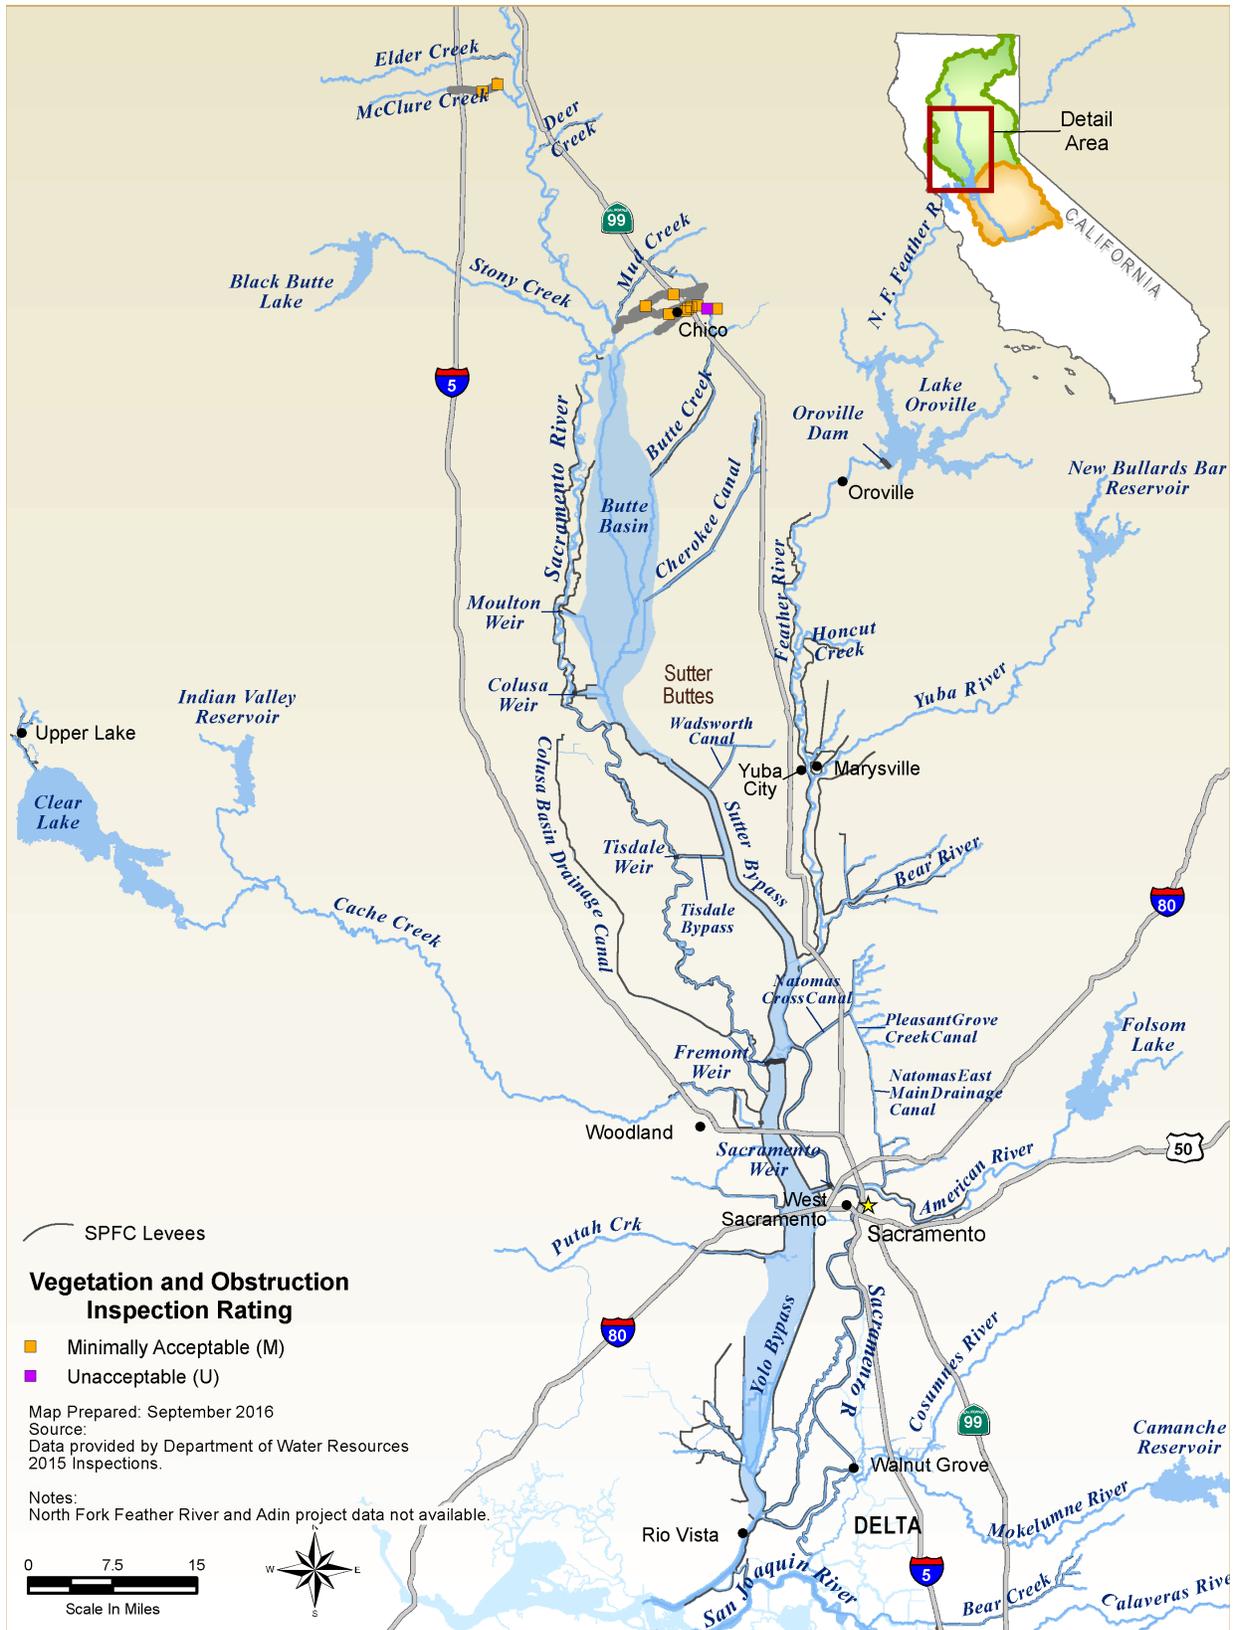
Figure 5-5. 2015 Channel Vegetation Inspection Ratings in the Sacramento River Watershed

Channel inspection ratings for vegetation from the 2015 Inspection and Local Maintaining Agency Report of the Central Valley State-Federal Flood Protection System (DWR, 2015b) are shown in Figures 5-5 and 5-6 for channels maintained by DWR and other maintaining agencies. Of the 233 miles of SPFC channels (containing 157 checkpoints) inspected by DWR, 13 checkpoints were rated Unacceptable and 56 locations were rated Minimally Acceptable for channel vegetation. Additional vegetation problems may be present in channels not inspected by DWR.

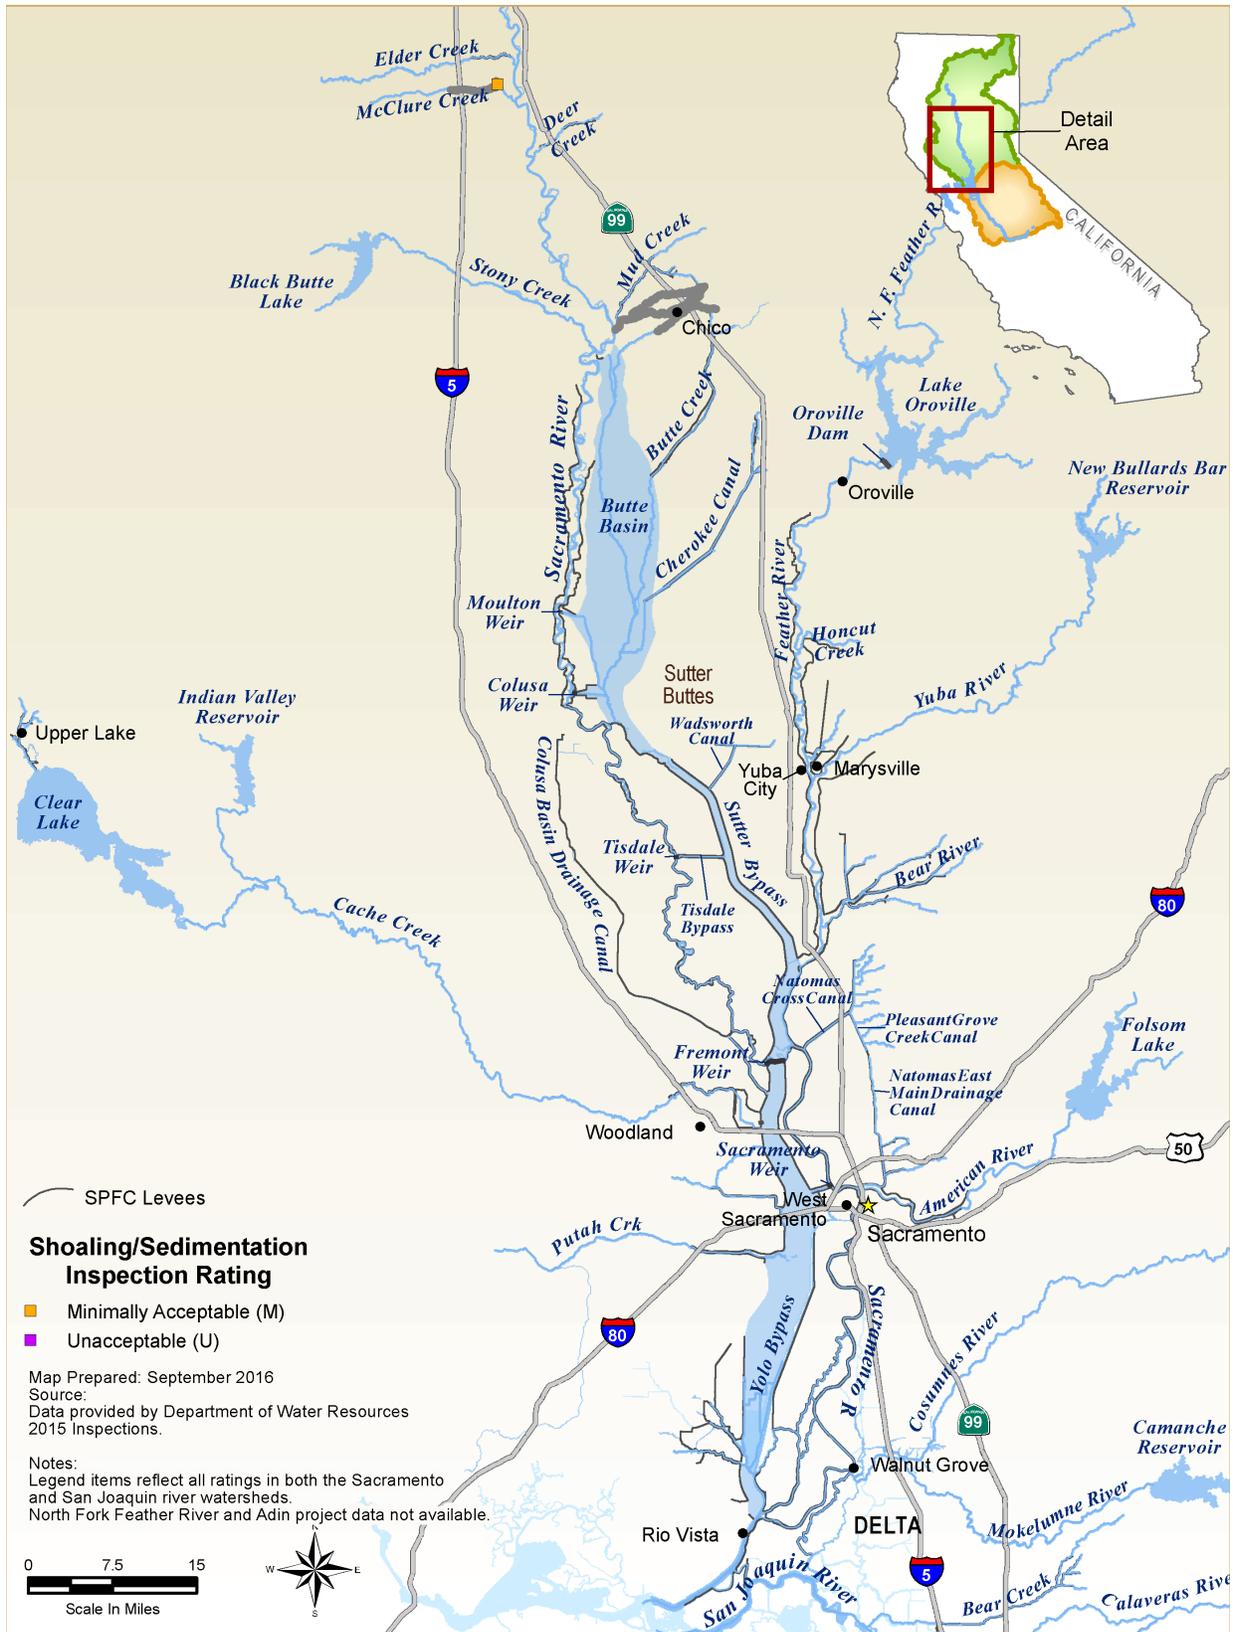
Figure 5-7. 2015 Channel Shoaling/Sedimentation Inspection Ratings in the Sacramento River Watershed

Shoaling and sedimentation channel inspection ratings from the shoaling and sedimentation channel inspection ratings from the 2015 Inspection and Local Maintaining Agency Report of the Central Valley State-Federal Flood Protection System (DWR, 2015b) are shown in Figures 5-7 and 5-8. Of the 233 miles of SPFC channels inspected by DWR, eight locations were rated unacceptable and 26 locations were rated minimally acceptable for shoaling and sedimentation. Additional channel sedimentation problems may exist in areas not inspected by DWR.

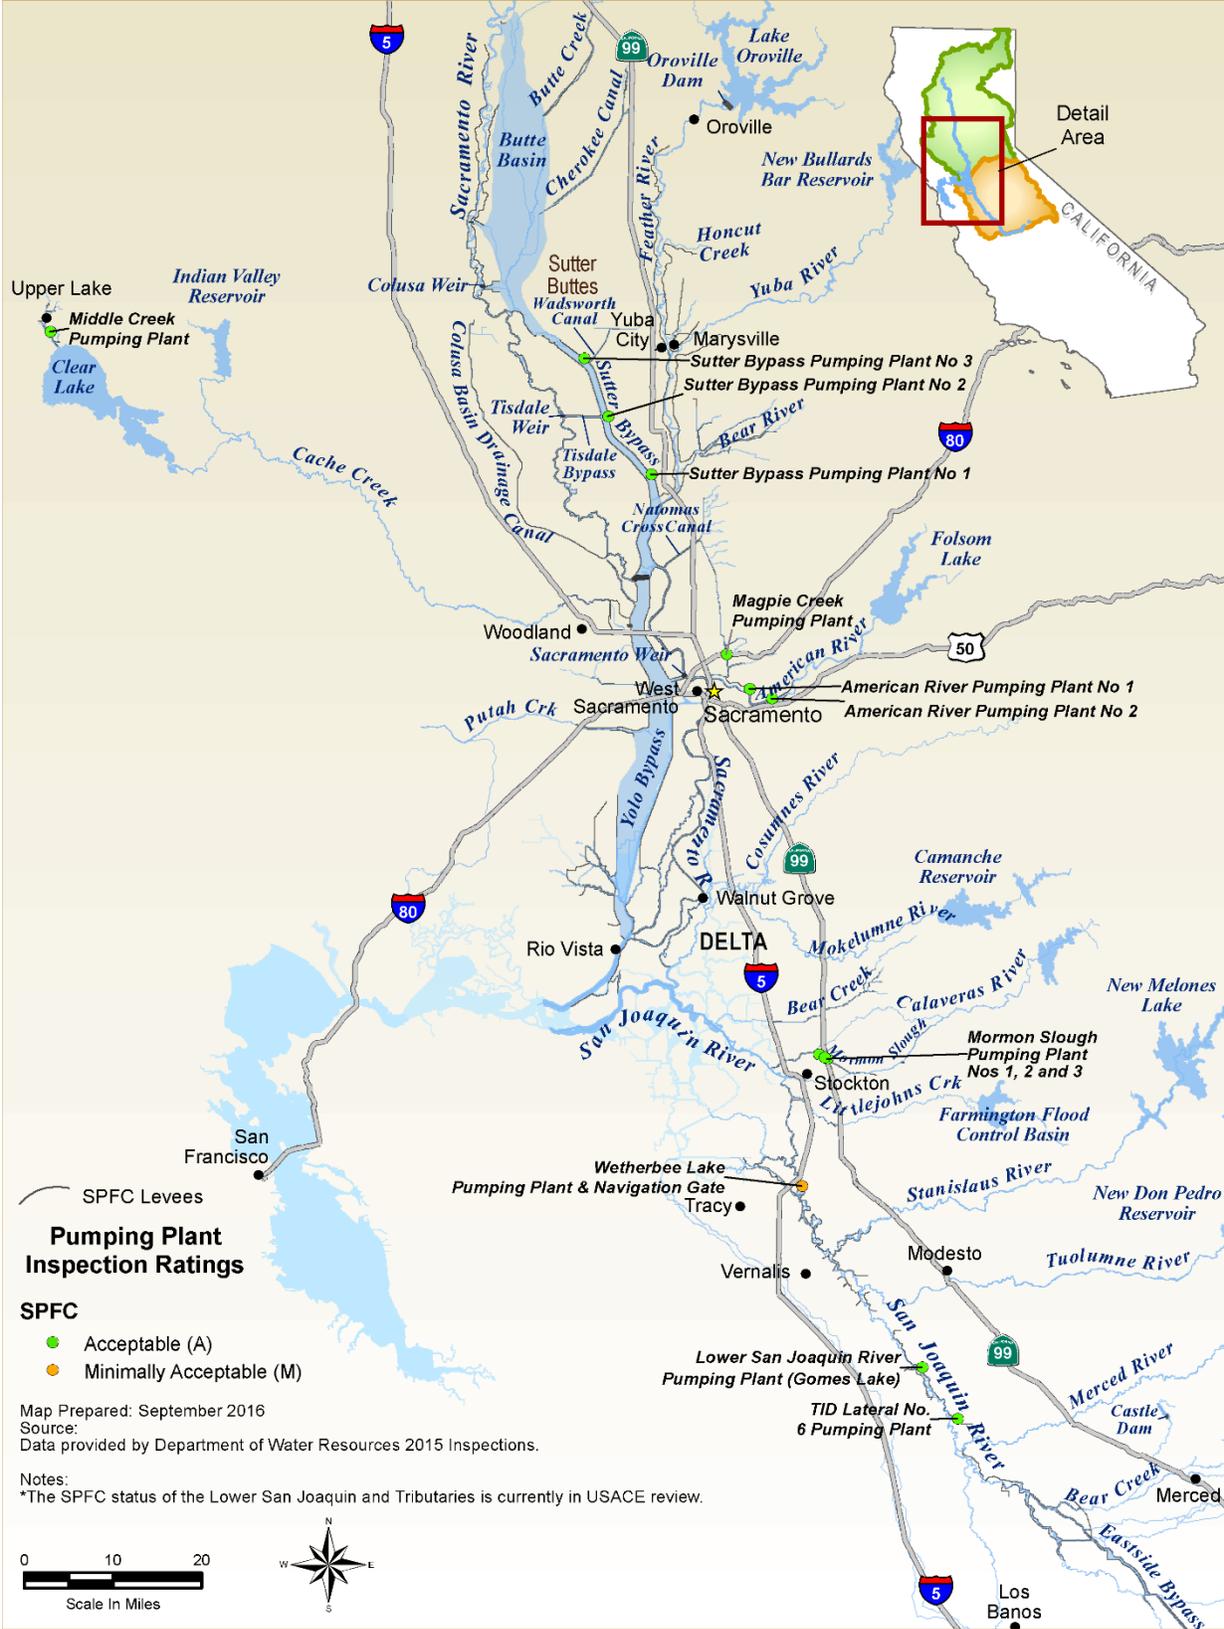
Figure 6-9. Pumping Plant Conditions in Sacramento and San Joaquin River Watersheds

Pumping plant conditions from annual inspections in 2015 (DWR, 2015) are presented in Figure 6-9 for the Sacramento and San Joaquin river watersheds. Of the 13 pumping plants inspected, no pumping plants were rated as Unacceptable and one pumping plants was rated as Minimally Acceptable.

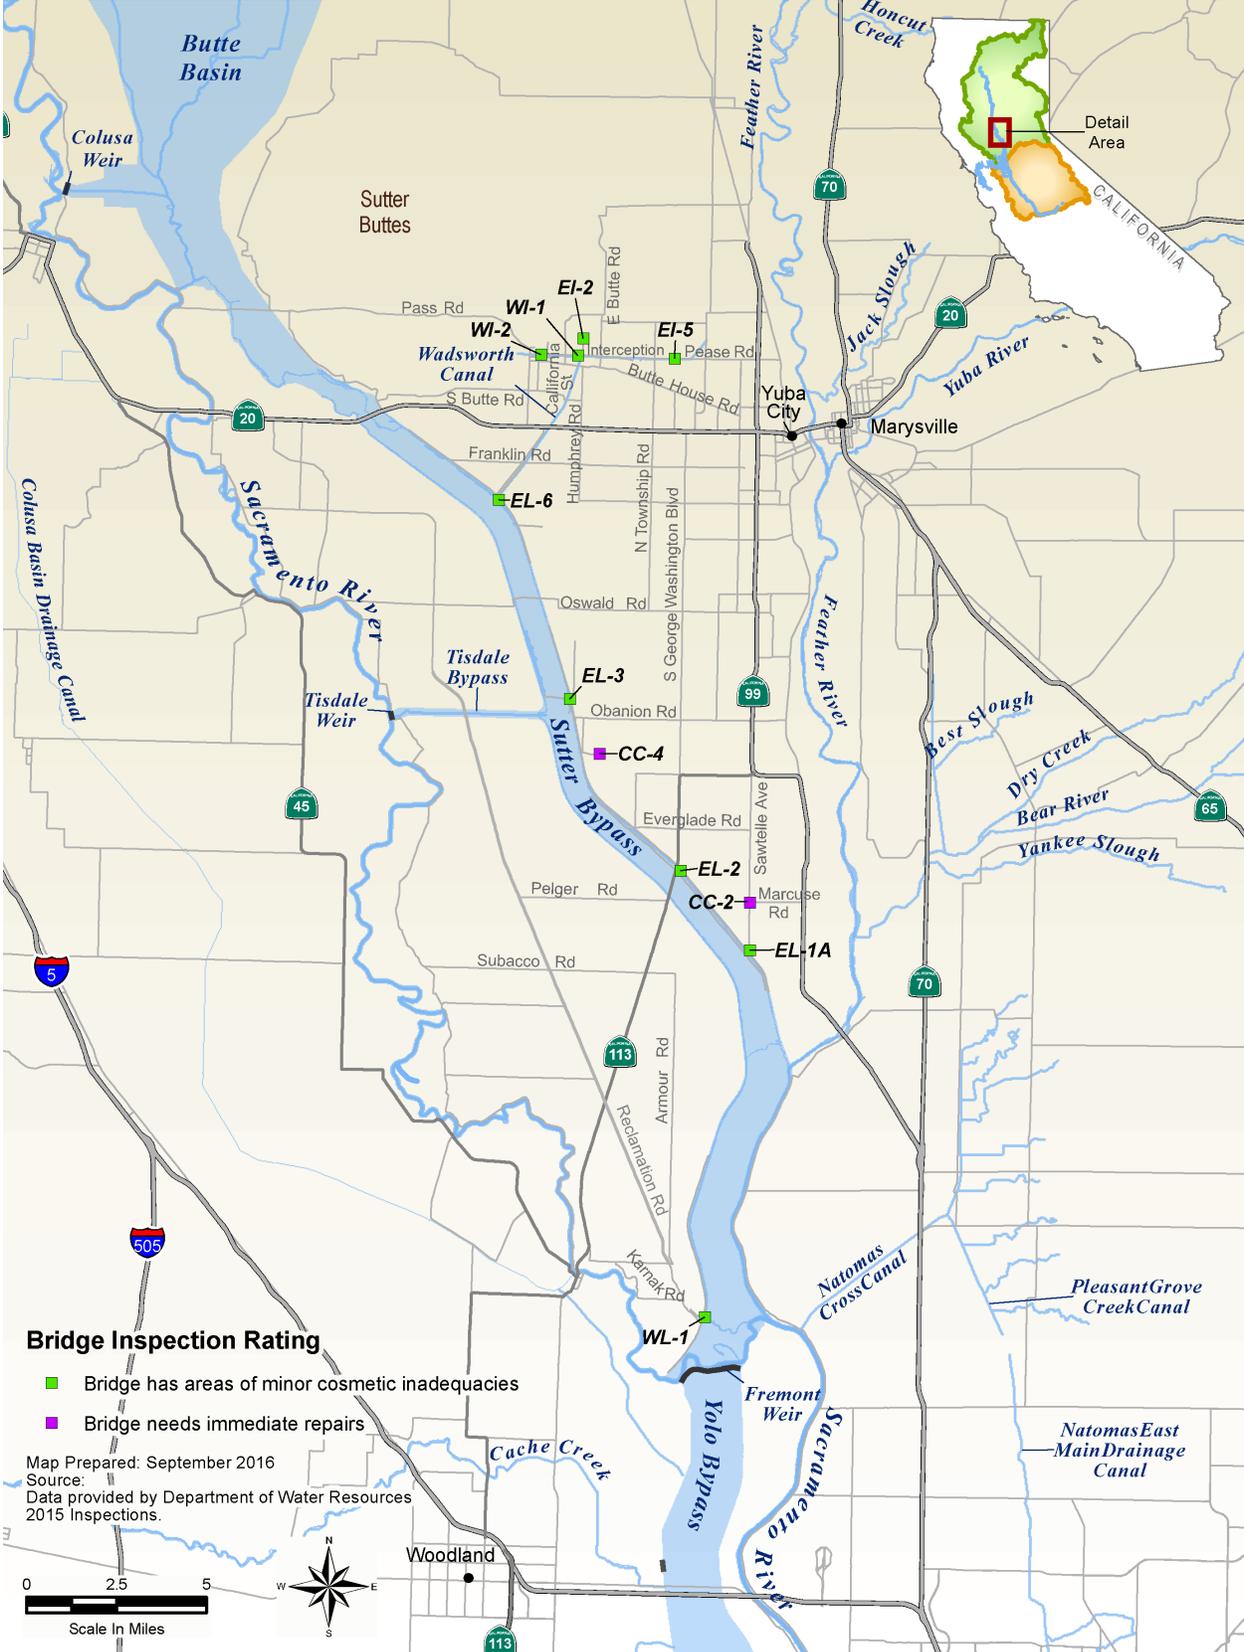
Figure 6-10. Bridge Conditions in the Sacramento River Watershed

Bridge conditions noted from the DWR Bridge Inspection Program are presented on Figure 6-10 for the Sacramento River watershed. Detailed description, of the DWR inspections can be found in the DWR Annual Bridge Inspection Report (DWR, 2015a).

Of the 11 bridges inspected by DWR, two had ratings of 4 and 5 overall, and were noted as needing repairs. Since 2000, three Sutter Basin bridges (not inspected by DWR or depicted in Figure 6-10) have been replaced and turned over to Sutter County for future O&M.
