California State Water Project

Volume III
Storage
Facilities

Bulletin Number 200
November 1974

State of California
The Resources Agency
Department of Water Resources

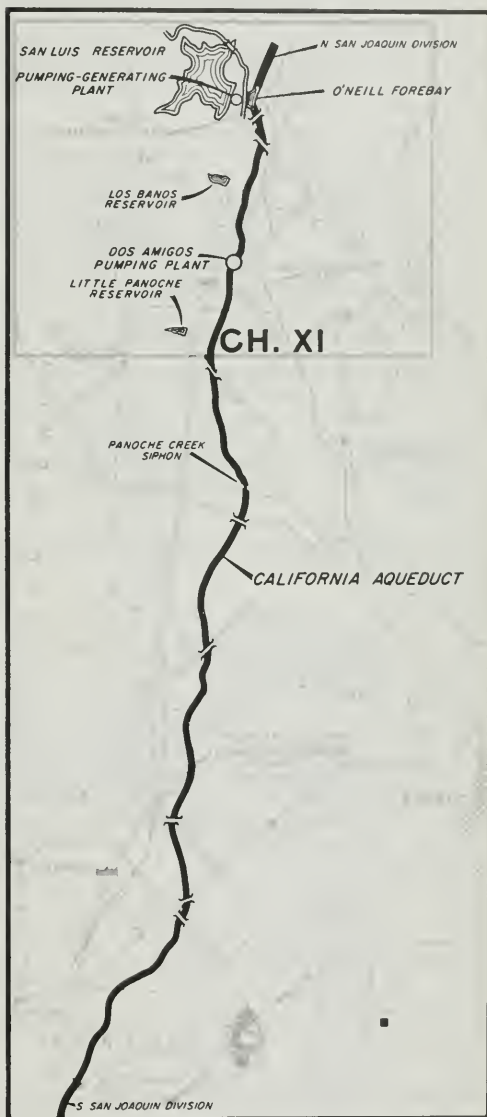
Figure 5. Son Luis Division

The 106-mile-long reach, designated the San Luis Division, constitutes the Federal-State Joint-Use Facilities (Figure 5). It includes, among other features, San Luis Dam and Reservoir and appurtenant pumping-generating facilities. This entire division was designed and built by the U.S. Bureau of Reclamation and is operated by the Department of Water Resources on a cost-sharing basis, which is discussed in Chapter XI of this volume.

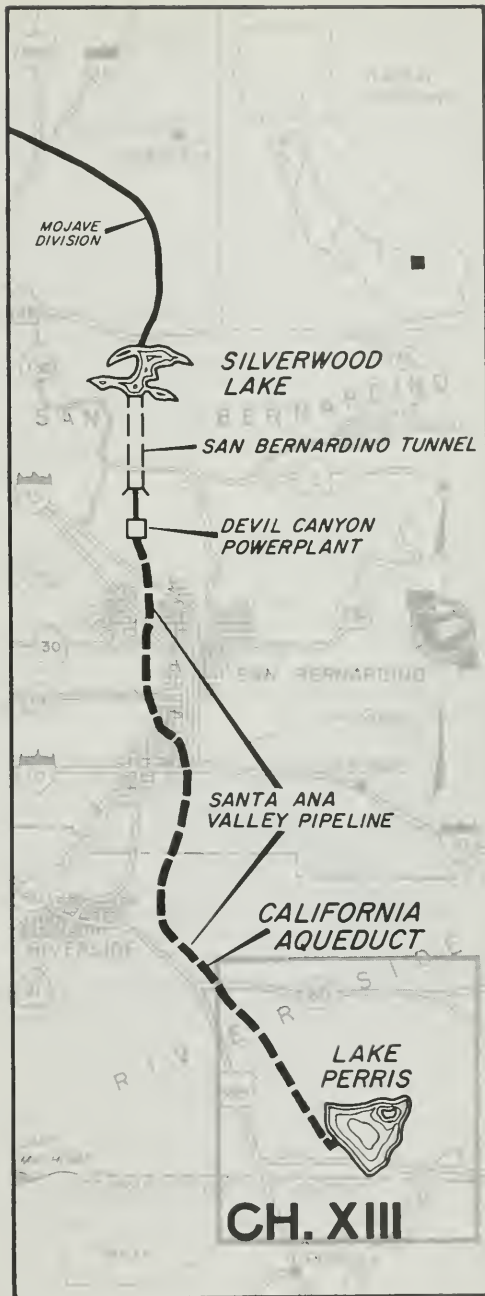
Figure 7. Santa Ana Division

The remaining reach along the California Aqueduct, designated the Santa Ana Division, is 34 miles long and terminates at Lake Perris, a 131,452-acre-foot reservoir (Figure 7). Flows are released from Silverwood Lake into the 3.8-mile-long 12½-foot-diameter San Bernardino Tunnel. This high-head pressure tun-

nel, with a capacity of 2,020 cfs, is directly connected to the Devil Canyon Powerplant penstock. The plant, situated at the mouth of Devil Canyon at the southern base of the San Bernardino Mountains, is a 119,700-kilowatt installation which operates under a normal static head of 1,418 feet. The penstock, which varies in diameter from 9½ feet to 8 feet, is an elevated steel pipeline. The Powerplant houses two impulse turbines rated at 81,000 horsepower each and two generators rated at 63,000 kVA each.

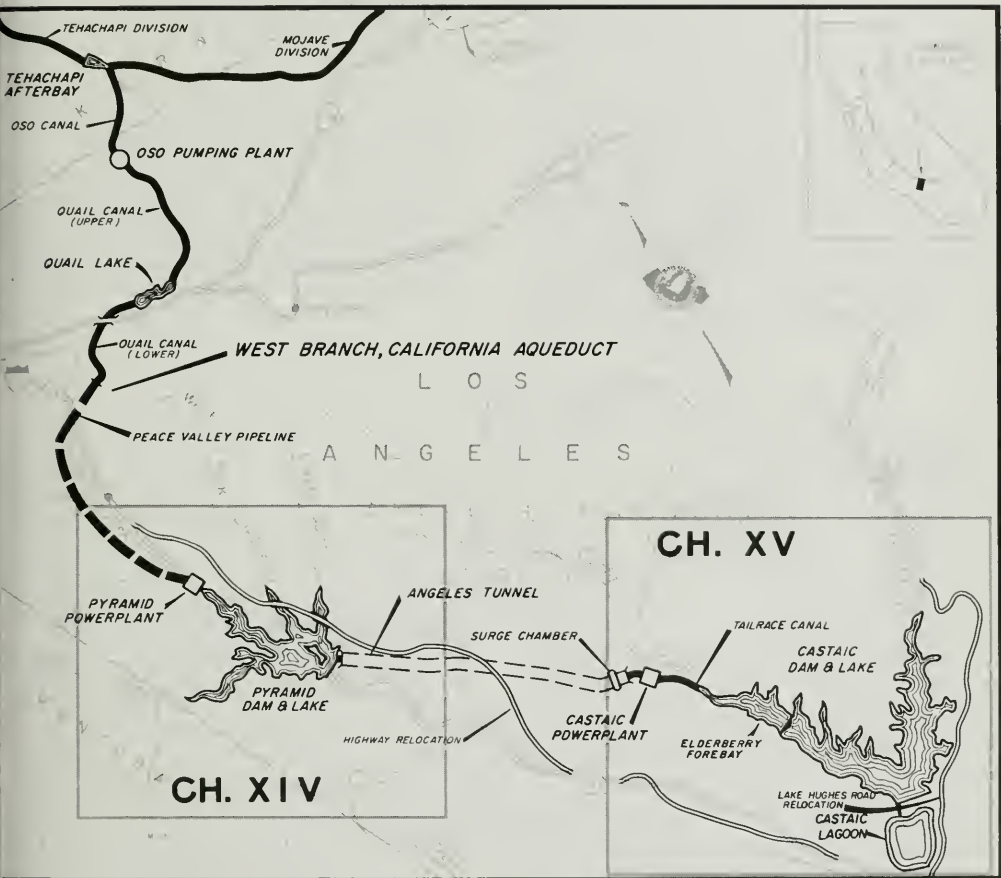
Figure 8. West Branch Division

The West Branch originates at Tehachapi Afterbay and extends southerly about 32 miles toward Los Angeles (Figure 8). Water flows by gravity southward from the Afterbay about 1½ miles to Oso Pumping Plant. This plant has a capacity of 3,128 cfs against a maximum static head of 231 feet. It is an indoor-type installation housing eight electric motor-driven pumps which require a total of 93,800 horsepower. The eight pumping units are manifolded to five 9-foot-diameter discharge lines.

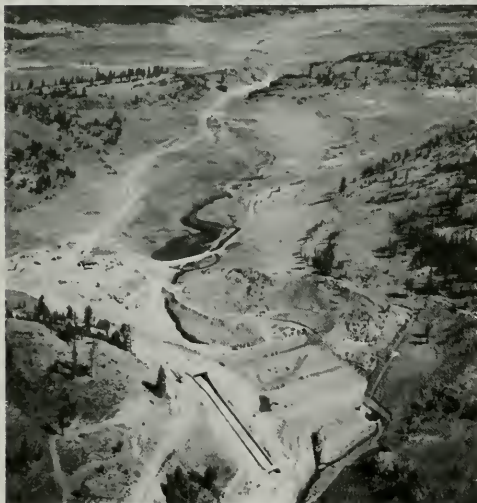
Figure 21. Embankment Construction

tion were: (1) rejection of material with a maximum dry density of less than 104 pounds per cubic foot, (2) a desirable relative compaction of 98%, and (3) rejection of material below 95% relative compaction. Average dry density for all rolled fill tested was 107.0 pounds per cubic foot (pcf) ranging from 90.7 to 115.2 pcf, with an average relative compaction of 97.7% ranging from 91.4 to 103.8%. Average dry density for specially compacted fill (hand-held compactors) was 107.8 pcf, ranging from 100.9 to 117.2 pcf, with an average relative compaction of 98.8% ranging from 94.5 to 102.9%. Only borrow materials with maximum dry density exceeding 104 pcf were drawn from the borrow areas. Areas within the borrow where light materials were known to exist in substantial quantities were avoided. Fill with a relative compaction of less than 95% was either rejected or reworked and retested. The embankment under construction is shown on Figure 21 and the completed Dam on Figure 22.

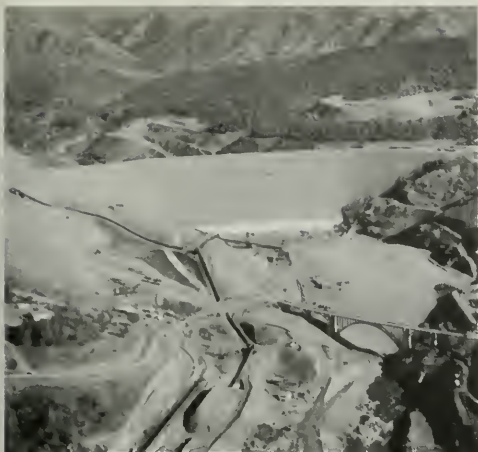
Figure 61. 1964 Cofferdam

A 400-foot-high cofferdam (Figure 61), which was incorporated into the final embankment, served to divert the Feather River and protect the Dam site during construction. This solution was the result of studying several sizes of diversion tunnels and embankment-placing schemes in which the standard project flood with a peak flow of 440,000 cfs was routed past the Dam. The plan for protecting the Dam during the first flood season by making allowance for the fill to be overtopped is discussed later in this chapter in describing the core block. During the second and third years, considerable storage was required behind the Dam to route the flow through the tunnels. It was doubtful if the impervious material in the main core could be placed at a rate great enough to provide the required dam height, particularly in the first full year of embankment placement. The high-cofferdam scheme reduced the required embankment placement rate during this shakedown year to little more than one-half the average rate required to complete the remainder of the Dam. When the need for the cofferdam

had passed, the contractor elected to remove the bulge it caused in the upstream slope and to use the gravels in the Dam.

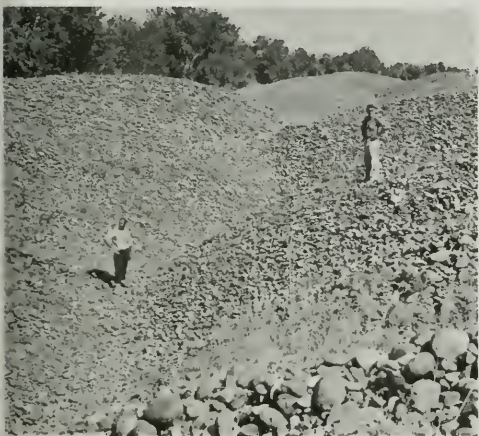
Figure 63. Dredge Tailings

Procedure on the pit exploration started with the bulldozer leveling a site between two linear ridges of dredge tailings (Figure 63). By pushing the material from the ridge into the adjoining valleys at each side, an attempt was made to obtain an average thickness of gravel. This procedure reduced the depth of dragline excavation and gave relative assurance that the sand table would be reached. After leveling by the bulldozer, the dragline was moved in and test pits were excavated through the gravel and several feet into the sand so that an uncontaminated sand sample could be collected and an accurate elevation could be obtained

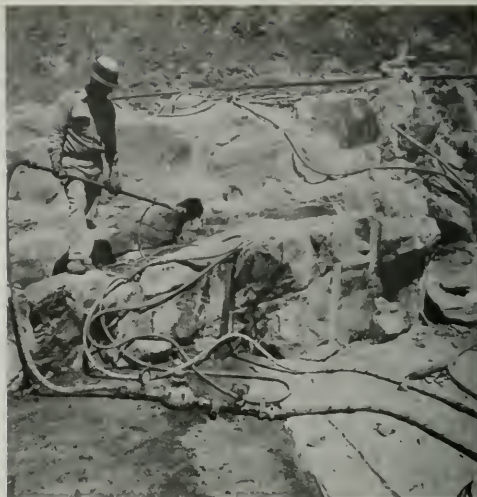
Figure 66. Grouting

Grouting. A single cement grout curtain of 200-foot maximum depth was provided in the foundation beneath the core (Figure 66).

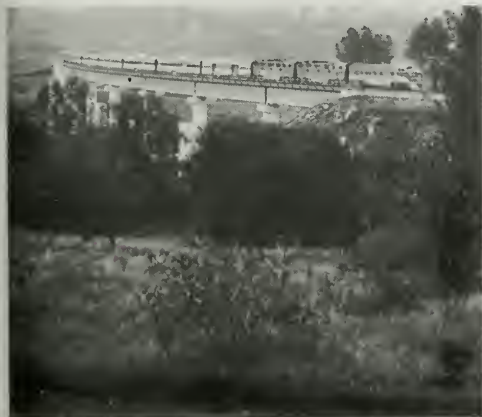
Figure 88. Feather River Bridge

Feather River Bridge. The crossing of the Feather River approximately 1 mile north of the City of Oroville was designated the Feather River Bridge (Figure 88). This bridge was designed by an engineering consultant to the Western Pacific Railroad Company using 1956 American Railway Engineering Association (AREA) specifications. Horizontal alignment of the Bridge is on a 3°00' curve with a track grade of 0.88% ascending eastward.

A riveted-deck plate-girder structure was selected as the most economical design for this bridge. The centerline of track span lengths, center to center of piers, vary from 90 to 128 feet, for a total length of bridge of 1,012 feet in ten spans. Two plate girders were installed on 8-foot centers to support the 16-foot-wide, lightweight-concrete, ballast trough. The girders vary in length from 125 to 88 feet and their depths vary from 9 to 10 feet.

Supporting this superstructure are reinforced-concrete cylindrical piers founded on spread footings placed into bedrock, which vary in height from 44 to 77 feet. The top 44 feet of the cylindrical piers are 10 feet in diameter. They are 12 feet in diameter for the remainder of their length. Piers for a future track were installed 18½ feet upstream of the new bridge and on the same footings. These piers rise above the maximum normal water surface.

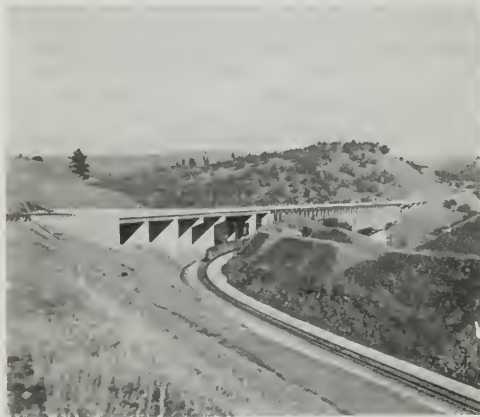
Figure 89. West Branch Bridge

The West Branch Bridge (Figure 89) is a riveted-steel, cantilevered, Warren truss with verticals. The single-track railroad is on an 18-foot-wide, lightweight-concrete, ballast trough supported by steel

stringers and floor beams attached to the lower chord of the truss. The highway is four lanes on a 56-foot-wide concrete roadway supported by steel stringers and floor beams on the top chord of the truss.

The three main piers supporting the truss sections are 216 feet, 252 feet, and 257 feet in height. They are founded on spread footings placed against undisturbed rock excavated to near-vertical lines. The other piers and abutments are reinforced concrete on spread footings.

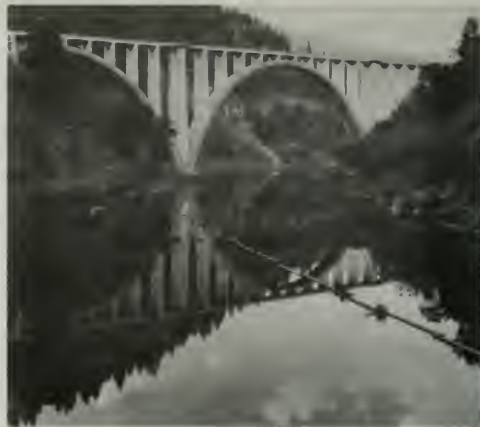
Figure 90. North Fork Bridge

North Fork Bridge. In order for the relocated Western Pacific Railroad tracks to join the existing tracks at the North Fork of the Feather River, a bridge had to be constructed across the River (Figure 90).

The reinforced-concrete arch structure has arch spans of 191.5, 308, and 257.5 feet, six east approach spans 22.5 to 28 feet long, and abutments for a total length of 1,010.5 feet. The 119-foot-high concrete arches vary in width from 20 to 30 feet. They are founded on concrete pedestals placed on bedrock.

The single-track railroad is on 20-foot-wide, concrete, ballast trough with a parabolic soffit. The ballast trough is supported by walls rising from the arch. These walls vary in thickness from 9 feet at the piers to 2 feet at mid-span. They vary in height from 130 feet at the piers to approximately 5 feet at mid-span.

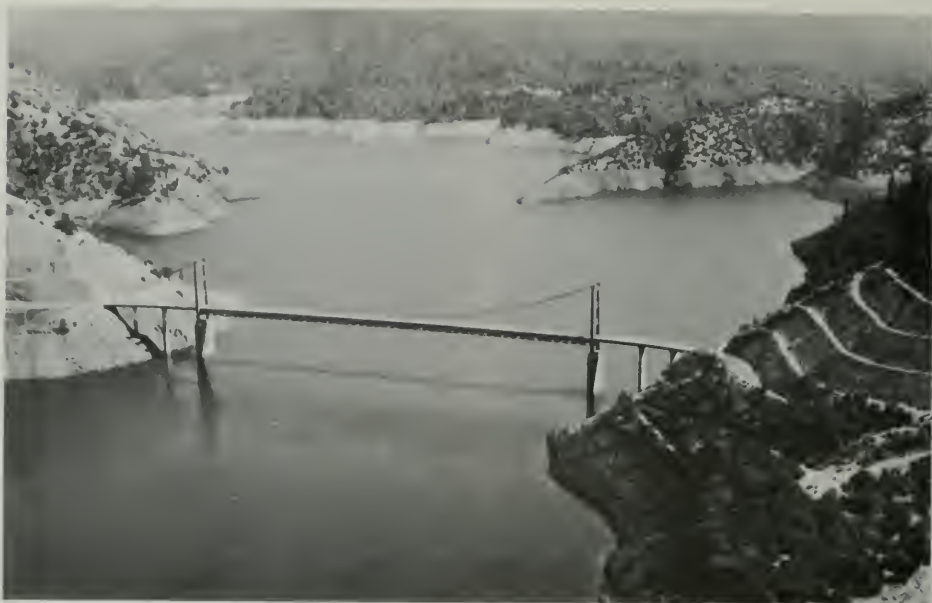
Figure 91. Bidwell Bar Bridge

Bidwell Bar Bridge. Bidwell Bar Bridge (Figure 91), the key feature of the Oroville-Quincy county road relocation, crosses the Middle Fork arm of Lake Oroville about 1 mile upstream from the former crossing at Bidwell Bar. The inundated Bidwell Bar crossing was the location of the historic Bidwell Bar suspension bridge, said to be one of the first suspension bridges erected in the West. The historical bridge was removed and is to be reassembled at a new site at the Kelly Ridge recreation area. The Bidwell Bar Bridge originally was designated the "Middle Fork Feather River Bridge". After construction, it was renamed after the geographical and historical site inundated by Oroville Reservoir.

Selection studies for the Bridge were based upon an investigation of several types of existing structures. Types other than cantilever or suspension bridges were quickly eliminated due to site conditions, span length requirements, and economics.

Studies for a cantilever bridge emphasized the difficulties of fitting an economical structure to the steep slopes at the selected site. Two piers over 300 feet in height would have been necessary to support the bridge. Even with piers of such height, the balance between anchor, cantilever, and approach span was

The main cables are covered with a plastic cable covering developed by the Bethlehem Steel Company. This bridge is the first to use a cable protection system other than the painted wire wrapping introduced by John A. Roebling in 1845. An obvious advantage in using the plastic (glass-reinforced acrylic) cable covering is found in comparing its estimated 50-year life without maintenance to the two- to three-year repainting cycle required by the painted wire-wrapping system.

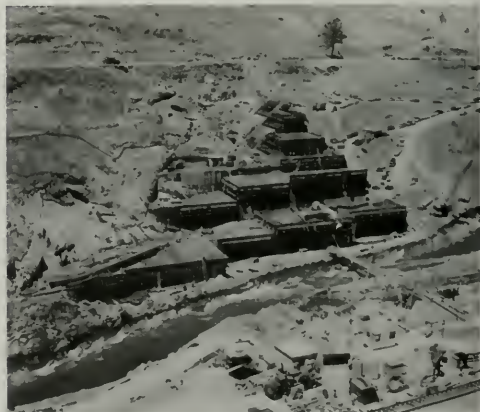
Figure 94. Stage 1 Diversion

For Stage 1 (Figure 94), the River was allowed to remain in its natural channel while the lower lifts of blocks 1 through 7 and 9 of the core block were being placed.

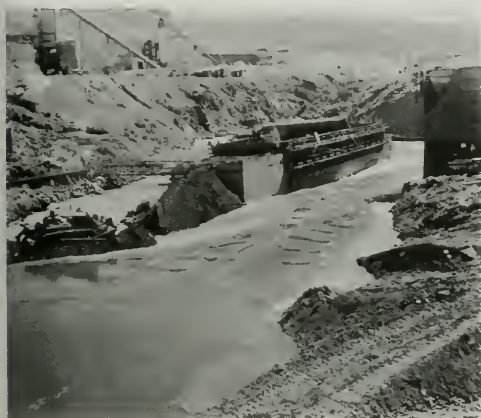
Figure 95. Stage 2 Diversion Earth Dike

Stage 2 (Figure 95) was started on July 18, 1963, when the River was diverted through block 8 by means of an earth dike across the channel upstream of the core block. A similar earth dike downstream permitted dewatering of the remaining foundation.

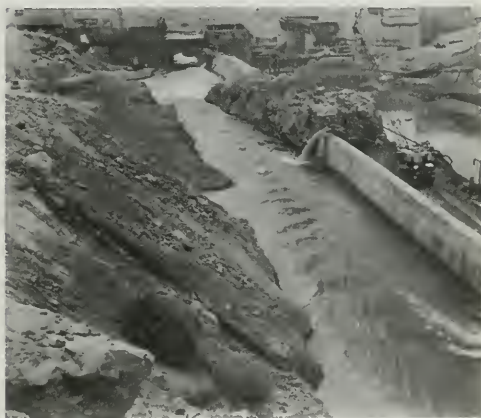
Figure 96. Stage 3 Diversion

Stage 3 (Figure 96) of the diversion was provided by a 30-foot by 22.5-foot sluiceway through block 12. On September 4, 1963, the River was diverted through this opening allowing block 8 to be dewatered and its construction resumed.

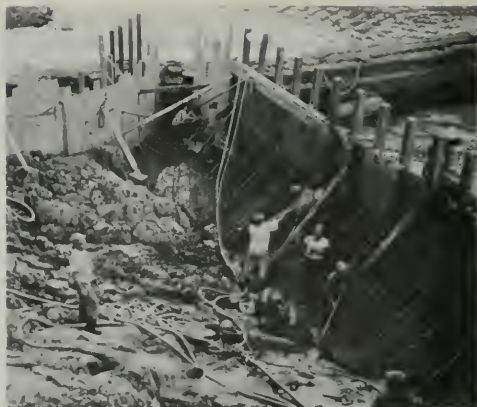
Figure 97. Wood Forms—Core Block

The core block is a mass concrete structure 900 feet long and is positioned approximately 700 feet upstream of the long chord and parallel to the dam axis. Wood forms, constructed in place (Figure 97), were used for concreting on foundation rock, and their use continued until the blocks reached sufficient height to use steel forms. From this point, steel cantilever panel forms were used. A hydraulic crane, operating on top of the blocks, was used to raise and set forms (Figure 98). The crane was moved from block to block by means of a high line. The high line, the same one used at Glen Canyon Dam, was of 25-ton capacity (Figure 99). The main cable or "gut" line was 3 inches in diameter and spanned 1,400 feet. Two rail-mounted steel towers on opposite sides of the canyon provided the anchorage and support for the cable (Figure 100). The towers had a 400-foot travel parallel to the River. A tramway traveled on the cable and carried an 8-cubic-yard placing bucket. All points within the core block area could be reached with this piece of equipment.

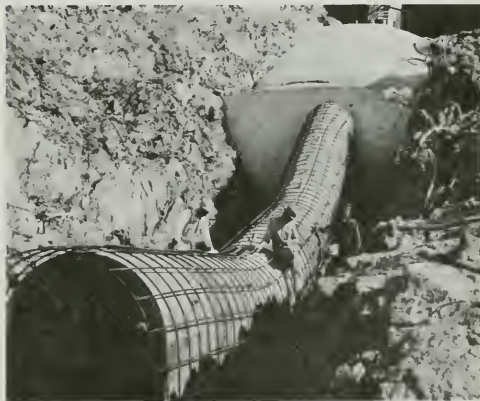
Figure 101. Grout Gallery

The grout gallery is located in rock below the final excavation in the core trench (Figure 101). Construction was initiated early in October 1963. However, the first 14 months of activity amounted to only a small effort and was used to take up work slack at the core block and Thermalito Diversion Dam which was included in the construction contract for the Dam.

The gallery segments were about 30 feet long and constructed in two lifts, which consisted of an invert placement and an arch placement. Interior forms were the same as had been used in the core block galleries. They were steel panels of 2-foot sections and were assembled at the placing site while the walls of the excavation served as the outside form for the trench section of the gallery. Exterior forms were required only in the projected section of the gallery. These were made of plywood or shiplap panels and assembled in place.

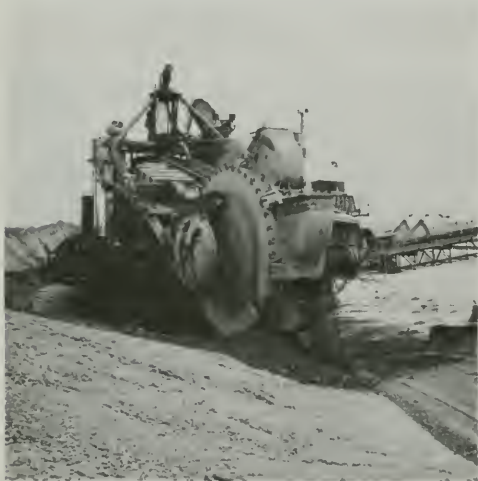
Figure 102. Bucketwheel Excavator

The bucketwheel excavator had a rotating wheel 30 feet in diameter and was equipped with eight buckets of 1.8-cubic-yard-capacity each (Figure 102). The excavator dug 30-foot-wide strips into the piles of dredger tailings, rotating through an arc of 90 degrees before moving along parallel to the face of the piles. For the first three passes, material was delivered to a field conveyor system from the belt mounted on the excavator (Figure 103). On the fourth and successive passes, when the distance from the excavation to the conveyor was excessive, a 200-foot-long transfer conveyor was joined to the excavator (Figure 104). When the width of excavation reached 300 feet, the field conveyor system was moved. Tractors, at intervals of 150 to 200 feet, moved along the length of the portable system and skidded the conveyor assembly approximately 2 feet sideways. This produced a severe bending in the rails which straightened out as the succeeding sections were skidded. As the tractors reached the end of the conveyor system, the direction of travel was reversed and another 2 feet of move accomplished. This procedure continued until a full 300-foot move was made and the conveyor was again adjacent to the excavator. The moving of the portable conveyor sys-

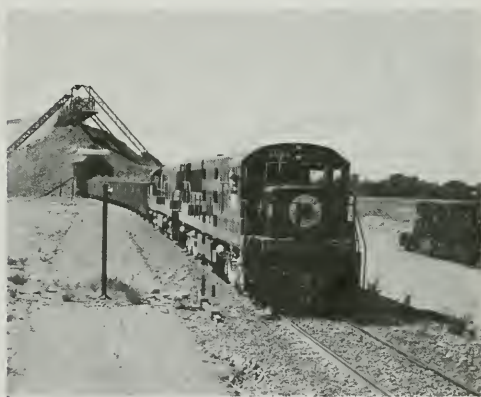
Figure 105. Pervious Loading Station

The fixed conveyor, which was up to 3 miles long, moved material into a hopper which discharged to an elevating belt that fed a shuttle belt which distributed material over ten hoppers at the loading station. These loading hoppers loaded 40-car trains (Figure 105). The train loading station was moved along with the permanent conveyor after the northern borrow areas were excavated.

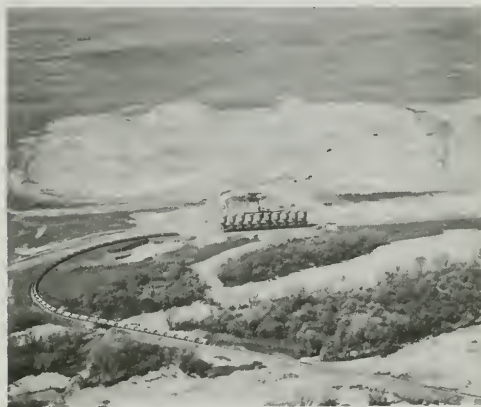
Figure 106. Impervious Loading Station

The scrapers dumped into hoppers feeding two vibrating screens where the plus 3-inch material was removed. This was the only processing of the impervious material required other than minor moisture conditioning. Material passing the screens was belt-conveyed to a shuttle conveyor that distributed to ten metal bins from which ten railroad cars could be loaded simultaneously (Figure 106).

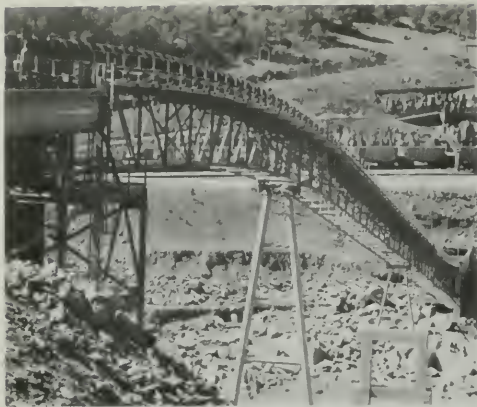
Figure 109. Conveyor Across Feather River

1. The conveyor carrying material over the Feather River from the car dumper was 2,380 feet long and carried up to 12,000 tons per hour on a steel cable belt 72 inches wide (Figure 109). It delivered to a traveling stacker that traversed 1,400 feet of stockpile; its belt, 96 inches wide, discharged at a distance of 60 feet over a reclaim tunnel (Figure 110).

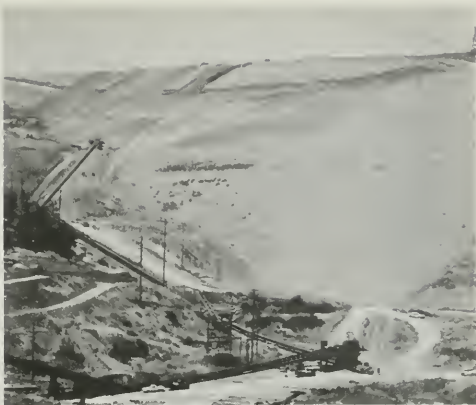
Figure 112. Distribution Conveyors on Right Abutment

3. Four multipurpose distribution conveyors (Figure 112) carried material from the stockpile to the 1,000-ton truck-loading hopper (Figure 113). Each of the conveyors was set up for a haul of 2,300 feet or less. Each was powered by two 1,000-horsepower motors. The conveyor was made up of steel sections 25 feet long.

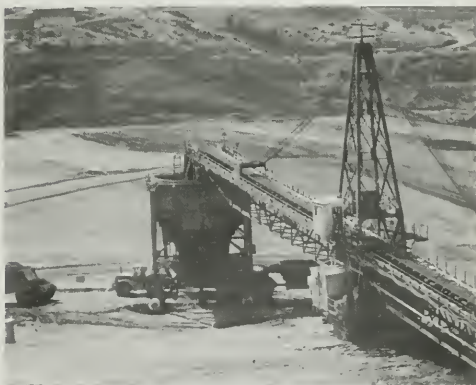
Figure 113. Truck-Loading Hopper

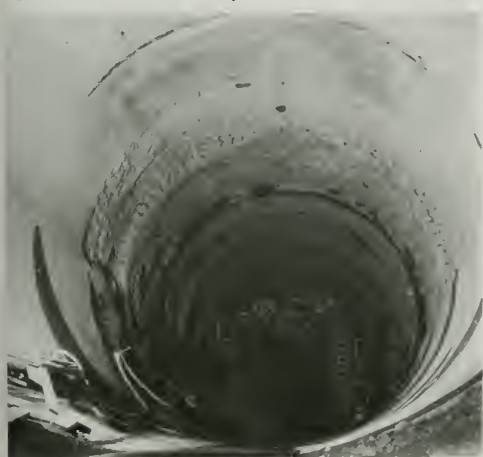
Figure 117. Wedge Seat Removal in Diversion Tunnels

Wedge seats (Figure 117) for the plug were excavated from the tunnel lining by blasting. The deepest holes at the upstream end of the wedges were 1 foot, and succeeding holes progressing downstream in each wedge were shortened to develop the taper. All loose material was removed with chipping guns prior to placing concrete. Stainless-steel grout stop was installed around the full circumference of the plug at each end. This was done concurrently with the concrete work.

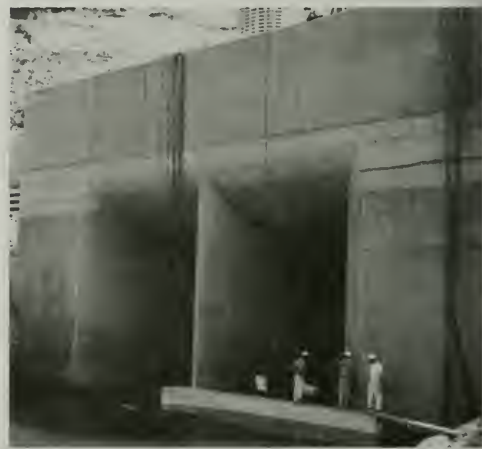
Figure 118. Lowering Stoplogs

For the seating of the gates, concrete stoplogs (Figure 118) were placed across each opening during closure. By producing quiet water at the bulkhead gate, a diver was able to clean the slots so that the gate could be lowered without the pressure of running water. (By prior arrangement with upstream dam owners, the riverflow was held to less than 1,000 cfs.) After the first bulkhead gate was dropped into place, the stoplogs were removed from that side, moved to the other side, and the procedure was repeated. There was a substantial amount of leakage around both gates after they were dropped into place. The contractor succeeded in sealing the right gate by pumping a 1:1 mix of bentonite and Silvace followed by fine sand into the edges of the gate. This was ineffective on the left gate. A section of 2-inch hose wedged between the slot and the gate on the left side succeeded in diverting the flow to the invert where it could be picked up in a drain.

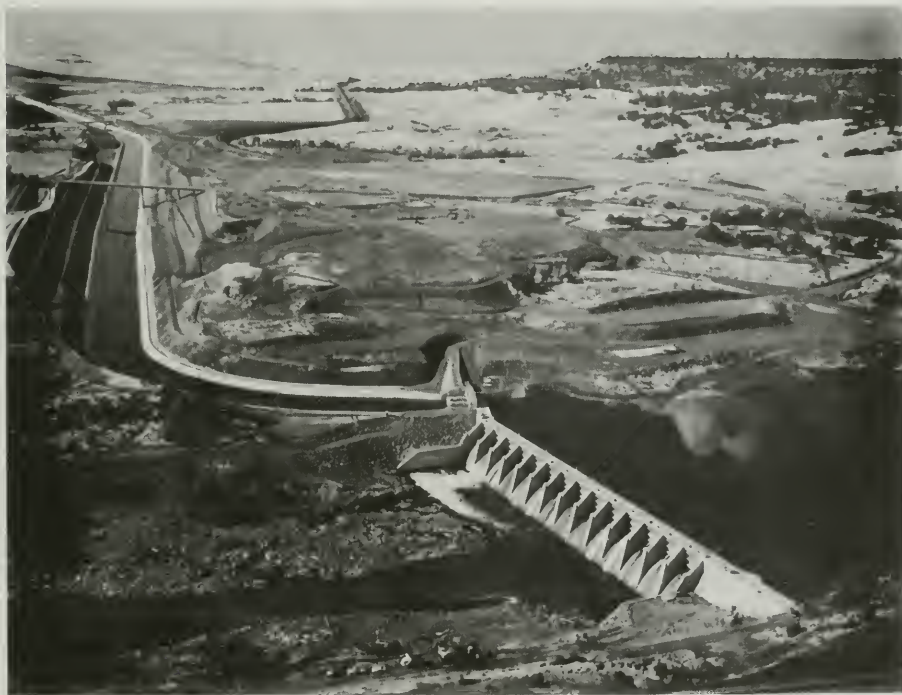
Figure 120. Aerial View—Thermalito Diversion Dam

Thermalito Diversion Dam (Figure 120) consists of a 625-foot-long, concrete, gravity section with an ogee spillway; a canal-regulating headworks structure; and an earth embankment section at the right of the canal headworks (Figure 121).

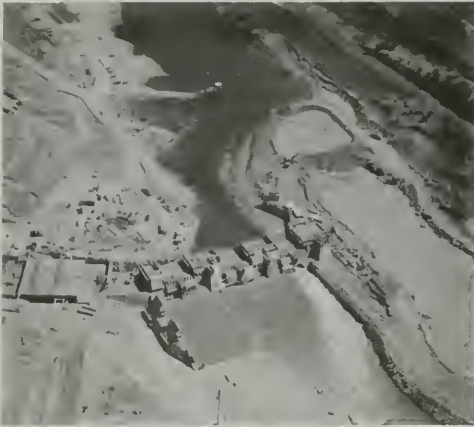
Figure 128. Cofferdam Closure

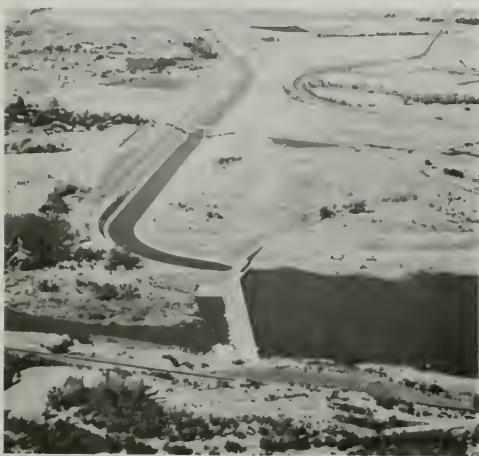
Figure 140. Thermalito Power Canal

Thermalito Power Canal extends from a headworks structure, which is a portion of Thermalito Diversion Dam, to Thermalito Forebay (Figure 140). The canal invert is level to facilitate conveyance in both directions. It was designed to convey a maximum flow of 17,000 cfs for the generating cycle of pumped-storage operation. Maximum flow in the pumping cycle is 9,000 cfs. Canal cross-section dimensions were set for convenience of doubling the canal capacity at a later date in connection with a possible second Oroville Powerplant. Bridge pier foundations were deepened to allow for this expansion.

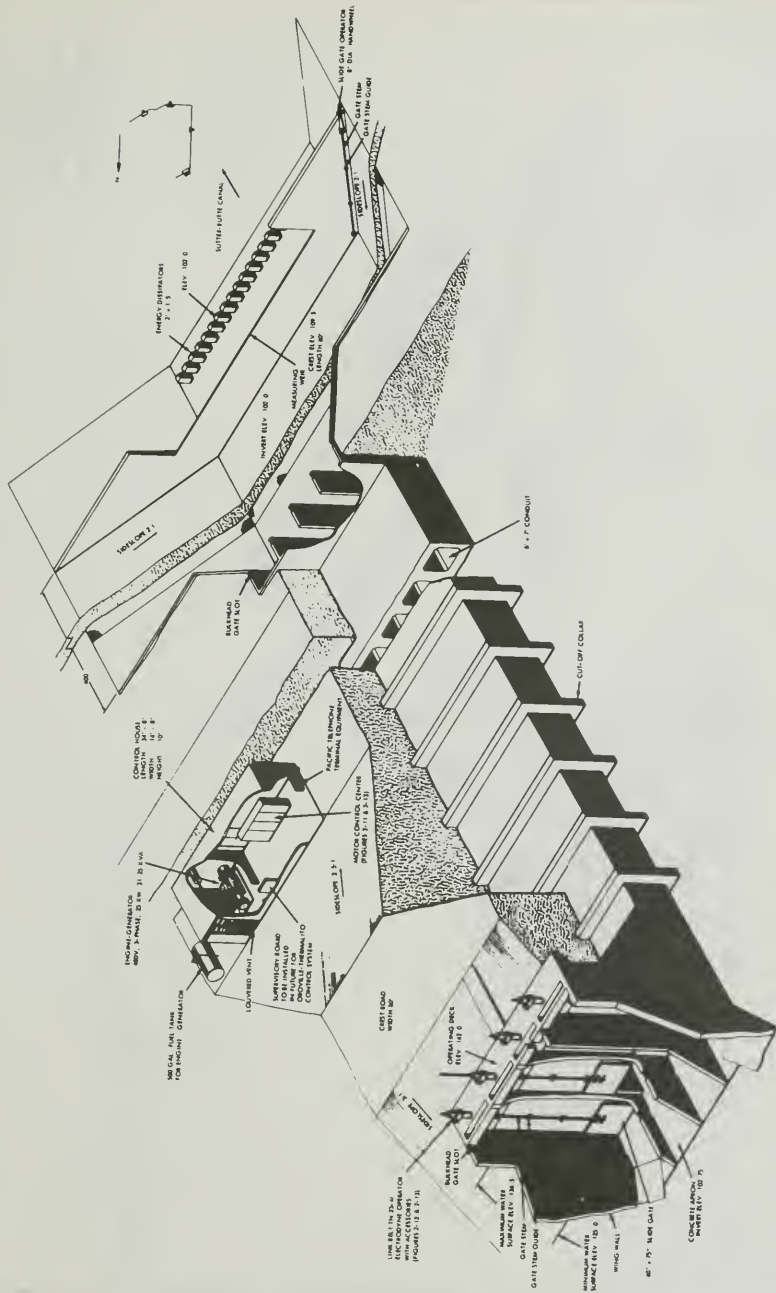
Figure 147. Pacific Gas and Electric Outlet—Isometric View

The PG&E lateral outlet (Figures 146 and 147) consists of a 30-inch-diameter conduit, a small intake training structure with provisions for bulkheading, a wet well upstream of the dam centerline containing a 30-inch-square slide gate, and an outlet stilling box with a weir for measuring flow.

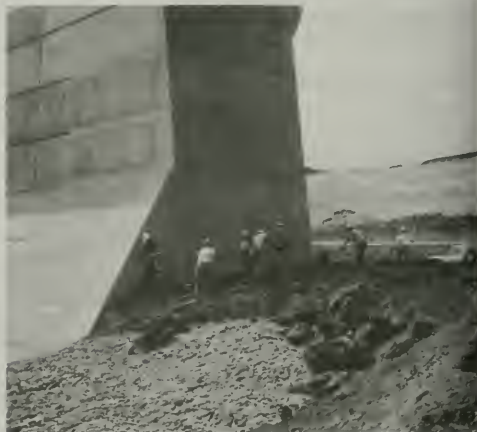
Figure 153. Hand Placement of Forebay Dam Adjacent to Powerplant Wingwall

Excavated material was transported to the embankment by scrapers and placed parallel to the dam axis in 8- to 10-inch loose lifts. It was then leveled and scarified with a bulldozer with a "Trinity Scratcher" or a motor patrol with a scarifier. The embankment lift was compacted with 12 passes of a sheepfoot roller. All rolling was performed parallel to the dam axis, except where insufficient space prevented this procedure from being followed. Zone 1F material placed in contact with the powerplant wingwall was compacted with hand equipment (Figure 153). A relative compaction of 97% was required for Zone 1F and 95% for Zone 2F.

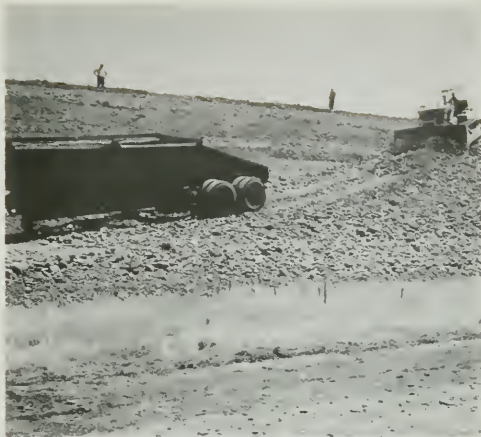
Figure 155. Placement of Zone 4A—Afterbay Dam

Pervious—Afterbay. Placement of Zone 3 and 4A material consisted of a blanket of Zone 4A material on the entire downstream face of the dam (Figure 155) and Zone 3 material on the upstream face of the dam.

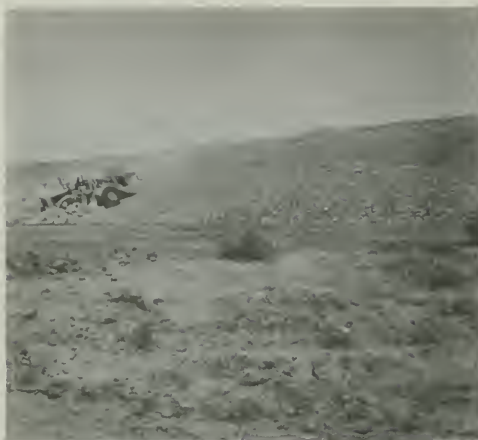
Figure 156. Riprap Placement

Riprap. Riprap was hauled to the dams utilizing end-dump highway trucks and trailer rigs and dumped in stockpiles along the upstream toe of the dams. Placement was performed with rubber-tired front-end loaders with chain wrapping on the front wheels for better traction (Figure 156). The loaders carried the rock from the stockpiles to the top of the slope and windrowed a lift for a distance of 50 to 100 feet longitudinally, then added another windrow below it. This procedure was continued until the bottom was reached.

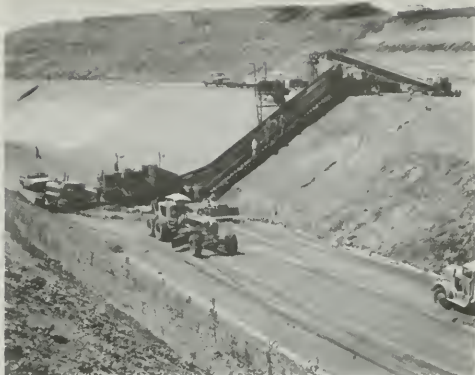
Figure 158. Placing Type II Drain Pipe Along Toe of Slope and Type B Filter Material on Invert of Power Canal

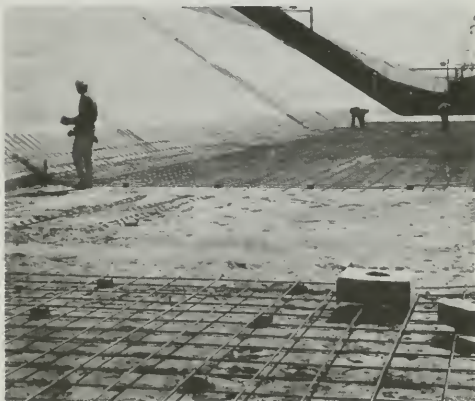
Figure 160. Reinforcing Steel Being Placed in Canal Invert

Reinforcement steel for the canal lining consists entirely of No. 4 bars placed on 12-inch centers each way. Precast mortar spacers were attached to the steel, and the invert and side slope mats were placed on the filter blanket with a mobile crane (Figures 159 and 160).

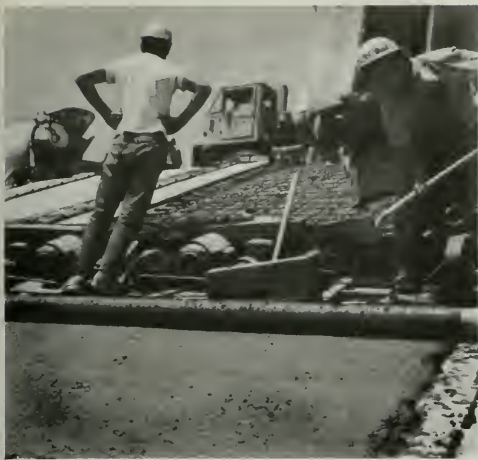
Figure 162. Closeup of Slip Form Lining Operation on Thermalito Power Canal Transition Slopes

Concrete placements, referred to as "hand lining" were made in areas inaccessible to the canal lining machine and in the transition area west of State Highway 70. A small paver (Figures 161 and 162) was designed by the contractor and used to place concrete in these areas.

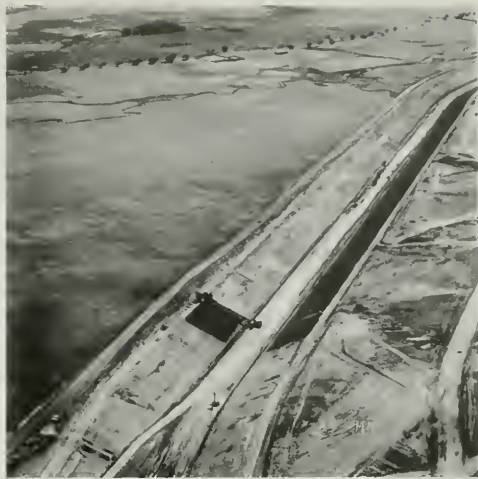
Figure 163. Bedding Placement on Tail Channel

Placement of Channel Protection. Upon completion of slope trimming, placement of the stone slope protection and bedding material commenced with a Gilli-K-Hike (Figure 163). Power to the belt was provided by a diesel engine-generator mounted adjacent

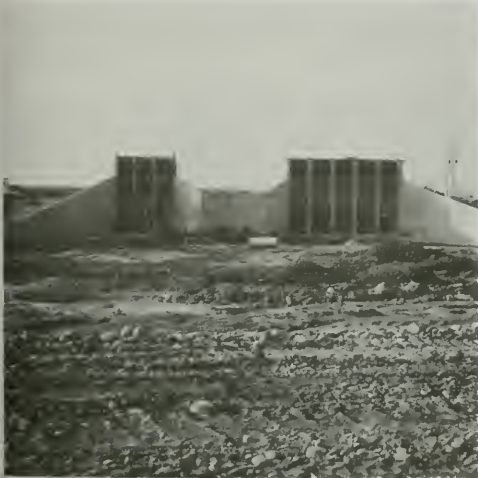
Figure 165. Western Canal and Richvale Canal Outlets—Upstream View

Western Canal and Richvale Canal. Western Canal and Richvale Canal outlet structures were built immediately north of the existing canal alignment so that the canal could be used during construction (Figure 165). At the upstream end, the structures are connected by a retaining wall, footing, and cutoff wall. The entire area between the two structures and the adjoining area for the structures themselves were excavated in one operation. This made dewatering easier since drainage channels could be cut across the entire area and fewer sumps were required.

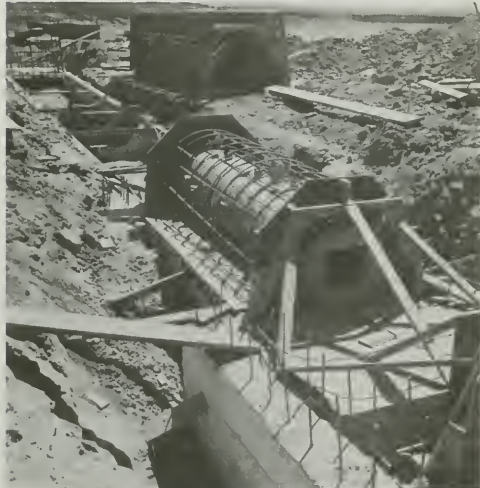
Figure 166. Pacific Gas and Electric Lateral Outlet Conduit

Conduit concrete (Figure 166) was placed in a series of sections as determined by construction joints. Each section was placed in two lifts, the first of which was made with the inside conduit forms and all of the

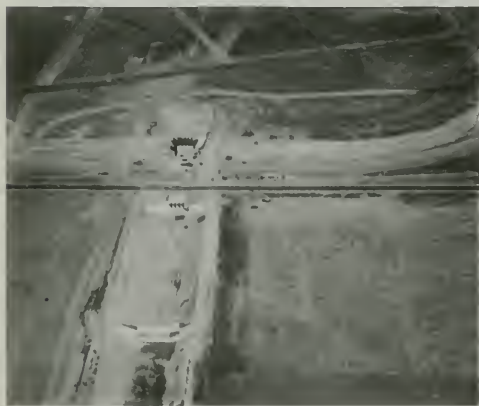
Figure 167. Sutter-Butte Canal Outlet

Sutter-Butte Canal. Sutter-Butte outlet structure (Figure 167) consists of an approach and headworks section, four 6- by 7-foot rectangular conduits approximately 340 feet long, and an exit structure. A rectangular, modified V-notch, sharp-crested weir was constructed 370 feet downstream of the exit structure. Incorporated in the headworks section are 4- by 6-foot, steel, slide gates and hoists.

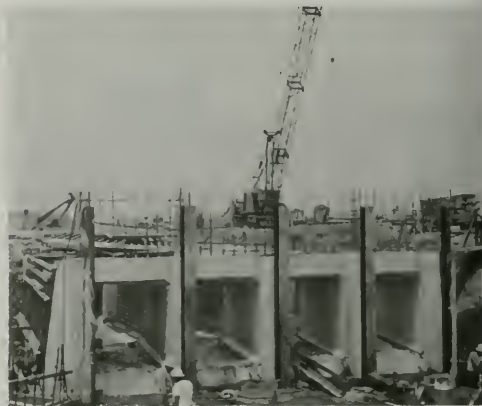
Figure 168. Sutter-Butte Canal Outlet Conduits

Bottom slabs of the conduits were placed in alternate 25-foot-long sections for the full width of the structure. The walls and top slab of the conduit sections were placed next, in a like manner (Figure 168).

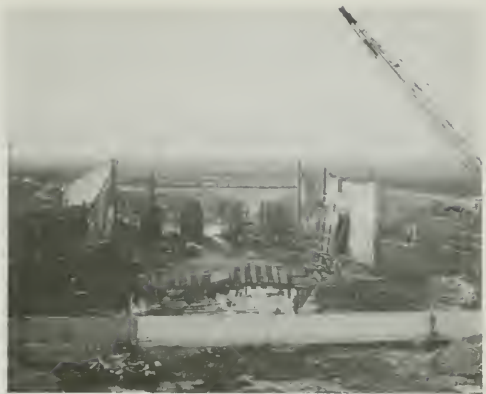
Figure 170. River Outlet

The river outlet structure (Figure 170) is located in the southeast corner of the Afterbay (Figure 130).

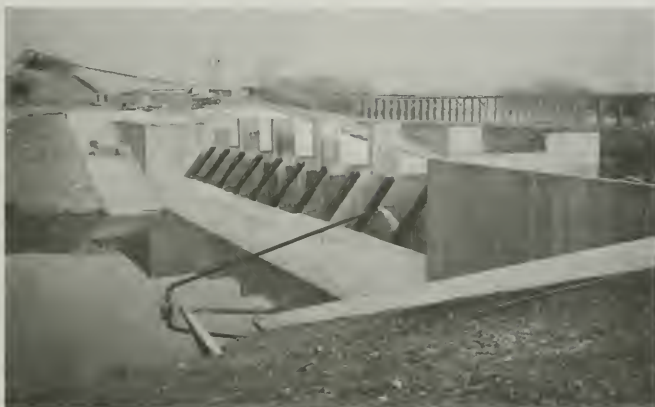
Figure 171. River Outlet—Fish Barrier Weir

Fish Barrier Weir. The fish barrier weir structure (Figure 171) is located on the bank of the Feather River approximately 860 feet southeast of the river outlet headworks.

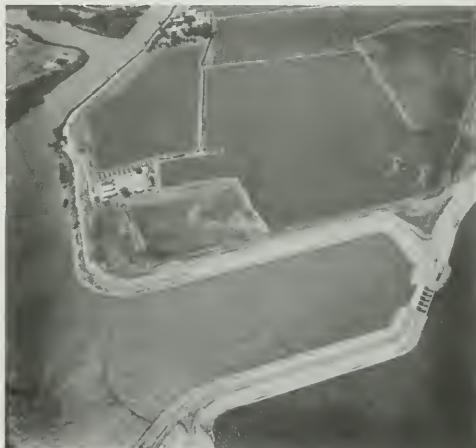
Figure 178. Control Structure and Inlet Channel Connection to West Canal and Old River (in background)

To regulate flow into Clifton Court Forebay and to isolate the Forebay from the Delta, a gated control structure was required (Figures 177 and 178). It will serve only as emergency control once the Peripheral Canal is completed. This structure consists of five 20-foot-wide by 25.5-foot-high radial gates, housed in a reinforced-concrete gate bay structure. The gate structure includes a 10-foot-wide bridge for vehicular traffic, one set of stoplog slots, and a hoist platform. A riprapped earthen transition extends from both the inlet and outlet of the structure. A 1,000-foot-long riprapped channel with a 300-foot base width connects the control structure to West Canal. A log boom was provided at the channel inlet to discourage boats from entering the area (Figure 178).

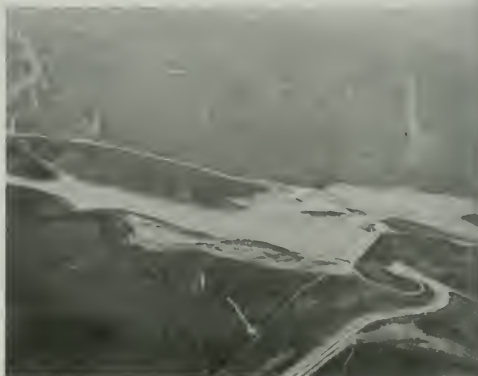
Figure 184. Bethany Forebay

The five dams were built under two separate contracts. A single dam, designated the Forebay Dam, was constructed initially to create a reservoir to supply South Bay Pumping Plant (Figure 184). This initial pool was designated Bethany Forebay. After a few years of operation and with the construction of the California Aqueduct underway, the second contract was awarded for construction of four smaller dams southeast of the Forebay Dam. These four dams allowed expansion of the initial reservoir and provided the most economical conveyance facility for this portion of the California Aqueduct (Figure 185). The resulting pool is designated Bethany Reservoir.

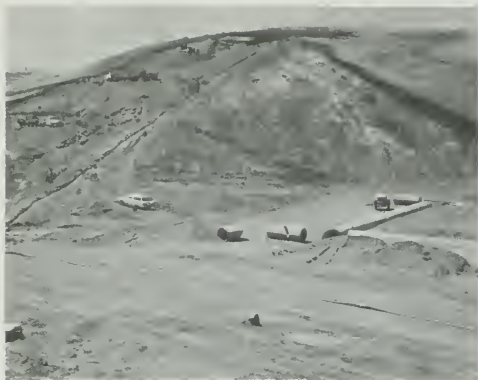
Figure 199. Foundation Grouting—Bethany Forebay Dam

The split-spacing method was used for drilling and grouting the curtain along the entire length of Bethany Dam (Figure 199) and the adjacent dams. Primarily, holes were drilled and grouted at 40-foot spacing, and secondary holes were set midway between the primary holes. The spacing similarly was "split" twice more, so that the final spacing of the grout curtain holes was 5 feet except on the higher portions of the forebay dam abutments where the spacing was 10 feet. The specification provided for the holes on 10-foot spacing to be 50 feet deep and the intermediate holes to be 25 feet deep.

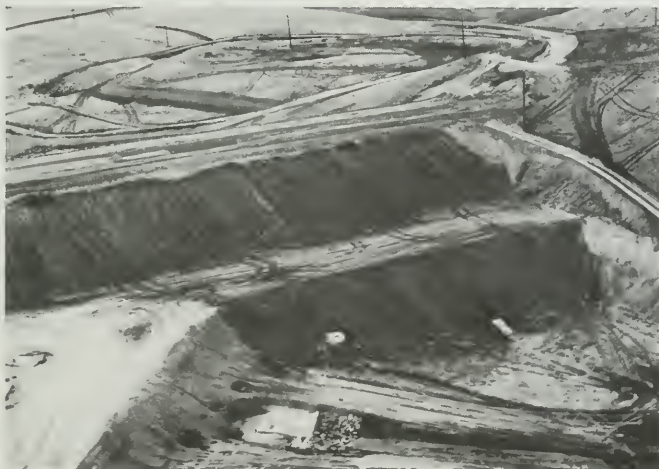
Figure 201. Bethony Forebay Dam Construction

Good compaction results were obtained when moisture control, rolling of lifts, and rock removal were done properly. Compaction improved as the work progressed. The low densities found early in construction of the Forebay Dam were not considered critical, and it was reasoned that the overburden weight of the upper material would sufficiently consolidate the low-density areas. Twelve years after the completion of the Forebay Dam, settlement gauge readings showed a maximum settlement of 5 inches, well within the anticipated amount. The Forebay Dam during final construction stages is shown on Figure 201.

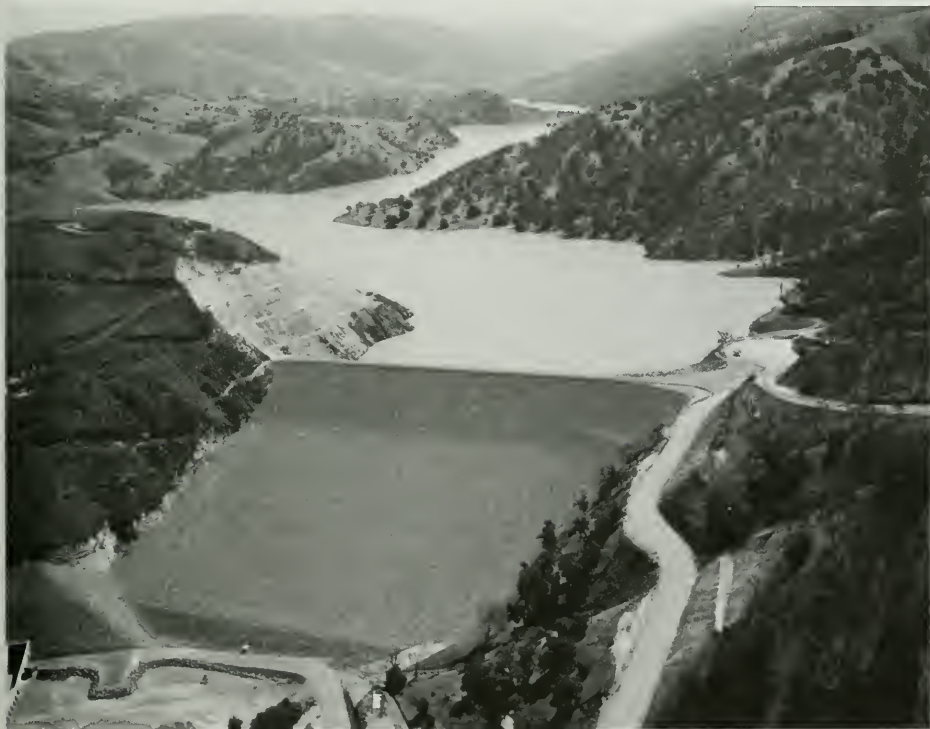
Figure 203. Aerial View—Del Valle Dam and Lake Del Valle

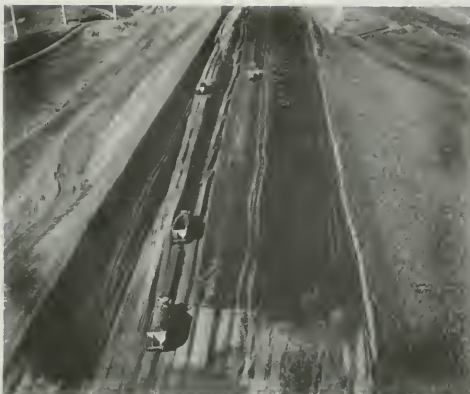
Figure 233. Placing and Compacting Embankment—San Luis Dam

San Luis. The 385-foot-high San Luis Dam is a zoned earthfill (Figure 232) with a rock face section on a 3:1 slope upstream above elevation 400 feet, and an 8:1 slope of random material below elevation 400 feet, steepening to 2½:1 below elevation 310 feet (Figure 233). The downstream slope is 2:1 above and 2½:1 below elevation 450 feet, flattening to a 6:1 slope below elevation 400 feet. The Dam incorporates a chimney drain below elevation 500 feet connected to a foundation blanket drain. This drain system terminates in toe drains. The dam crest is at elevation 554 feet.

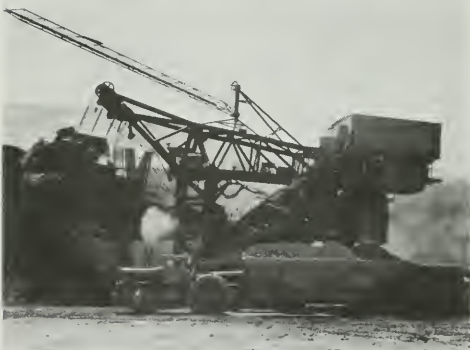
Figure 234. Wheel Excavator Cutting on 50-Foot-High Face

Embankment materials for Zone 1 were the alluvial valley fills from within both the San Luis and O'Neill reservoir basins. The largest portion was excavated by a large wheel-type loader (Figure 234). The sand, gravel, and cobbles of Zone 2 were obtained from channel deposits along San Luis Creek, beginning upstream of San Luis Reservoir. Zone 3 consisted of miscellaneous material, including that removed in foundation excavation which was moved directly to placement in the embankment. Material for rock fill, bedding, and riprap was quarried from Basalt Hill, high on the right abutment. It was separated at the 3-inch size with some of the material passed through a crusher to manufacture bedding for riprap (Figure 235). Zone 4 consists of the fraction less than 8 inches and Zone 5 that fraction greater than 8 inches.

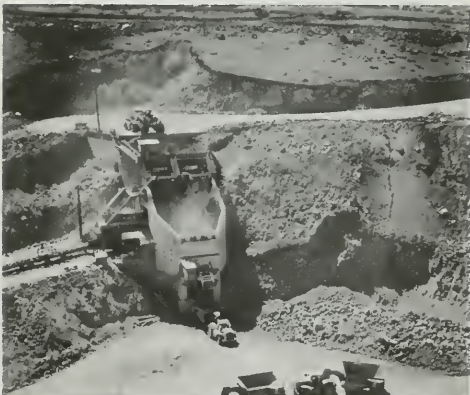
Figure 235. Basalt Hill Rock Separation Plant

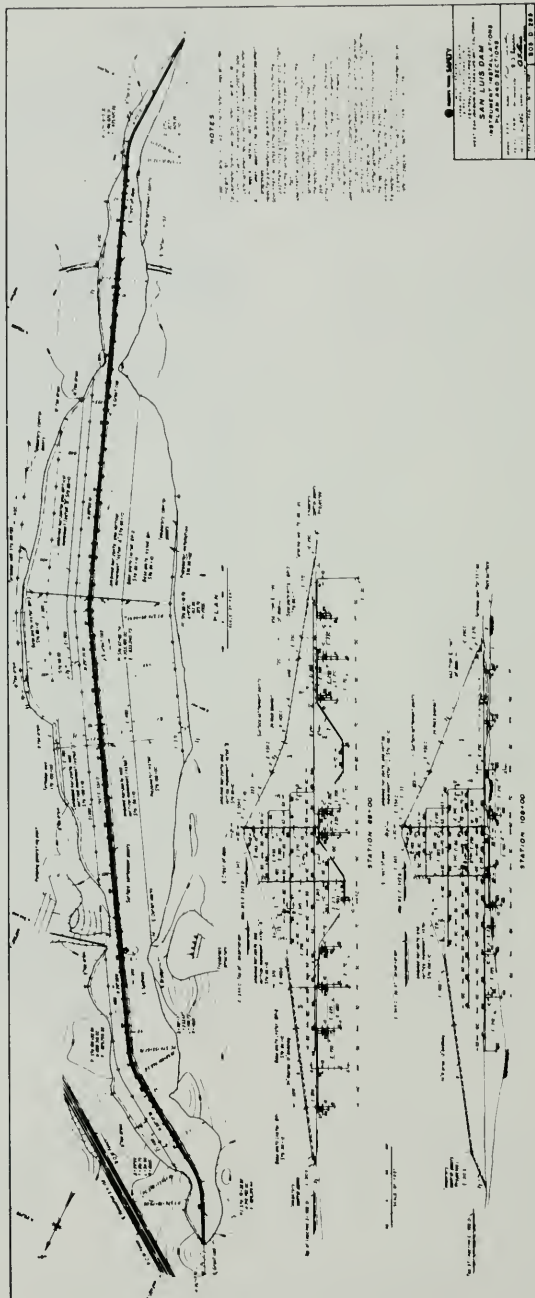
Figure 244. Location of Instrumentation—San Luis Dam

The location of certain instrumentation at San Luis Dam is shown on Figure 244.

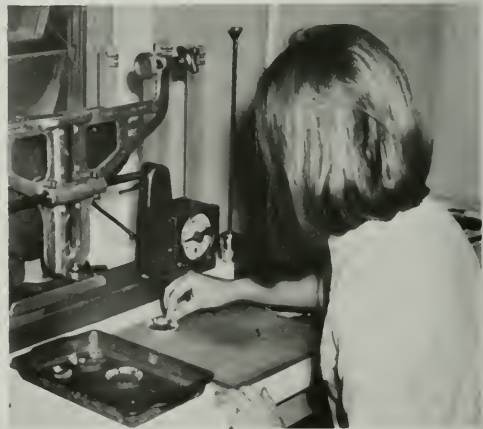
Figure 253. Determining the Plasticity Index Number of the Impervious Zone

Initial explorations showed that no clay material was located in the lake area. An extensive search was conducted to find suitable material that would have a Plasticity Index greater than 15 and have the Liquid Limits fall between 30 and 50. Bucket auger holes were drilled at Summit Valley and in dry lakebeds as far as 40 miles away. An unnamed lakebed 20 miles northeast of the Dam site was selected since it showed the desired clay quality (Figure 253).
