California State Water Project

Volume III
Storage
Facilities

Bulletin Number 200
November 1974

State of California
The Resources Agency
Department of Water Resources

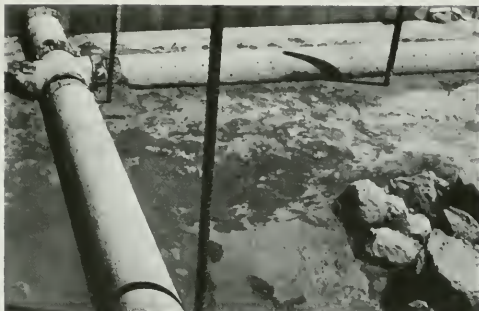
Figure 263. Perforated Drain Pipes in Spillway Chute

Drainage. A drainage system is located under the spillway floor slabs and along the wall heels in the chute and stilling basin to help relieve uplift. The chute drainage system consists of lateral-perforated drain pipes placed in a herringbone pattern with the perforations down and surrounded by drain material (Figure 263). In the stilling basin, the drainage system consists of perforated drain pipes bedded in concrete in a rectangular pattern, with the perforations up and drain material placed over the pipe.

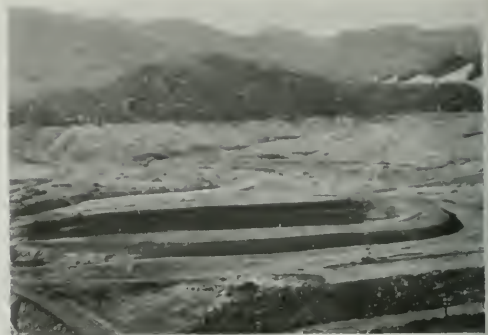
Figure 271. Embankment Construction

During the first phase of dam construction, the River was diverted through the Dam site west of the right abutment to allow completion of right abutment excavation and foundation grouting. By October 1969, right abutment excavation, core trench excavation, and foundation grouting had progressed sufficiently to permit commencement of construction of the flood diversion channel located along the right abutment (Figure 271).

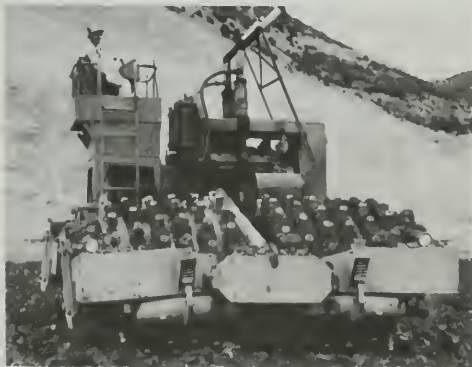
Figure 272. Compacting Zone 1 Material

Placement of contact material to a depth of 12 inches was followed by the placement of Zone 1 embankment in the conventional manner using sheepsfoot rollers (Figure 272). The material was spread and leveled by a rubber-tired dozer and compacted by self-propelled, four-drum, sheepsfoot rollers. Twelve passes with the sheepsfoot roller were required to compact the material to a maximum depth of 6 inches and to a required compaction of 95%. The top layer of foundation contact material, compacted by a wheel-roller, was scarified to a depth of 2 inches prior to placing Zone 1 embankment. A total of 1,090,000 cubic yards of Zone 1 material was placed in the dam embankment.

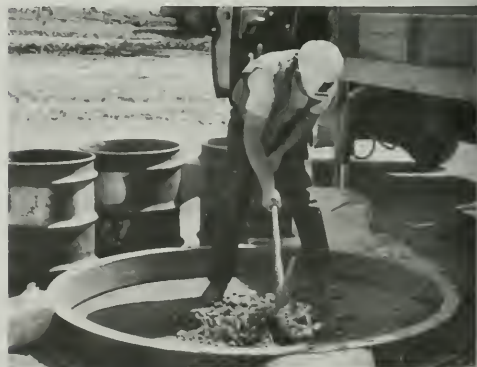
Figure 273. Performing Field Density Test on Zone 3 Material

material was extended in a thick blanket along the foundation and under the Zone 4A embankment all the way to the upstream toe of the Dam. The materials were leveled by dozers and moisture-conditioned on the fill by water tankers. The material was compacted by two passes of a vibratory roller. Lifts were limited to a depth of 24 inches. Compaction tests were performed for every 10,000 cubic yards of material placed (Figure 273).

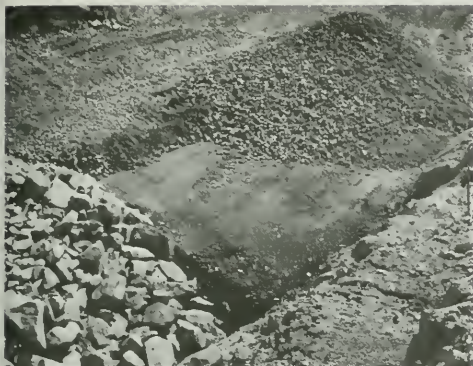
Figure 274. Zone 3 and 4 Material

Materials for Zone 4 embankment, lying downstream of Zone 3, varied in size from 3 to 30 inches. The rock for Zone 4 was hauled in rear-dump trucks and spread on the fill by dozers. No moisture conditioning was required. Lifts were limited to 36 inches after compacting (Figure 274) with two passes of a vibratory roller. A total of 776,000 cubic yards of Zone 4 material was placed in the dam embankment.

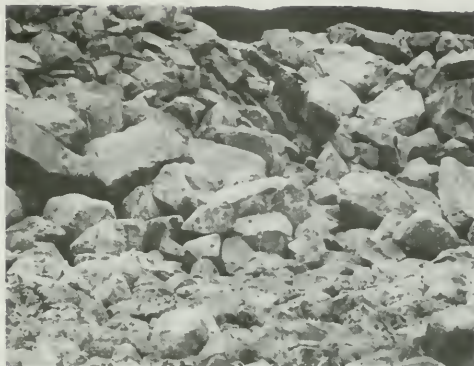
Figure 275. Zone 5 Embankment Shell Material

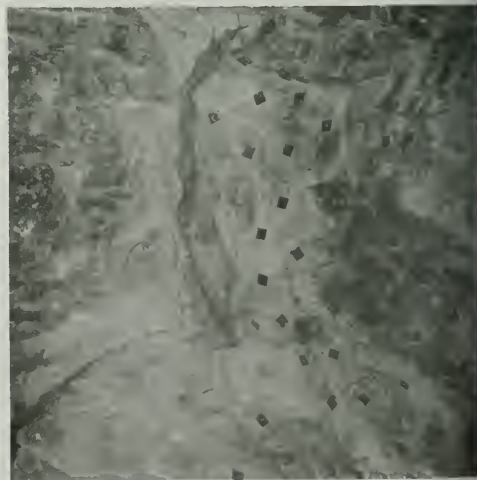
Figure 276. Rock Bolts in Dome of Outlet Works Gate Chamber

After completing the excavation of the air tunnel, the contractor resumed excavation in the gate chamber by driving an 8-foot-diameter shaft from the floor of the gate chamber (elevation 3,196.30 feet) to the top of the dome. The dome at the top of the shaft was rock-bolted with 10-foot-long rock bolts on 3-foot cen-

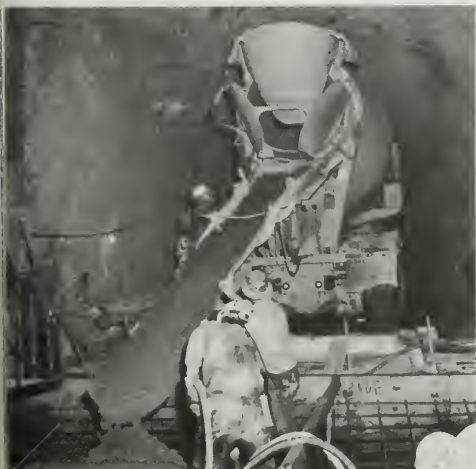
Figure 277. Placing Concrete in Gate Chamber

Concrete Placement. The first two placements for the gate chamber were made to level the foundation to allow setting of jack plates and anchor bolts for the steel-plate liner supports. The concrete was transported from the batch plant to the gate chamber in transit mix trucks (Figure 277).

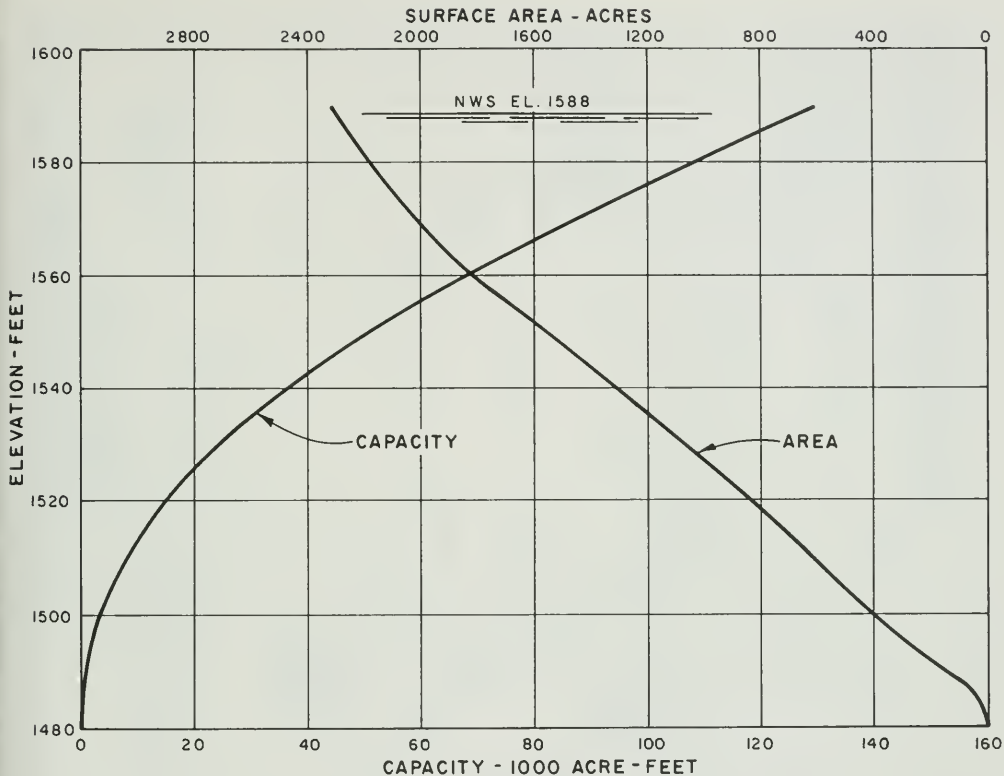
Figure 280. Area-Capacity Curves

A statistical summary of Perris Dam and Lake Perris is shown in Table 35, and the area-capacity curves are shown on Figure 280.

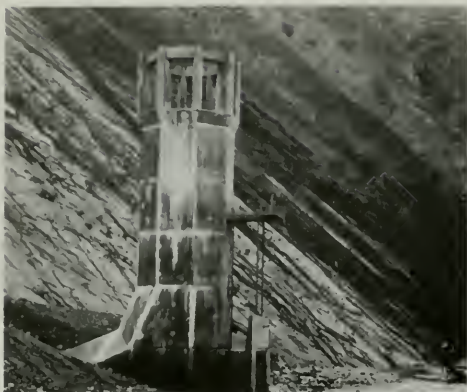
Figure 310. Intake Tower

The low-level intake provided for initial diversion flows. It was blocked when the interim dam was completed and later plugged with concrete except for two 30-inch-diameter and one 10-inch-diameter temporary conduits. This allowed water to pond behind the Dam to elevation 2,293 feet. Stream releases during construction were controlled through the conduits by sluice gates (30-inch) and a butterfly valve (10-inch). Floodflows passed over the interim spillway the first winter of dam construction and through the upper tower opening the second.

1. Tower submerged and discharging 1,000 cfs (standard operation).
2. Tower submerged and discharging 11,300 cfs (diversion condition).
3. Reservoir at normal water elevation 2,578 feet, with seismic load.
4. Tower bulkhead closed and empty with external hydrostatic head to elevation 2,578 feet.

The trashracks were sized to limit the velocities to 2 feet per second during a discharge of 1,000 cfs, and the trash bars were designed to fail at stresses result-

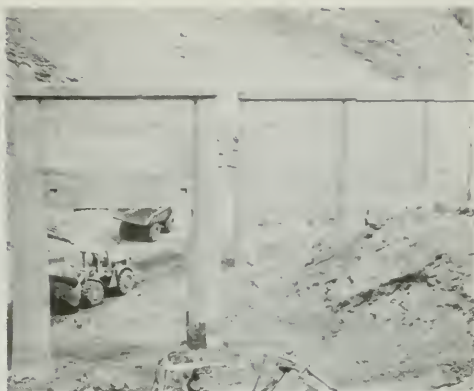
Figure 323. Old Highway 99 Bridge Bents Uncovered in Downstream Shell Area of Dam

Removal of the highway fill in the downstream area of the foundation revealed four old highway bridge bents of reinforced concrete (Figure 323). These were located in the pervious shell section of the Dam, and they were left in place as they did not hinder placement or compaction of the embankment.

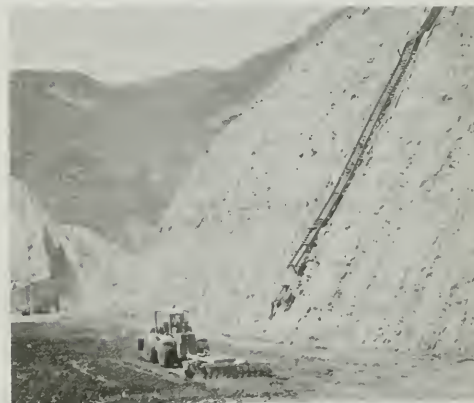
Figure 325. Presplit Face of Shaping Area on Right Abutment

Shaping. The right abutment of Pyramid Dam was very steep and irregular. Extensive shaping excavation was performed to provide a uniform surface for placement of impervious embankment and to flatten the slope in the area of the old Highway 99 cut slope (Figure 324). Drilling for this excavation started at the end of the Dam in January 1971, and excavation to the stream channel was completed in March 1971. The slopes of the excavation were presplit with an average hole spacing of 30 inches. This produced a neat line excavation with deviations limited, in general, to within 12 inches of the drilled line (Figure 325). Lifts normally were 30 feet deep.

in shell areas and 1/2:1 in the core zone. It was required that these areas be removed by the presplit method. Presplit hole spacing was varied from 18 inches to 36 inches, and it was found that a spacing of 30 inches gave excellent results.

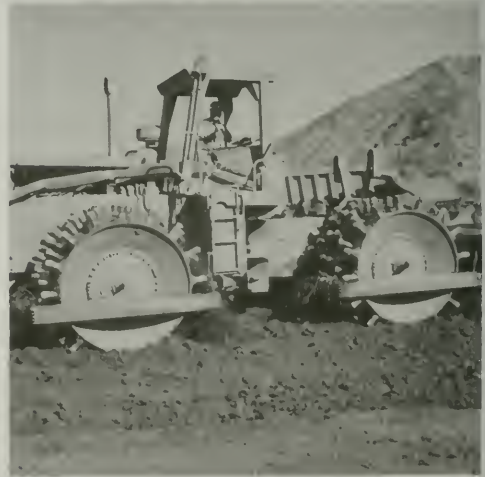
Figure 330. Rolling of Impervious Fill

raised to that elevation. After being dumped by the hauling units, the material was spread with a bulldozer into 8-inch loose lifts, then processed by at least two passes of a disc. At this time, if any supplemental moisture was required, it was added by a water wagon. After disk, the lift was compacted by 12 passes of a self-propelled, four-drum, sheepfoot roller (Figure 330). Compaction of the fill was closely monitored with an average of one relative compaction test being taken for each 2,500 cubic yards of fill placed. The average relative compaction for the impervious embankment was 98.5%.

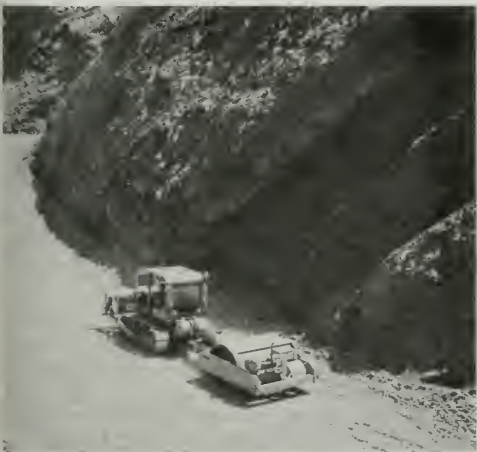
Figure 331. Compacting PerVIOUS Material With 10-Ton Vibratory Roller

Shell. Rock shell material was dumped and spread in 3-foot-thick layers and then rolled with two passes of a vibrating drum roller (Figure 331). Both self-propelled and towed rollers were used. The compacting and grading of this material were closely monitored by testing. These tests involved considerable effort as a field density test required the excavation and weighing of 1,000 to 1,500 pounds of rock, and mechanical analyses required the screening of several thousand pounds of material.

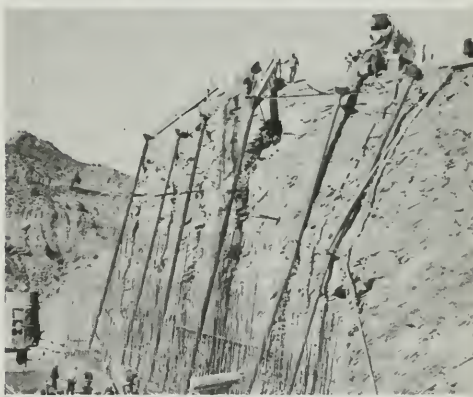
Figure 333. Concrete Placement in Spillway Headworks Invert

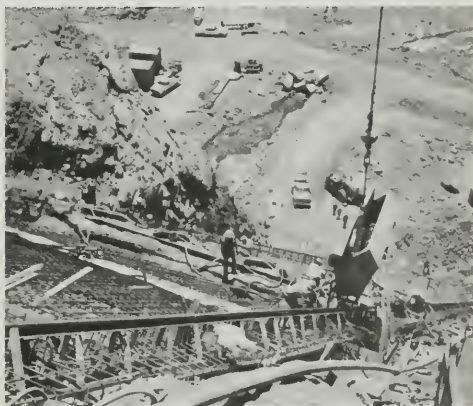
Figure 334. Concrete Placement in Spillway Chute Slab

these conditions, one invert section per day was placed (Figure 334).

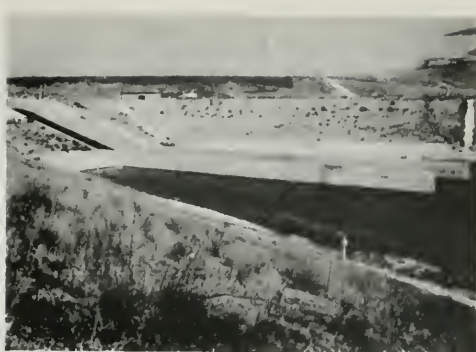
Figure 343. Outlet Works Energy Dissipator

Although counterforts generally are more economical for walls of the height used for the energy dissipator, a gravity structure was designed to increase stability. This was achieved by designing the walls as tapered cantilevers with thickened bases. The additional concrete required for this design increased the weight of the structure and produced the desired stability (Figure 343).

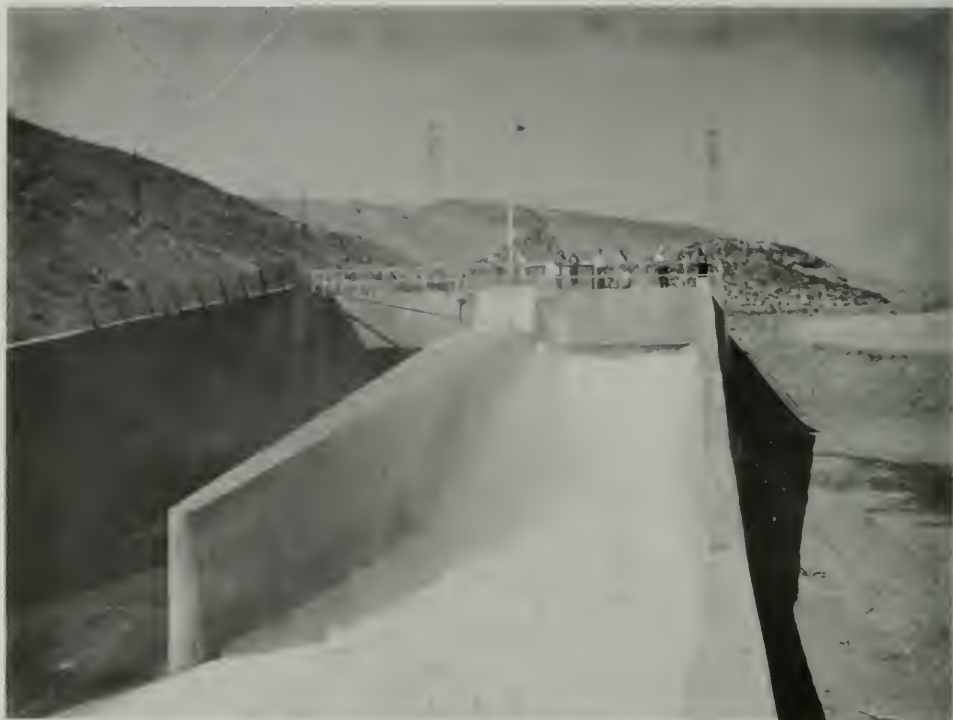
Figure 356. Outlet Works Stream Release

A 19-foot-diameter steel penstock, located in the 27-foot-diameter diversion tunnel, terminates at a bifurcation at Station 50+50. This bifurcation reduces and separates into two 9-foot - 6-inch-diameter penstocks. The stream release facility (Figures 355 and 356) is composed of these two penstocks and three smaller lines that branch from the left 9-foot - 6-inch branch. Fixed-cone dispersion valves and a pressure-reducing valve are used to regulate stream releases. The control valves are protected by butterfly guard valves.

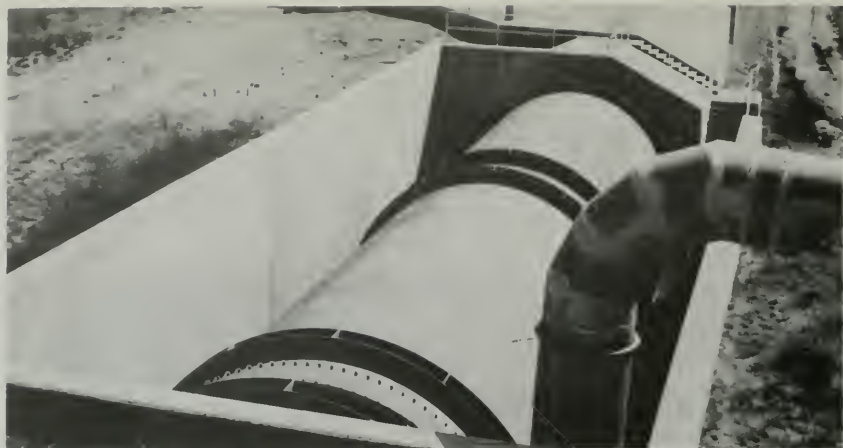
Figure 358. Outlet Works Turnouts

Turnouts just upstream from the bifurcation (Figures 357 and 358) deliver water to the various water users. These turnouts enter vaults containing guard valves which are operated either fully open or fully closed. This permits each water user to regulate the flow rate with his own downstream valving. Meter vaults are located downstream of the guard valve vaults.

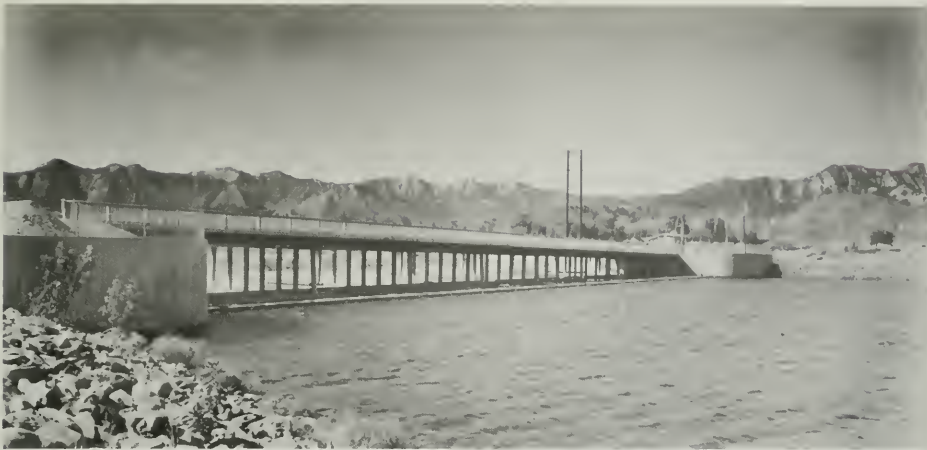
Figure 362. Castaic Lagoon Control Structure

The bridge abutments form a portion of the control structure walls. Cantilever walls of varying height flank these abutments upstream and downstream to complete the control structure walls (Figure 362).

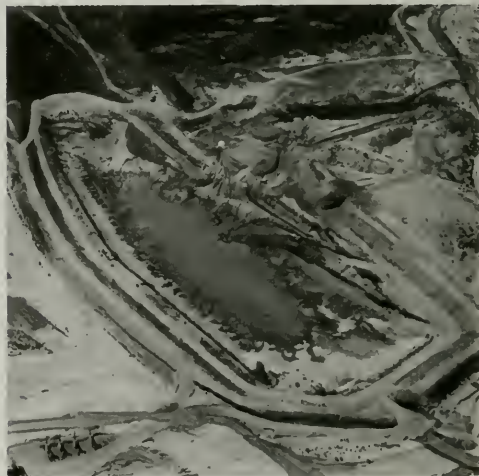
Figure 381. Foundation Exploration Trench

Dewatering operations started May 25, 1967, with pumping from the dam foundation exploration trench. This trench, excavated to bedrock on a previous contract, crossed the stream channel in the vicinity of the dam axis (Figure 381). As the water table was lowered, dam foundation excavation was extended outward from the exploration trench. Ditches at the bases of cut slopes diverted ground flows to sump holes where the water was pumped and discharged

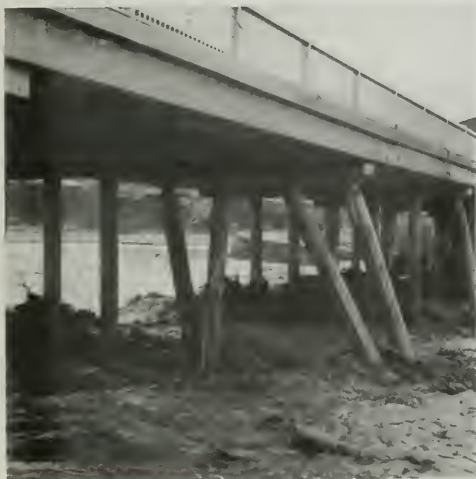
Figure 382. Flood Damage to Lake Hughes Road Bridge

Rainfall continued to delay the work during February 1969. An additional 11.87 inches of rainfall was recorded during that month. The floodflow through the project area at the end of February peaked at 32,000 cfs. The damages sustained during the January flooding were increased. A section of the Lake Hughes Road Bridge was destroyed, and extensive repairs were necessary (Figure 382).

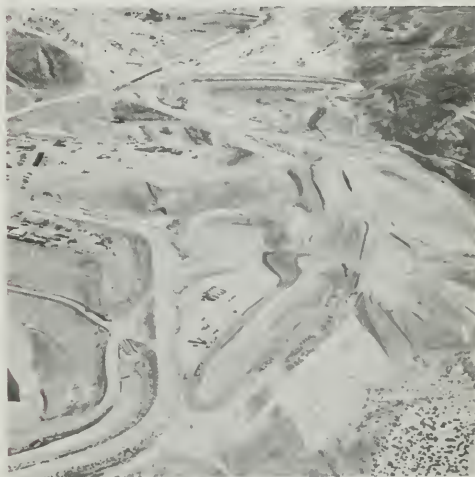
Figure 383. Dam Site at Beginning of Work

Excavation. Excavation for dam foundation included removal of all streambed sands and gravels, landslide material, terrace deposits, soil deposits, and weathered rock required to reach competent foundation material (Figure 383). The extreme upstream portion of the Dam within the stream channel was to rest upon streambed sands and gravels excavated to elevation 1,190 feet leaving about 60 feet of sand and gravel but, when excavation reached this elevation, large silt deposits were discovered. These deposits were removed under a change order, exposing bedrock.

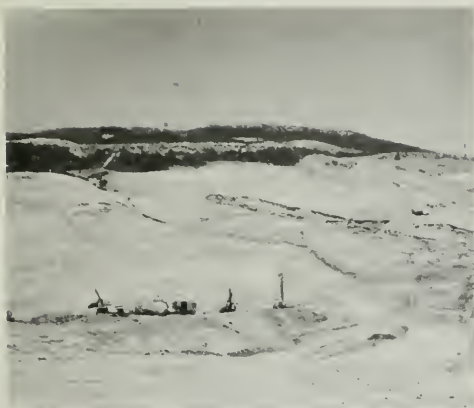
Figure 386. Excavating Slide Area at Left Abutment

Above streambed level, the excavation procedure established by the contractor was to start successive cuts within the abutment areas which would intercept the dam foundation at predetermined elevations to coincide with his embankment construction scheduling. Major problems encountered during the foundation excavation were (1) the uncovering of an existing slide mass not previously detected at the base of the upstream right abutment, (2) the easterly sliding movement of a triangular-shaped block of Castaic formation in the right abutment above the aforementioned slide mass (Figure 384), and (3) the massive slides at the left abutment (Figures 385 and 386).
