# Fire and Water: Assessing Drinking Water Contamination After a Major Wildfire

Cite This: *ACS EST Water* 2021, 1, 1878–1886

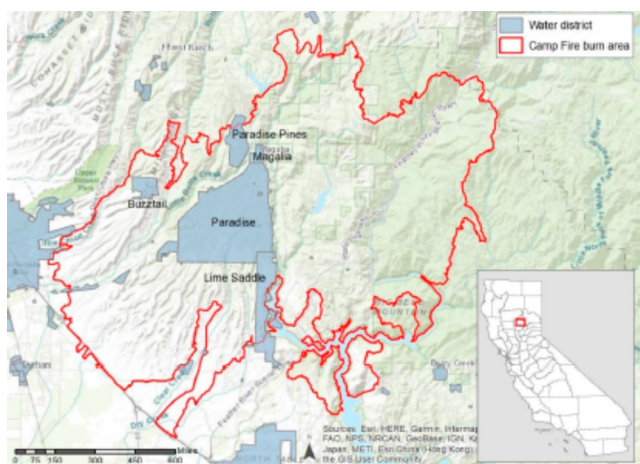
**Figure 1.** Camp Fire burn area and drinking water systems around Paradise, California. The fire burn area is outlined in red, and the water system service areas are shown in blue. Created by C.C. from refs 4–6.

Two water utilities were affected by the Camp Fire: PID and the Del Oro Water Company (DOWC) (Figure 1). Drinking water in the Town of Paradise is supplied by PID from a reservoir and treatment plant just north of the town. Smaller surrounding areas are supplied by noncontiguous districts of DOWC, with Paradise Pines and Magalia on groundwater systems to the north, Lime Saddle on surface water to the south, and Buzztail on a groundwater well to the west. A small

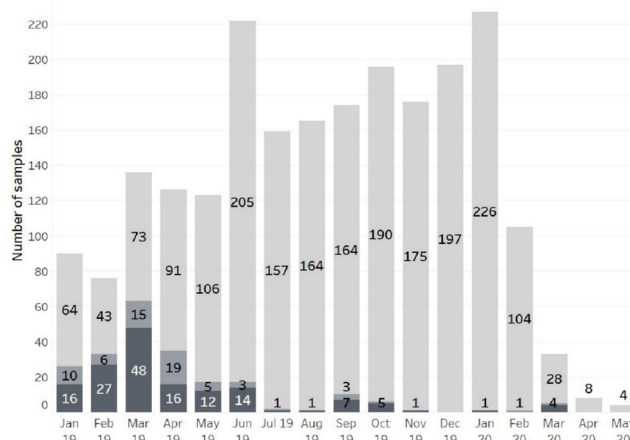
**Figure 2.** Benzene detections in service lines in the PID service area by sampling date (December 2018–May 2020). Sample results displayed by status from lightest to darkest gray: no benzene detection (ND), benzene detected under the maximum contaminant level (MCL), and benzene detected above the MCL.

and  $2.2 \mu\text{g/L}$  in hydrants (i.e., appurtenance). The median concentration of benzene in service line samples from destroyed structures was  $2.4 \mu\text{g/L}$ , compared to  $1.2 \mu\text{g/L}$  in service line samples from standing structures. A majority of benzene detections (74%) were found in service lines, as well as about 70% of detections exceeding the MCL. Service line samples collected at destroyed structures had a much higher proportion of benzene detections above the MCL (21%) compared to samples collected at standing structures (1%) ([Table 1](#)). The distribution of service line samples also showed a higher proportion of benzene detections above the MCL during the first 6 months of sampling ([Figure 2](#)).

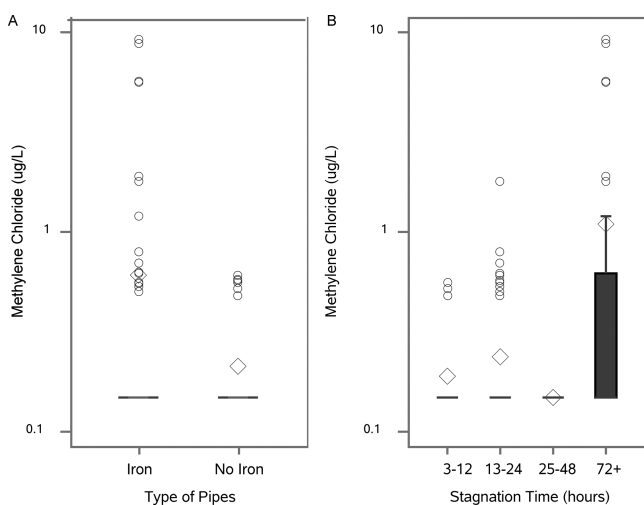
**Figure 3.** MeCl concentrations in tap water by (A) type of pipes and (B) stagnation time. The diamonds represent the means; open circles are outliers; upper and lower box limits are the first and third quartiles. Note: samples below the practical quantitation limit (PQL) minimum level of detection (MDL) were assigned a value equal to the PQL/square root of two; no respondents reported stagnation times between 49 and 71 h.

Although the median level of MeCl did not statistically differ between homes with and without galvanized iron pipes (median = 0.75 and 0.56  $\mu\text{g/L}$ , respectively;  $p = 0.30$ ), the homes with iron pipes had many more outliers in the high range (Figure 3). Among the homes with iron pipes, 14% had concentrations of MeCl above the measured median concentration of 0.62  $\mu\text{g/L}$ , whereas no homes without iron pipes had MeCl above that level. To investigate the hypothesis that bromodichloromethane (BDCM) and chloroform may be debrominated in the presence of zinc or iron to generate MeCl, we examined the sum of BDCM and chloroform concentrations compared to MeCl concentrations in the water (Figure 4). Overall, the sum of BDCM and chloroform was inversely correlated with MeCl ( $r = -0.43$ ,  $p = 0.03$ ). The inverse correlation was stronger when only homes with iron pipes were examined ( $r = -0.56$ ,  $p = 0.02$ ) and was nonsignificant in homes without iron pipes ( $r = -0.32$ ,  $p = 0.54$ ).

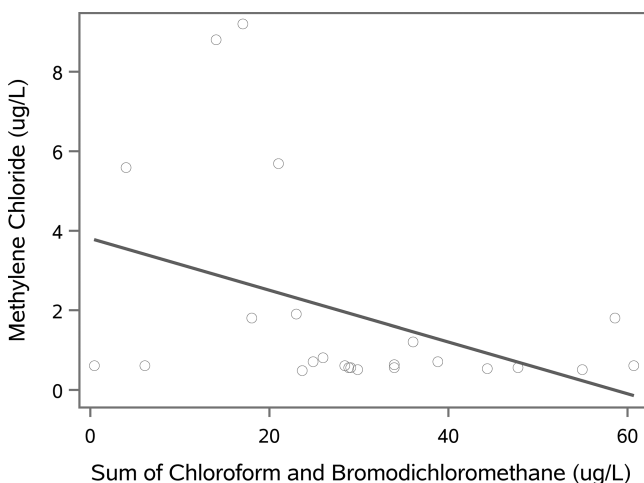
**Figure 4.** Relationship between methylene chloride concentration and the sum of the concentrations of chloroform and bromodichloromethane in 24 homes with detections of all three chemicals. Note: correlation coefficient =  $-0.43$ ,  $p = 0.02$ .

MeCl (dichloromethane) could potentially be produced from the dechlorination of chloroform (trichloromethane) or the debromination of bromodichloromethane (BDCM), especially in the presence of iron or zinc in pipes. One laboratory study found that chloroform can be transformed to MeCl within hours under experimental conditions and that MeCl subsequently remains stable for days or longer.<sup>19</sup> The dehalogenation hypothesis is supported by the higher concentrations of MeCl we found in tap water samples with longer stagnation times and longer distances between the tap and the service connection, especially in homes with galvanized iron pipes. The inverse association we found between MeCl concentration and the concentration of chloroform and BDCM, especially in homes with galvanized iron pipes, also supports the hypothesis that these trihalomethanes may be converted to MeCl in the presence of iron and zinc. PID was concerned that a galvanized riser they were using for sample collection was responsible for some of the MeCl detections in their data even though the water may have only been in contact with the galvanized riser for seconds, and they flagged some MeCl detections as potentially unreliable for this reason; however they also found MeCl in samples when the riser was not used. If this hypothesis is correct, MeCl could be produced in the absence of a wildfire, from stagnant disinfected water in iron pipes.
